# **Route 6 Westport / Dartmouth Safety Study**

**November 2003**

**Southeastern Regional Planning and Economic Development District**

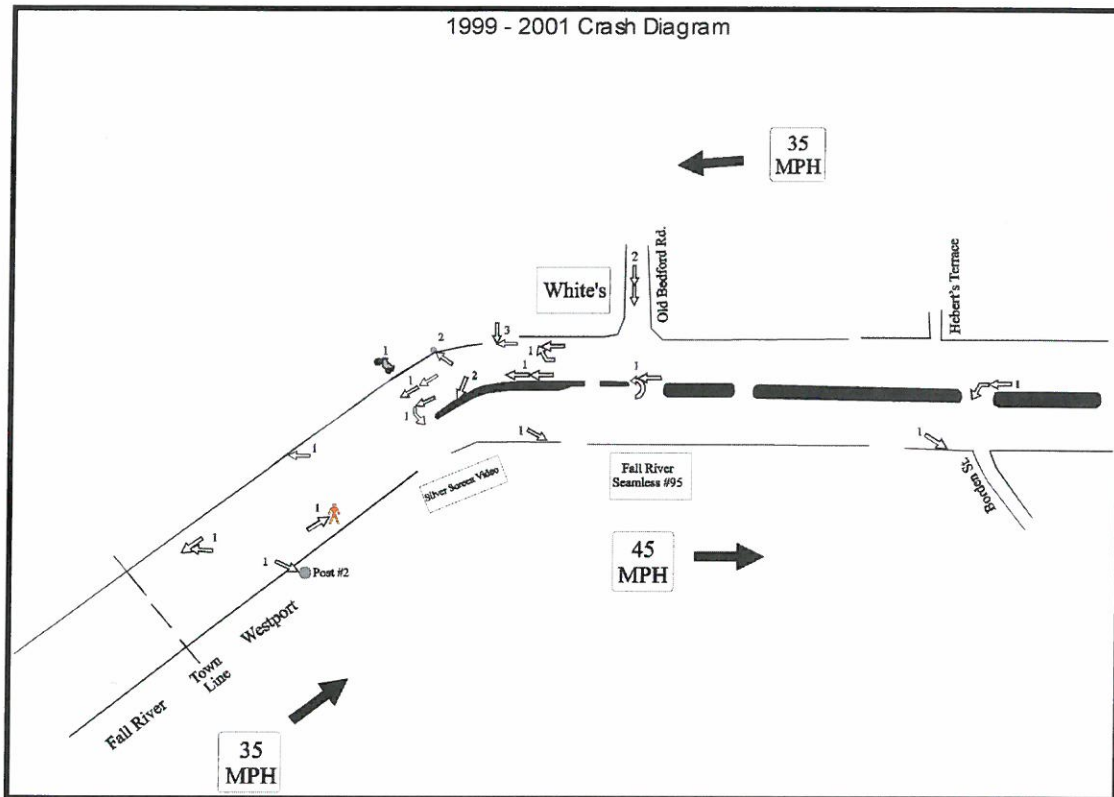
**Figure 2**  
**Route 6 - (Fall River Town Line to Borden Street) Crash Diagram**

The most evident problem in this area is the sharp curve at the White's property. 35% of the total crashes involved a westbound motorist hitting a fixed object following a loss of control, which is likely due to excessive speed. (See Figure 2, on the following page.) The average speed approaching the curve is 46 mph. The placement of the 35 mph speed limit sign in the westbound direction is intended to warn motorists of the danger ahead at the curve. The sign has limited effectiveness. The speed limit sign alone is simply not enough warning to slow traffic. There are also 2 chevron signs at the curve that are not visible until a motorist is already into the curve. (See Figure 3, on the following page.) According to the Manual on Uniform Traffic Control Devices (MUTCD) "Chevron...signs should be visible for a sufficient distance to provide the road user with adequate time to react to the change in alignment." This is presently not the case. The least expensive and most timely solution would be improved signage preceding the curve. In addition to adding chevrons, "Reduced Speed Ahead" and "Dangerous Curve" signs could also be added.

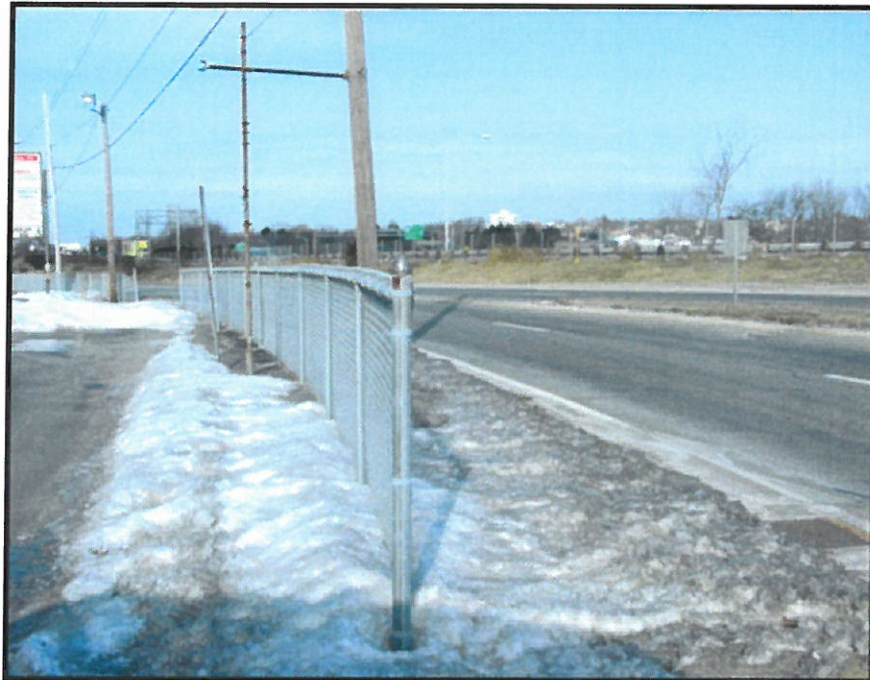
**Figure 4**  
**Westport Video Plaza sight distance looking westbound**

Looking to the west, there is a serious sight distance problem encountered by motorists attempting to exit the Video Plaza across from White's due to the curve in the road, as well as the placement of the fencing at the parking lot. (See Figure 4, below.) Following the curve, at the western entrance to the Video Plaza, the median ends and the road becomes undivided, making any attempted left-turns into or out of the plaza hazardous. This compounds the problem of the poorly designed driveways at the Video Plaza and adds to the overall safety issue of the sharp curve in the road.

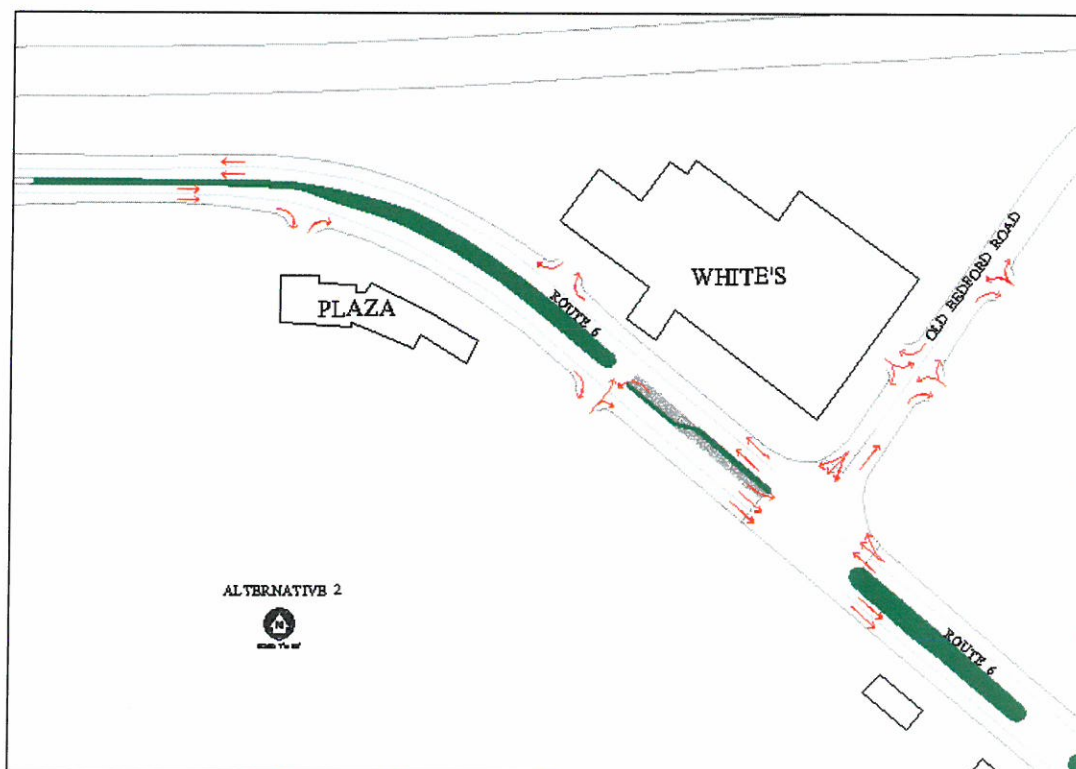
**Figure 6**  
**Extension of median in westbound direction & Plaza Entrance relocation**

There is a lack of curbing along the White's property, which fails to define for motorists where the proper exit points are in the parking area. This is a potential safety problem that could be easily rectified with curbing and markings.

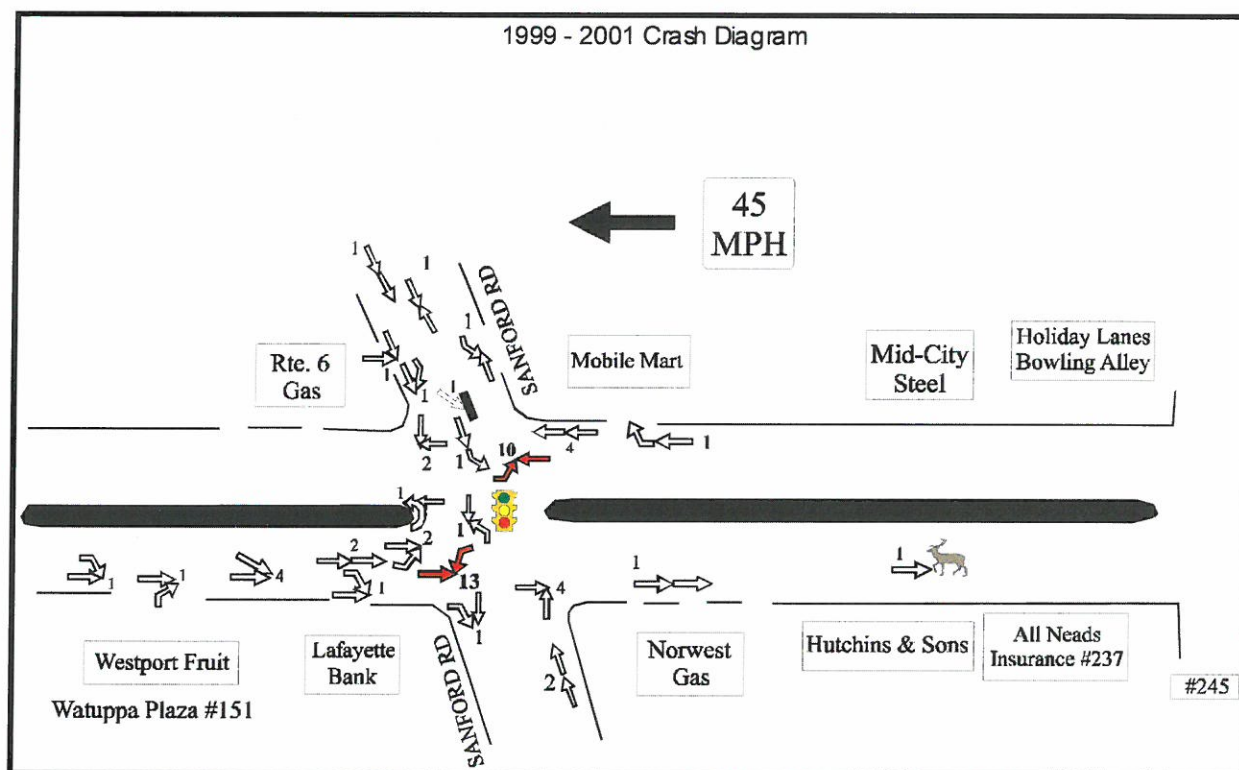
**Figure 7**  
**Route 6 - (Watuppa Plaza to Holiday Lanes Bowling Alley) Crash Diagram**

The most serious safety issue in this area is the intersection of Sanford Road at Route 6, which is the 10<sup>th</sup> most dangerous intersection in the region. The most frequent type of crash at this intersection is left-turn versus opposing thru movements along Route 6. (See Figure 7, below.) This configuration accounted for 23 of the total number of crashes, and 50% of these involved injuries. There were also a significant number of sideswipes on the eastbound approach, evidently due to motorists swerving into the right lane to avoid being delayed by left-turning vehicles.

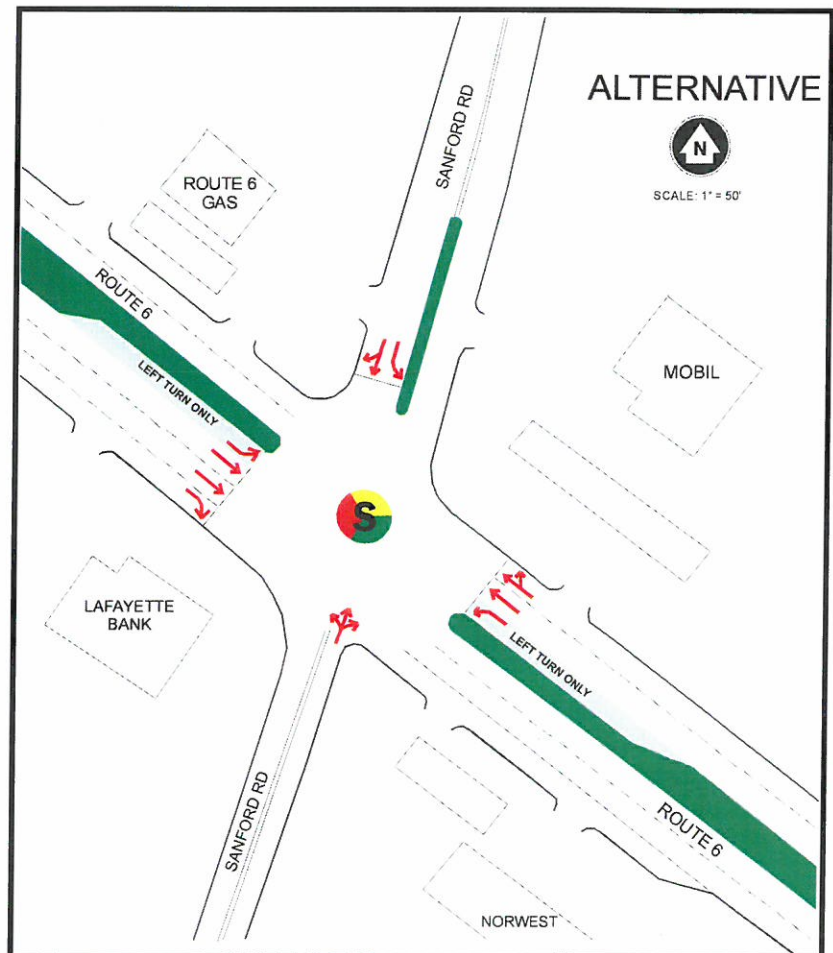
**Figure 8**  
**Route 6 @ Sanford Road with added left turning lanes**

Motorists approaching this intersection and attempting a last minute lane change in order to make a turn impede the flow of following traffic, as well as increase the probability of a crash, especially sideswipe crashes. In addition to the revision of the signal system and separate left turn lanes, appropriate pavement markings are recommended to adequately inform approaching motorists of proper and safe lane usage at the intersection.

Modifying the signal timing to protect the left turns will likely cause confusion and compound the existing eastbound sideswipe problem unless the left turning vehicles are provided with their own turning lane. This would entail reconstruction at the intersection by cutting into the medians to add separate left turn lanes, as well as revising the signal system. (See Figure 8.) A “to scale” drawing may be found in Appendix D. The addition of exclusive left turn lanes could add to the total cost established by MassHighway.

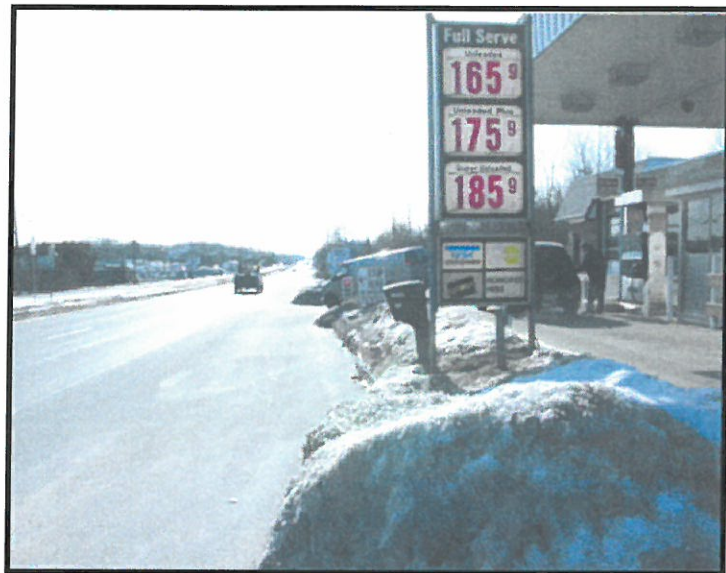
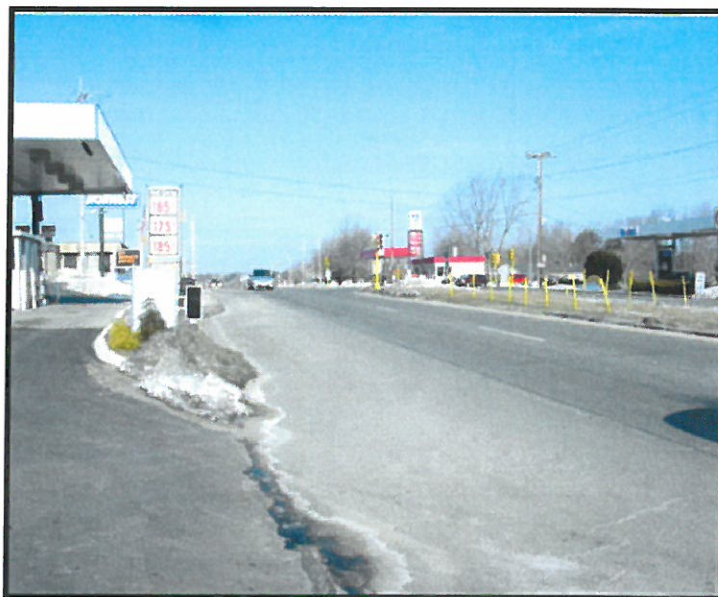
Another safety issue at this intersection is the inspection lane at the Norwest gas station that allows vehicles to queue up on Route 6 while waiting. (See Figures 9 and 10, below.) Allowing several vehicles, without brake lights, to park on the side of Route 6 is not only bad design, but a safety issue, as well. This practice needs to be eliminated.

**Figure 9**  
**Inspection lane looking eastbound**

**Figure 10**  
**Inspection lane looking westbound**

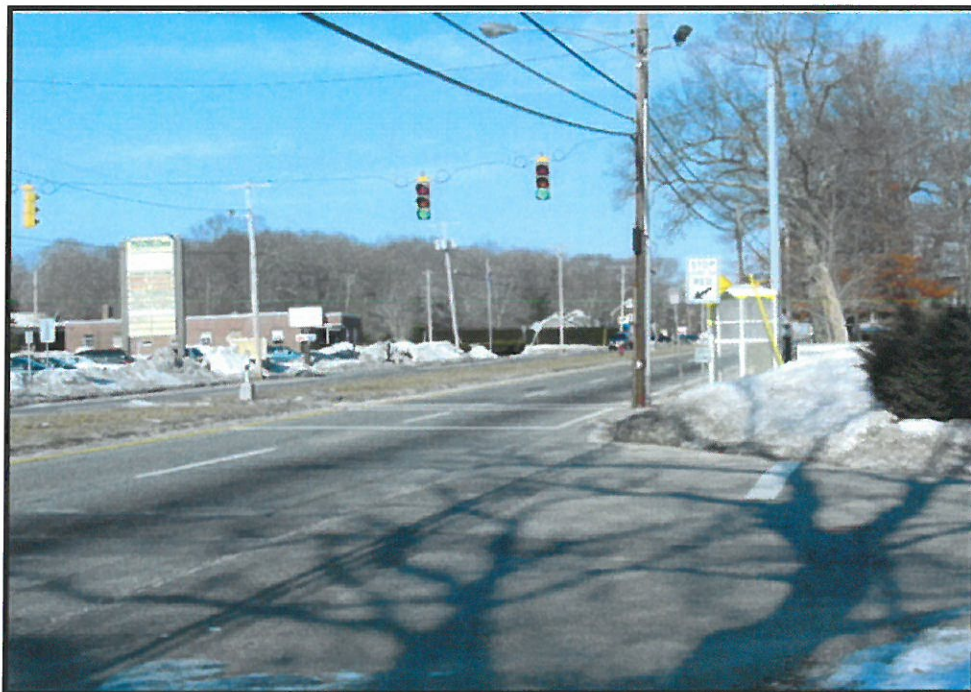
**Figure 14**  
**Signalized Crosswalk Connecting Westport Plaza**  
**& Greenwood Terrace**

Although the speed limit along Route 6 is not conducive to pedestrian travel, there are two pedestrian crosswalks within 300 feet. The first is a pedestrian activated signalized crosswalk that serves Greenwood Terrace (an elderly housing complex), a public bus stop and Westport Plaza. (See Figure 14, below.) Both the Westport Police Department and residents of Greenwood Terrace have expressed their concerns regarding the safety of the signalized crosswalk. Although this crosswalk operates under a pedestrian activated push-button control, motorists who regularly travel along Route 6 are so familiar with the almost constant “green” phase that they often drive right through the red light when it is activated. The Westport police stated that “9 times out of 10” motorists do not stop for this red light, which has obviously become an unanticipated stop for most motorists. The SRPEDD staff conducted their own testing of this light. The button was pushed 6 times and motorists ran the red light on 4 out of those 6 times. It was obvious that most of the motorists running the red light were not even aware of it. Regular police enforcement of this pedestrian signal is highly recommended.

The signal provides a 31 second red phase to allow pedestrians to cross four lanes and a wide median. This timing may be inadequate for an elderly or handicapped pedestrian, especially if they had to wait to recognize that all vehicles at both approaches had stopped.

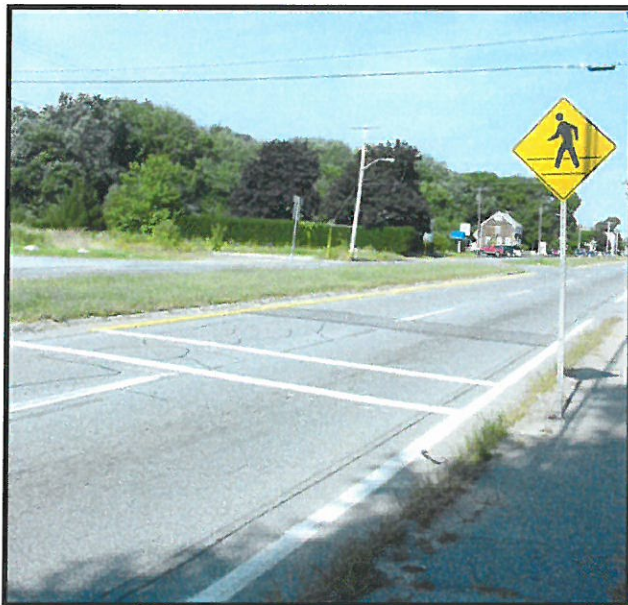
**Figure 15**  
Crosswalk Leading to Post Office

The other, unsignalized crosswalk leads to the Post Office. (See Figure 15, below.) This crosswalk gives pedestrians a false sense of security. If motorists do not always stop at the signalized crosswalk, there is little likelihood that they will stop at this unsignalized one. The crosswalk is very difficult to see, especially with the speeds regularly traveled and the amount of traffic on the road. This crosswalk is simply not visible enough. There is evidence, by the worn path in the median grass, that the crosswalk is regularly utilized, so although it has a great potential for accidents, removing it is not recommended. It is recommended that signals be placed at the unprotected crosswalk that are fully synchronized with the existing signals at Greenwood Terrace/Westport Plaza, so when the pedestrian light is actuated at either location, all the beacons will signal for traffic stoppage at both crosswalks simultaneously. (See Figure 16, below.)

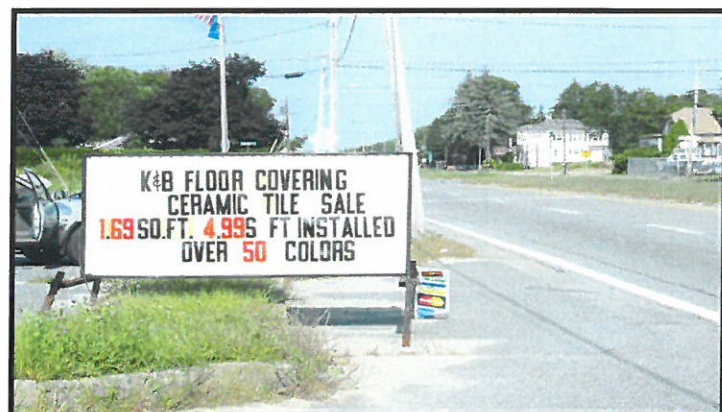
**Figure 17**  
Westport Plaza View looking Westbound

Another safety issue to note is a portable advertising sign that is presently creating a serious sight distance problem in the east bound direction of travel for any motorist attempting to exit the Westport Plaza. (See Figure 17.) This sign needs to be removed or relocated immediately.

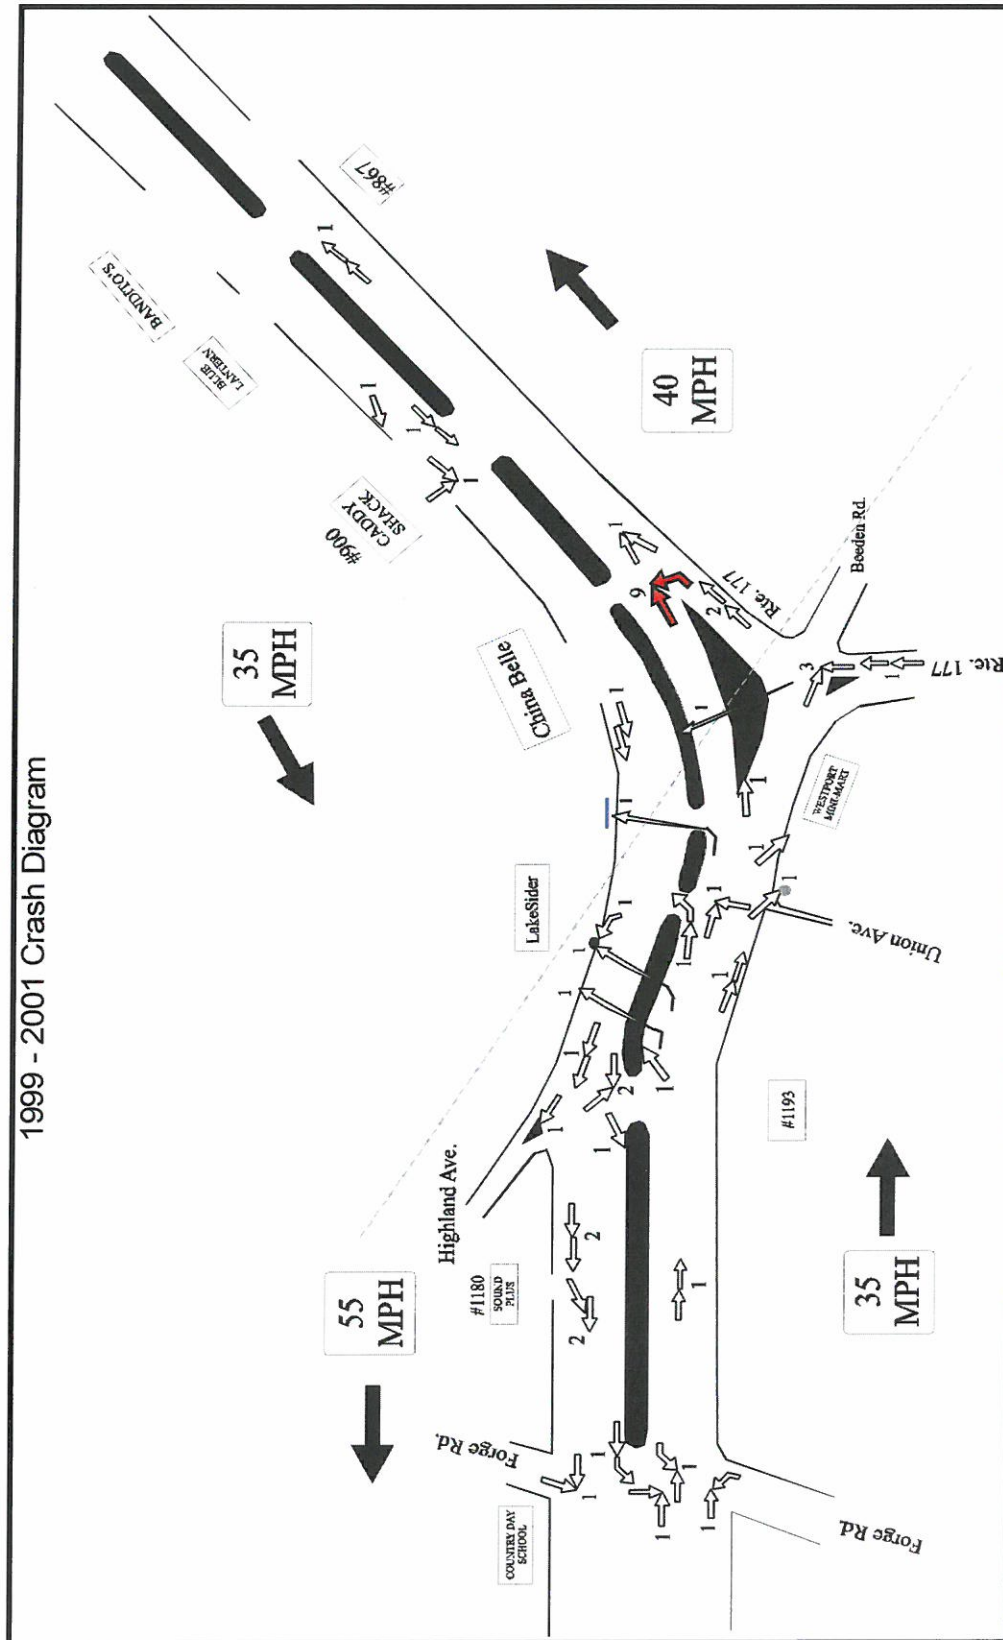
Figure 19  
Route 6 - (Forge Road to Bandito's) Collision Diagram

The intersection of Route 6 with Route 177 forms a merge onto Route 6 eastbound. Motorists wishing to go westbound on Route 6 from Route 177 need to first merge on a curve. The motorist must then very quickly change lanes over to the median opening at the China Belle Restaurant and wait for a gap in the westbound flow while sitting in the eastbound high speed lane. There were nine crashes during the study period that were a result of this movement. (See Figure 19, on the following page.) Unfortunately, there was a fatality in 2002 due to this movement. If the median is closed to alleviate the problem, the problem will then simply move to the next median in the road. There are several alternatives proposed for the intersection. All of the proposals entail closing the China Belle median opening and offer motorists wishing to make a turn an opportunity to do so safely at another location.

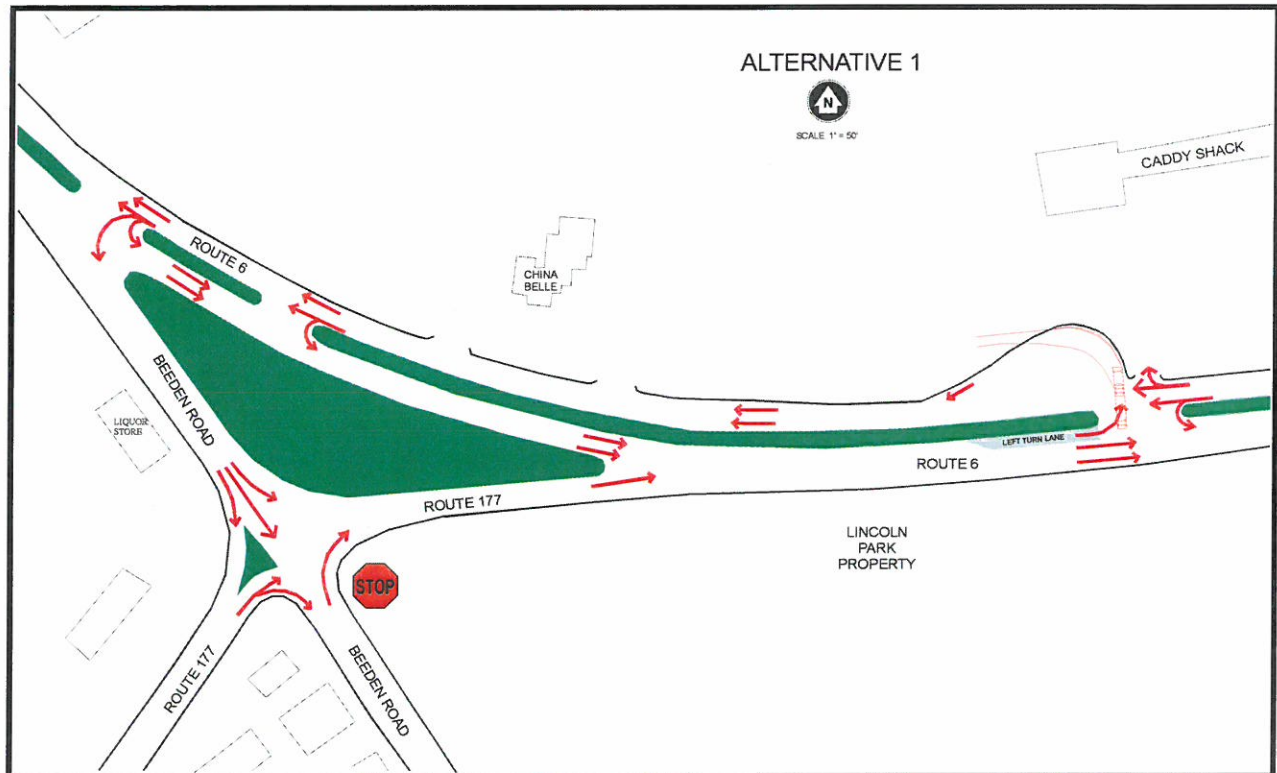
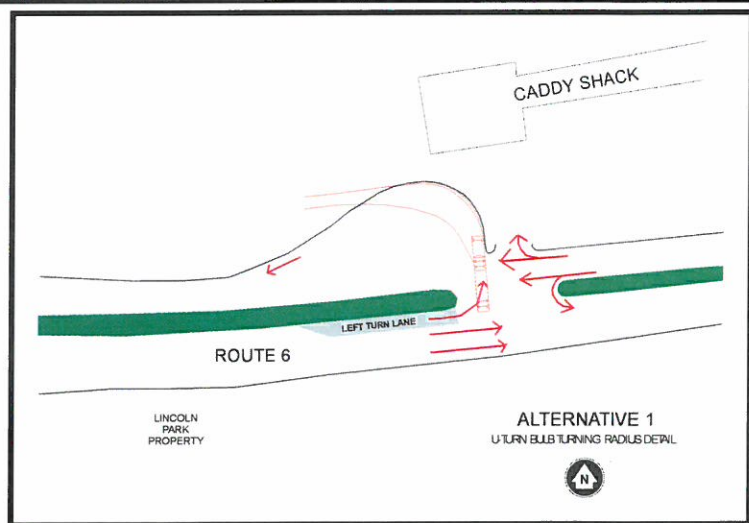
**Figure 20**  
**Alternative 1 - U-turn bulb**  
**at Caddy Shack frontage**

**Figure 21**  
**Alternative 1 - Close-Up of U-turn bulb at**  
**Caddy Shack frontage**

The first alternative would be to construct a U-turn bulb at the frontage of the Caddy Shack property. (See Figures 20 and Figure 21, below.) "To scale" drawings can be found in Appendix E. A U-turn bulb is a method to provide more road surface to accommodate the turning radius needed to make U-turns. This would entail private land takings from the Caddy Shack property. In addition to the construction of the bulb, a left turning lane would need to be provided at the entrance to the Caddy Shack in the eastbound direction of travel. This would involve modifications to the existing street layout and could require taking a sliver of land from the Lincoln Park property site. If this alternative were seriously considered, further analysis would be recommended to determine if a traffic signal would be warranted.

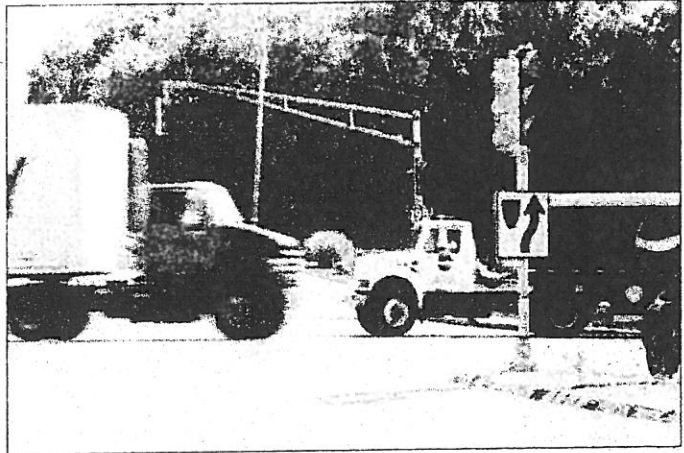
At the intersection of Route 6 and Sanford Road in Westport Wednesday, two trucks seem dangerously close to each other. The recently appointed Route 6 Task Force is trying to make the road safer for motorists and pedestrians.

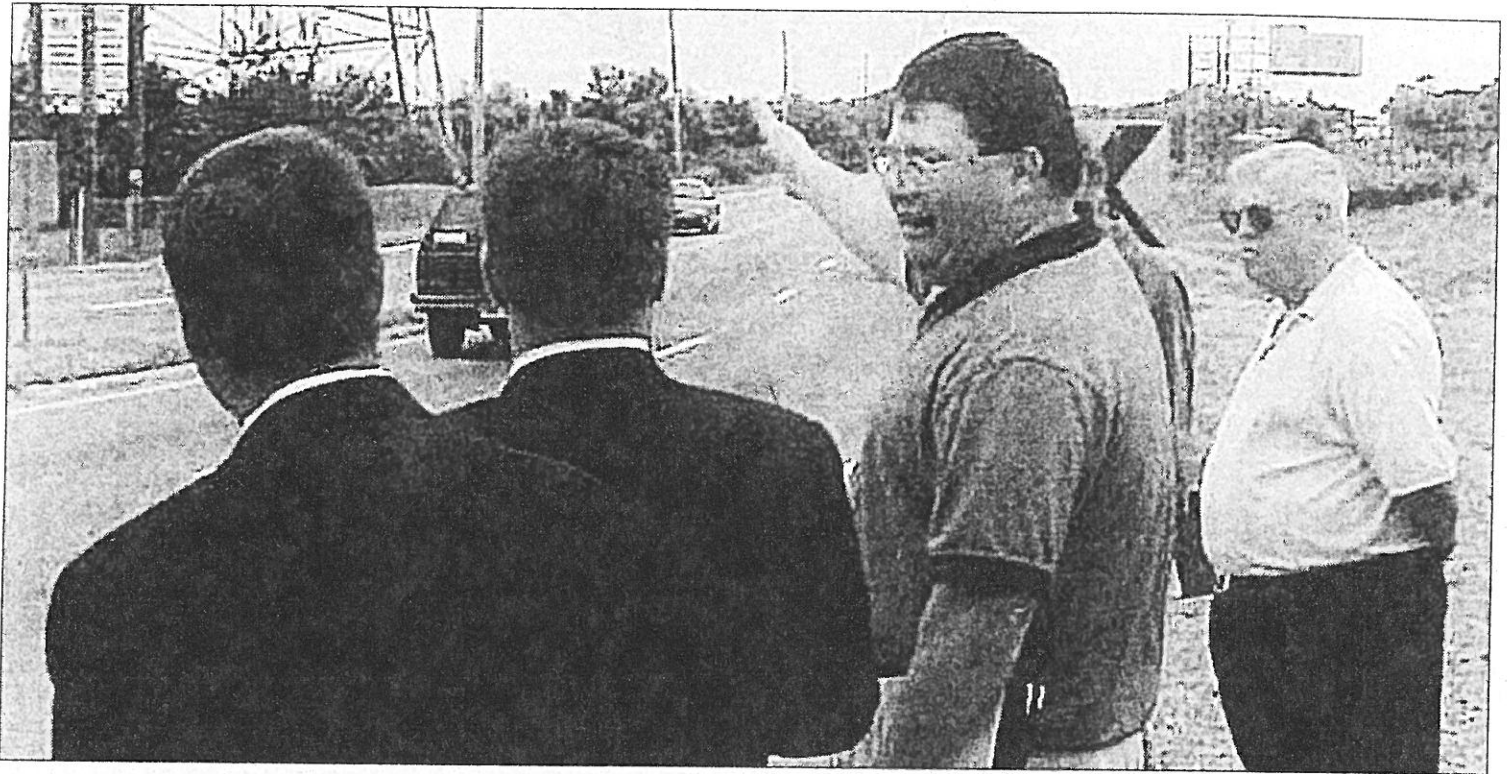
Route 6 Advisory Task Force chairman Steven J. Ouellette and members of his committee brief state highway officials of some of the safety problems near a sharp curve in the state highway near White's of Westport.

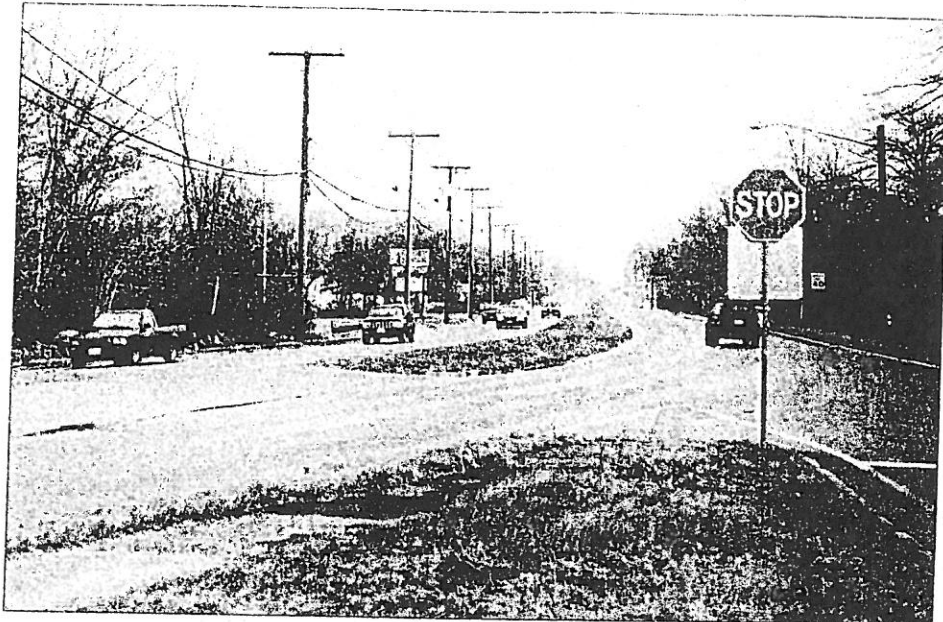
**OFFICIALS** are looking into the possibility of closing off this left hand turn on Rt. 6 at Lincoln Park, the site of several accidents including a recent fatality. (Chronicle Photo by Bill Hall)

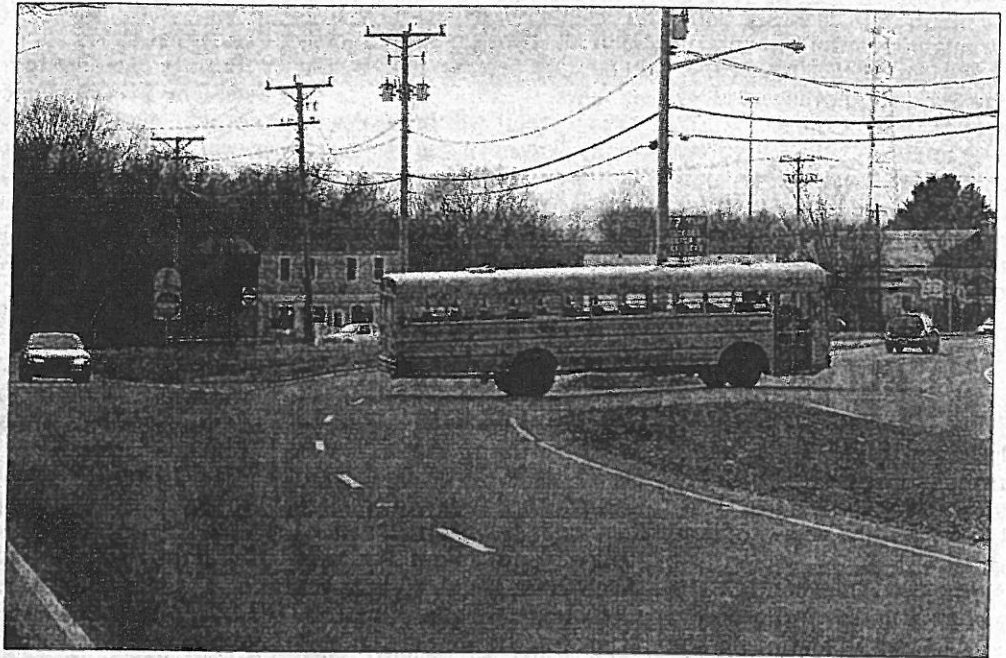
Looking west on Route 6 near the Lincoln Park property, the cut-out where this bus is turning was the site of the accident that killed Floyd Fineberg in December. Town officials in both Dartmouth and Westport, looking to increase safety on the road, are looking to make design changes to the road.
