# Route 1 Corridor Study

North Attleborough and Attleboro

SRPEDD 88 Broadway, Taunton

September 2019

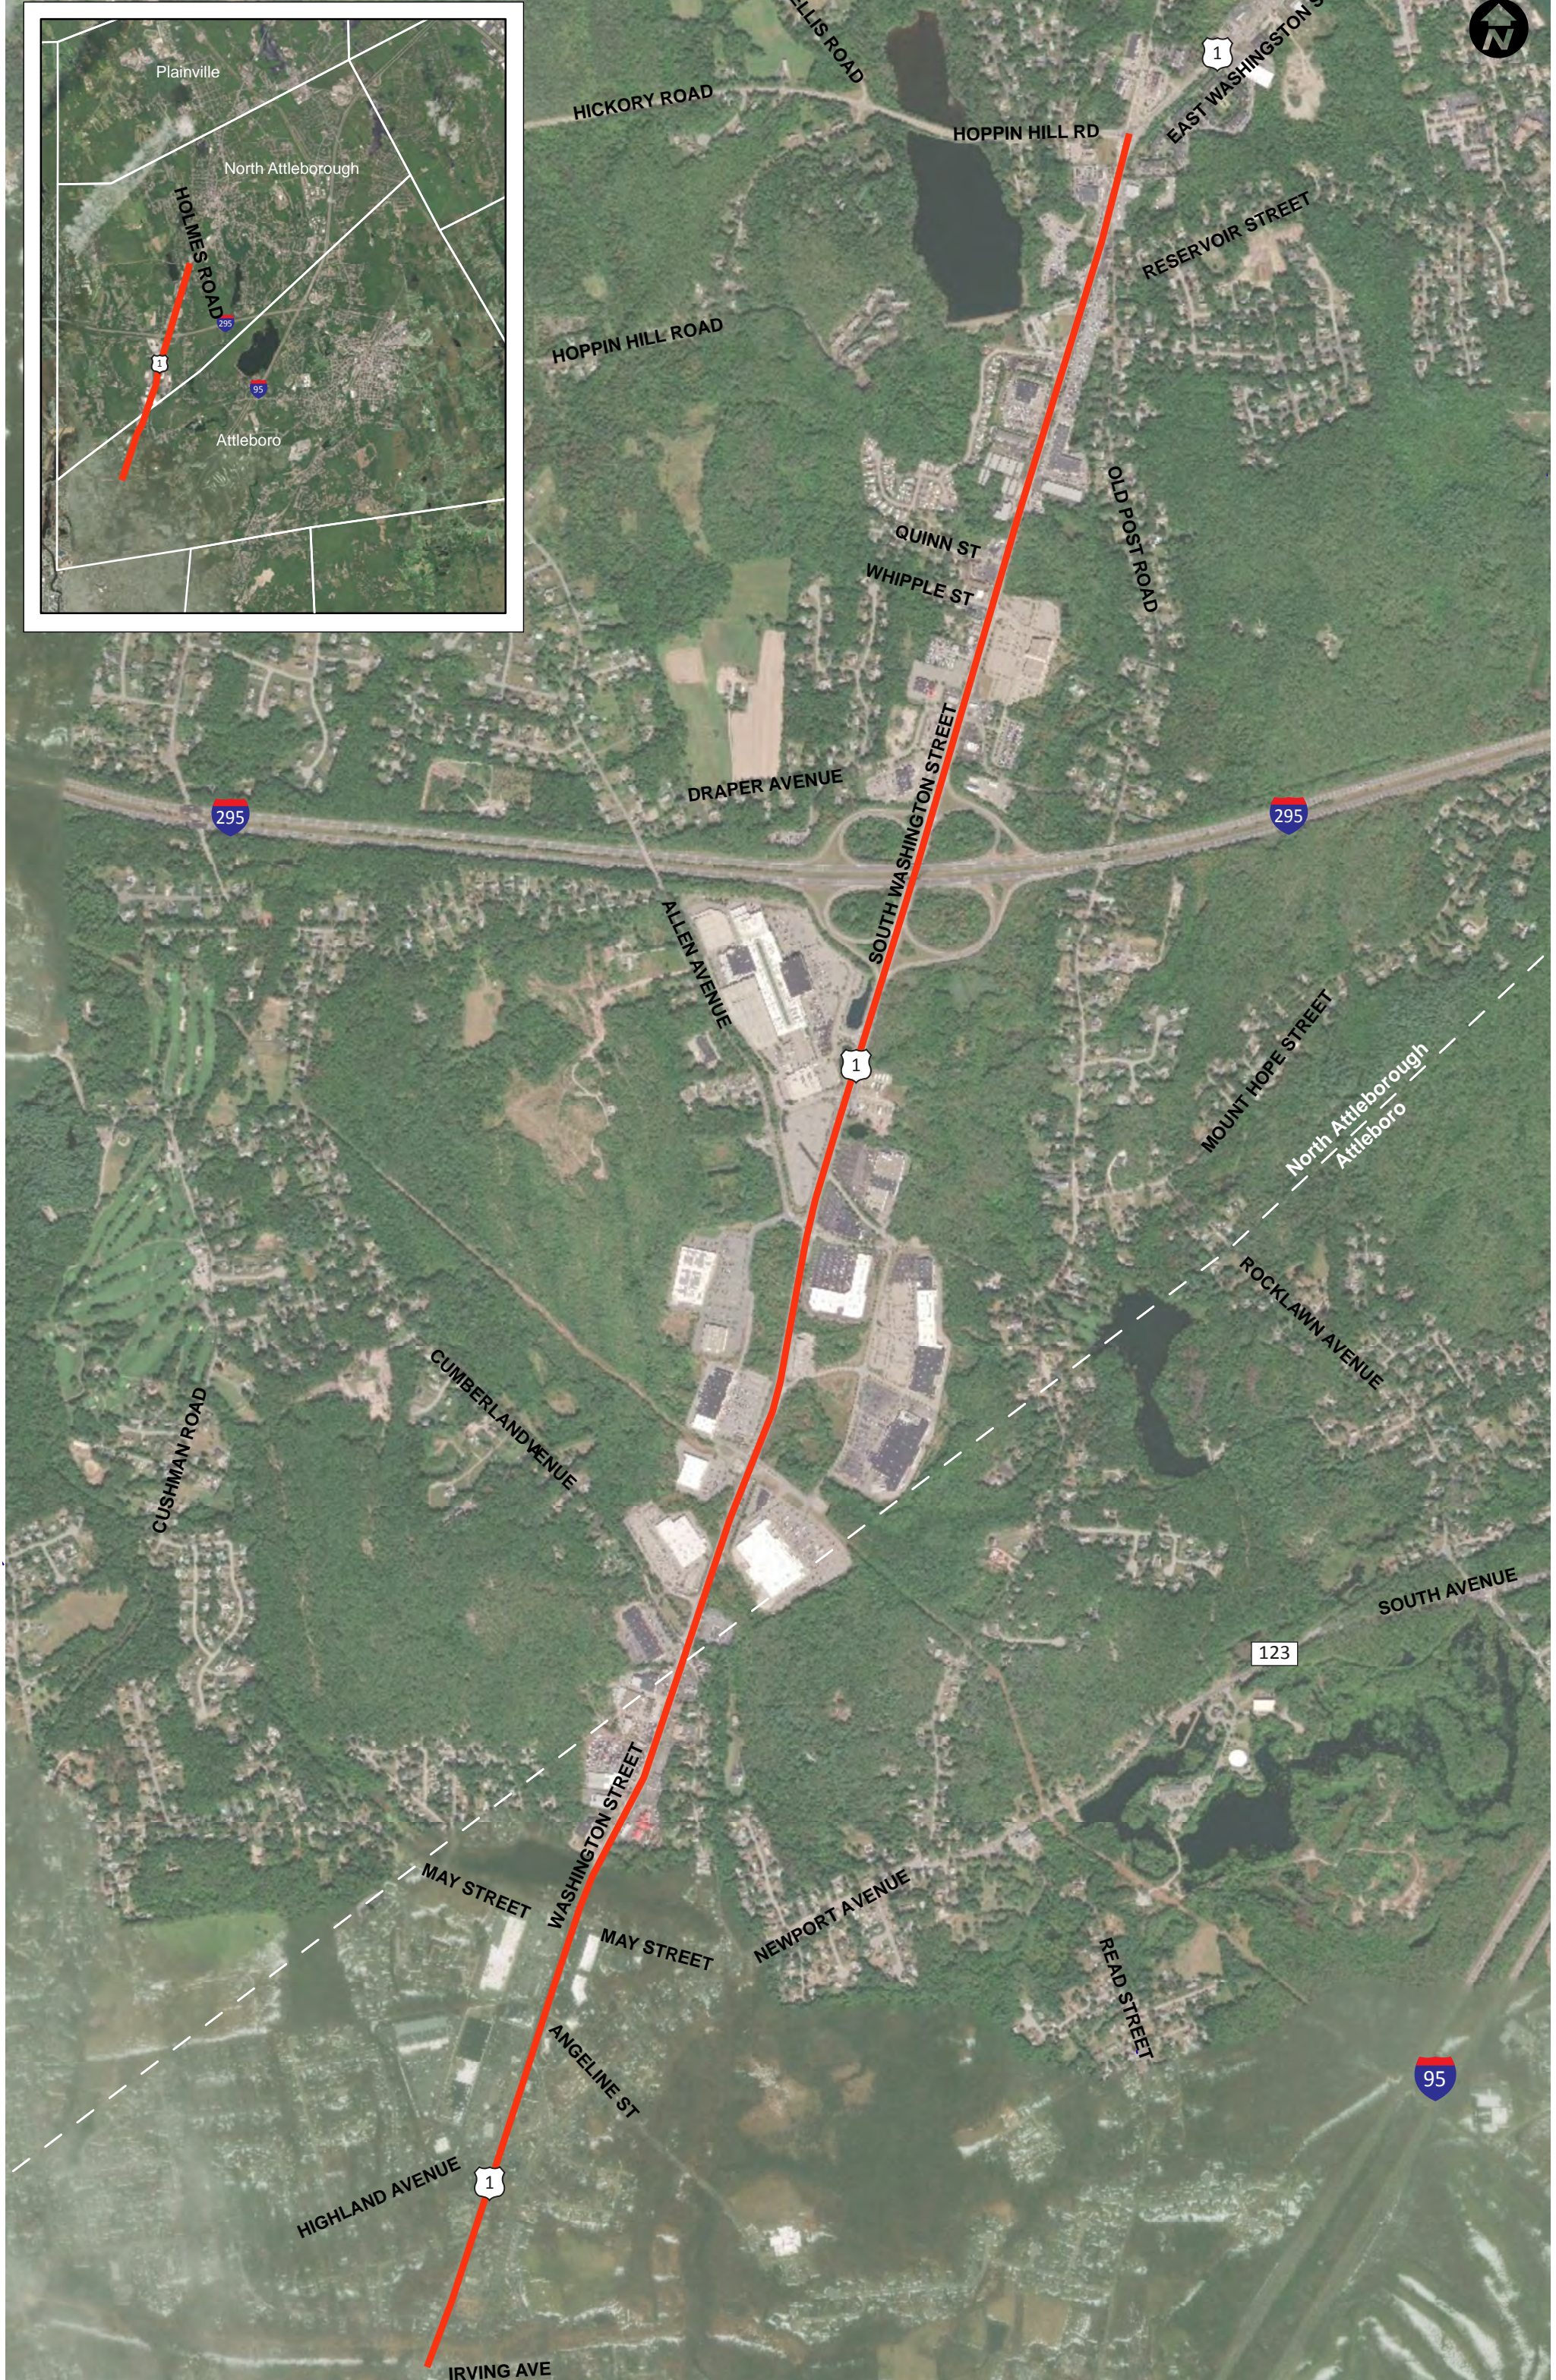
Figure 1- Study Area

The study area is a densely developed commercial corridor with plazas and retail outlets with numerous driveway curb-cuts. The corridor provides access to the Emerald Square Mall, a Walmart super center, Fashion Crossing, the Shoppes at Mayfaire, several auto dealerships, restaurants, gas stations and numerous smaller retail outlets. There is very little residential land use along the study area with the exception of the Riverview Estates and the Royal Park Apartments. Riverview Estates is a 55 and older mobile home park in North Attleborough, with its entrance located just south of Hoppin Hill Road (Route 120). The Royal Park Apartments is a 224-unit complex of apartments and townhouses with access from two locations directly from Route 1, the first just south of Hoppin Hill Road and the second just north of Hoppin Hill Road, both from Route 1.

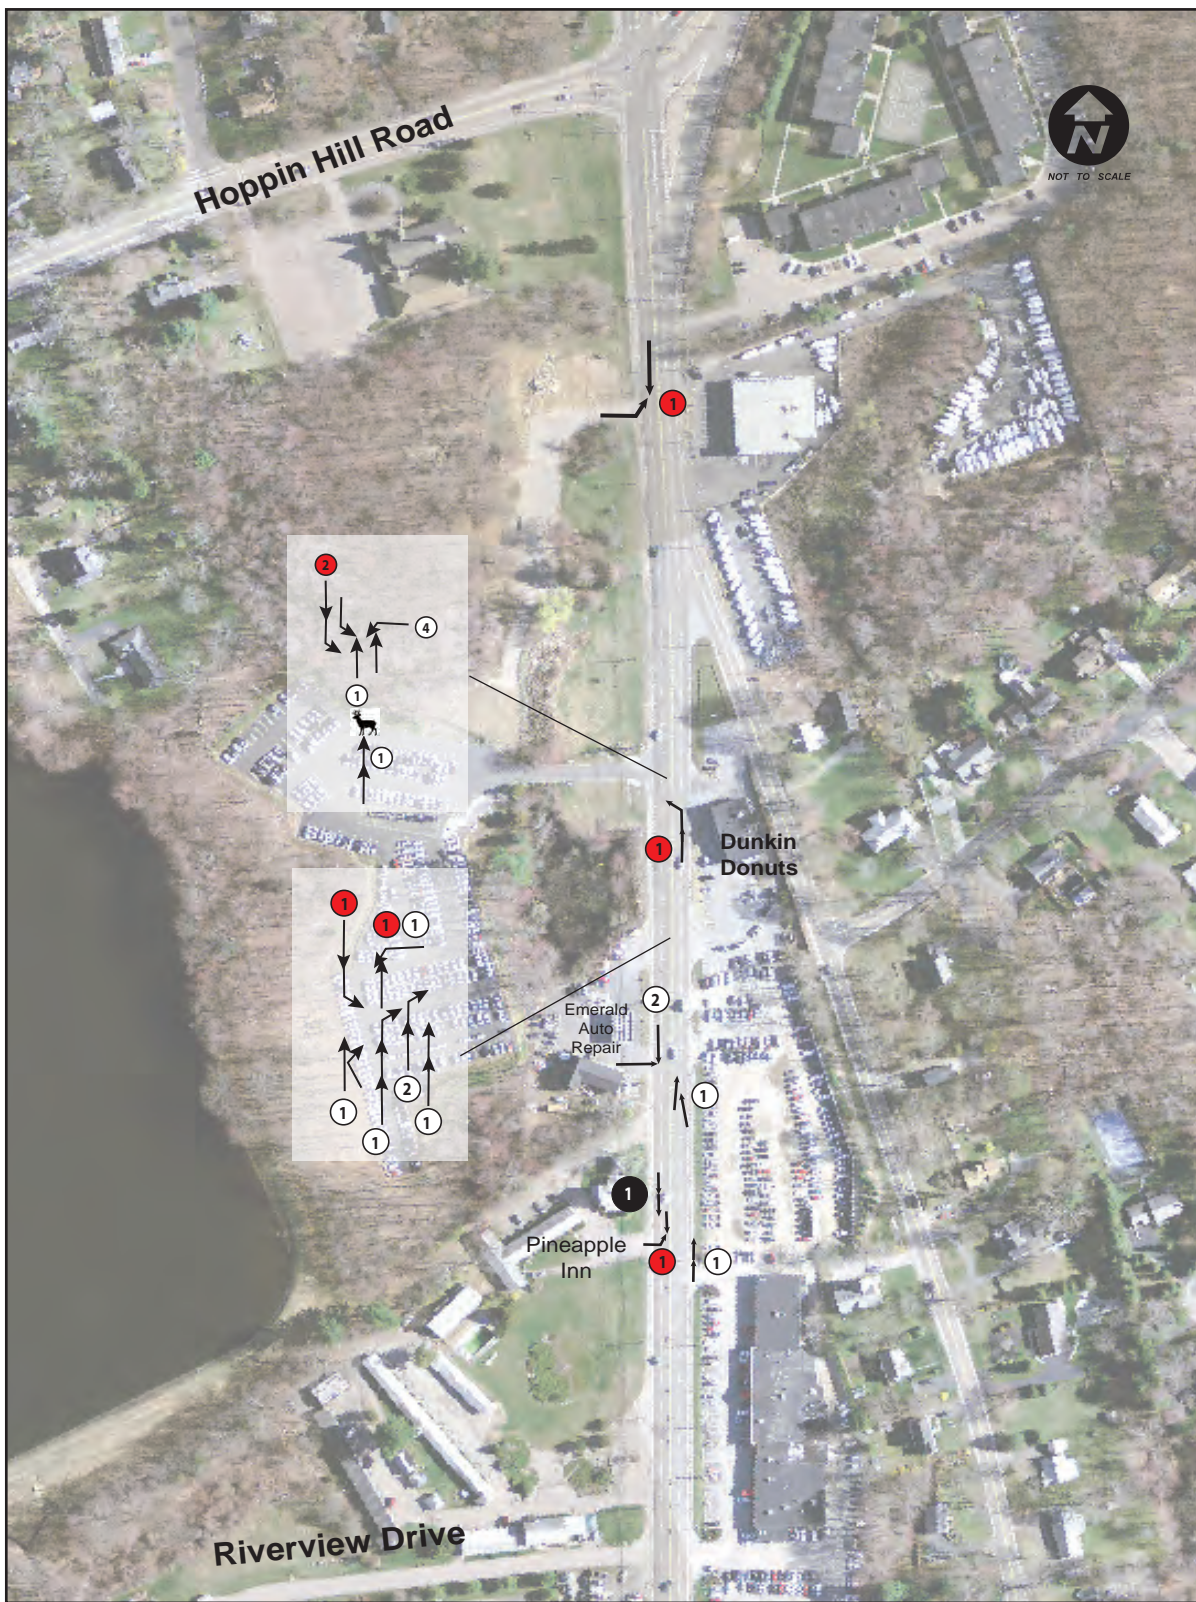
Lastly, the segment between Hoppin Hill Road and Riverside Drive in North Attleborough should be considered for improvements. (See Figure 5.) There were a total of 24 crashes along this segment of roadway with 8 (33%) of them resulting in injury, including a fatality. The majority of these crashes 16 (66%) occurred at the two driveways providing access to the Dunkin Donuts located there.

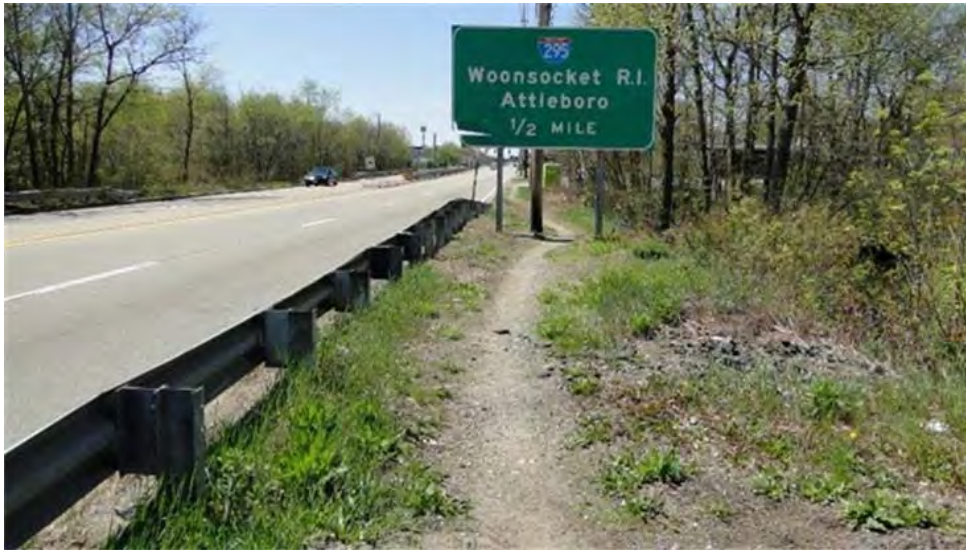
**Figure 7: Pedestrian beaten path in North Attleborough near Quinn Street**

There are several locations without sidewalks that show evidence of pedestrian demand through the presence of worn and beaten paths, an example shown in Figure 7.

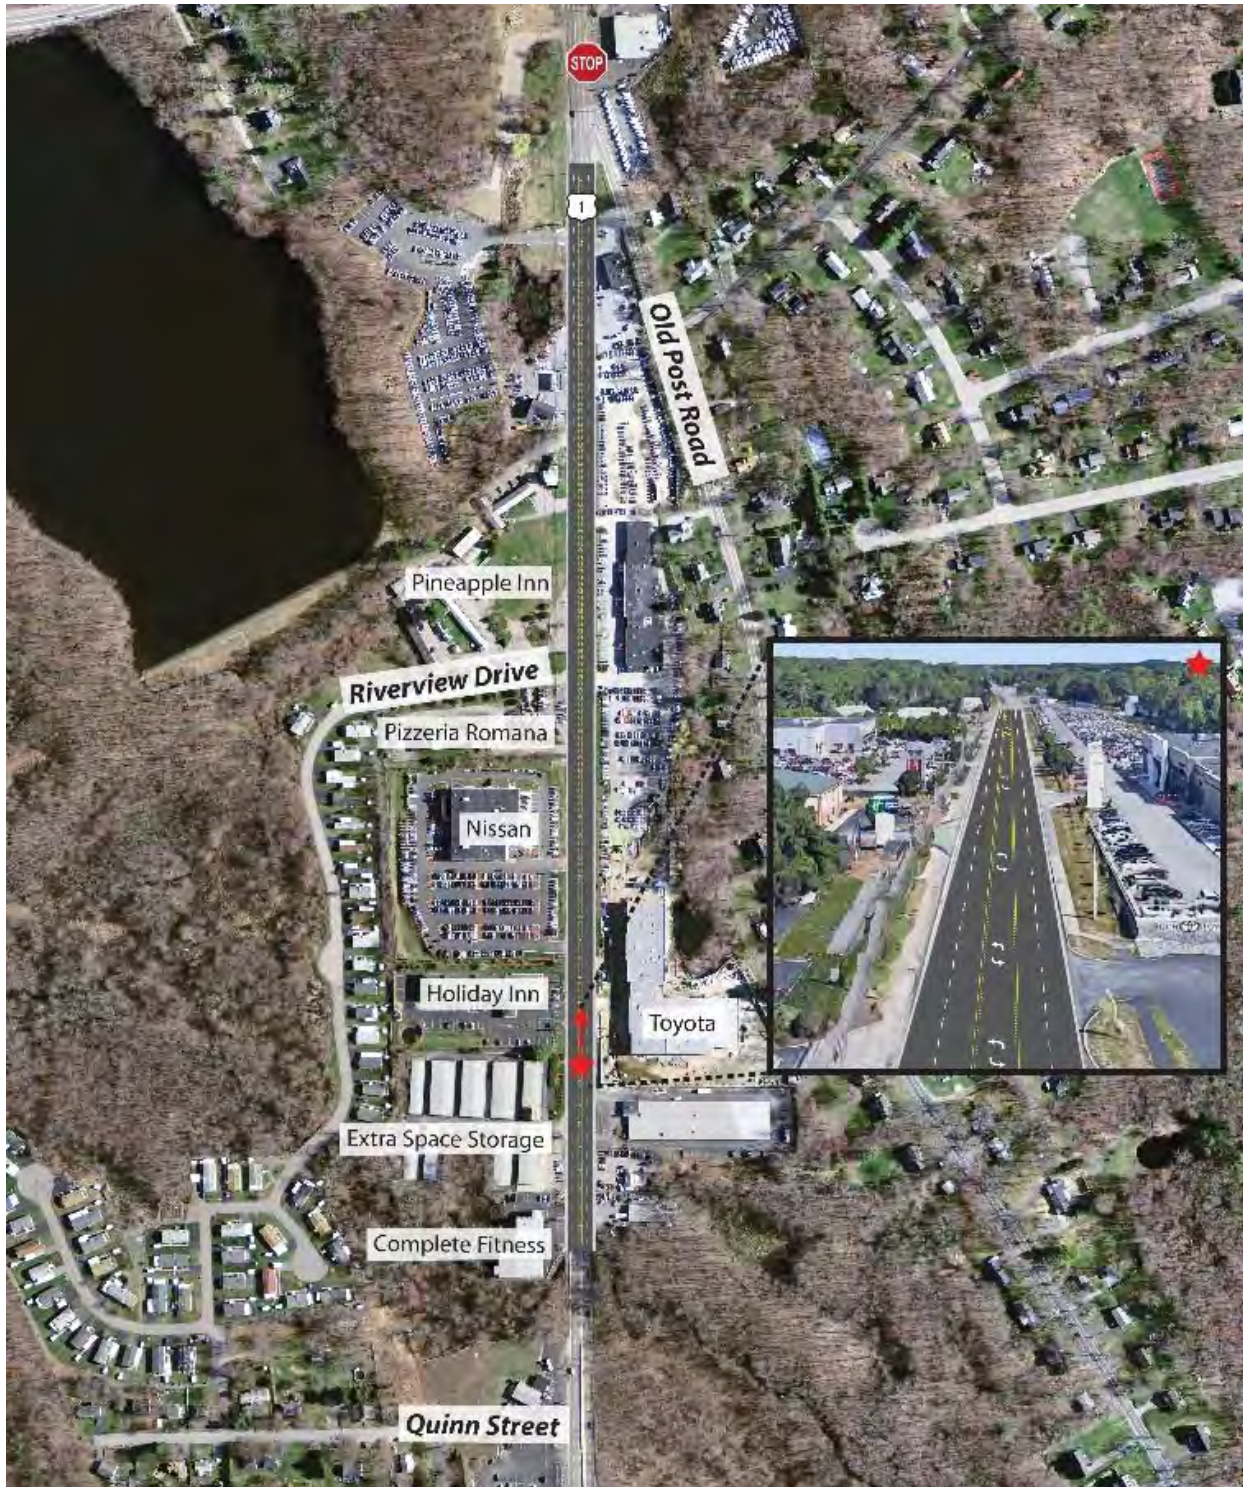
Figure 8 - Consideration of a TWLTL between Old Post Road & Quinn Street

Installation of a raised median will prevent these left-turns, as well as U-turns along this segment. It is recommended that the installation of the raised median start at Cumberland Avenue and end at May Street. May Street is located just south of that segment and should be considered as the beginning/terminus for a raised center median where traffic can be properly mitigated.

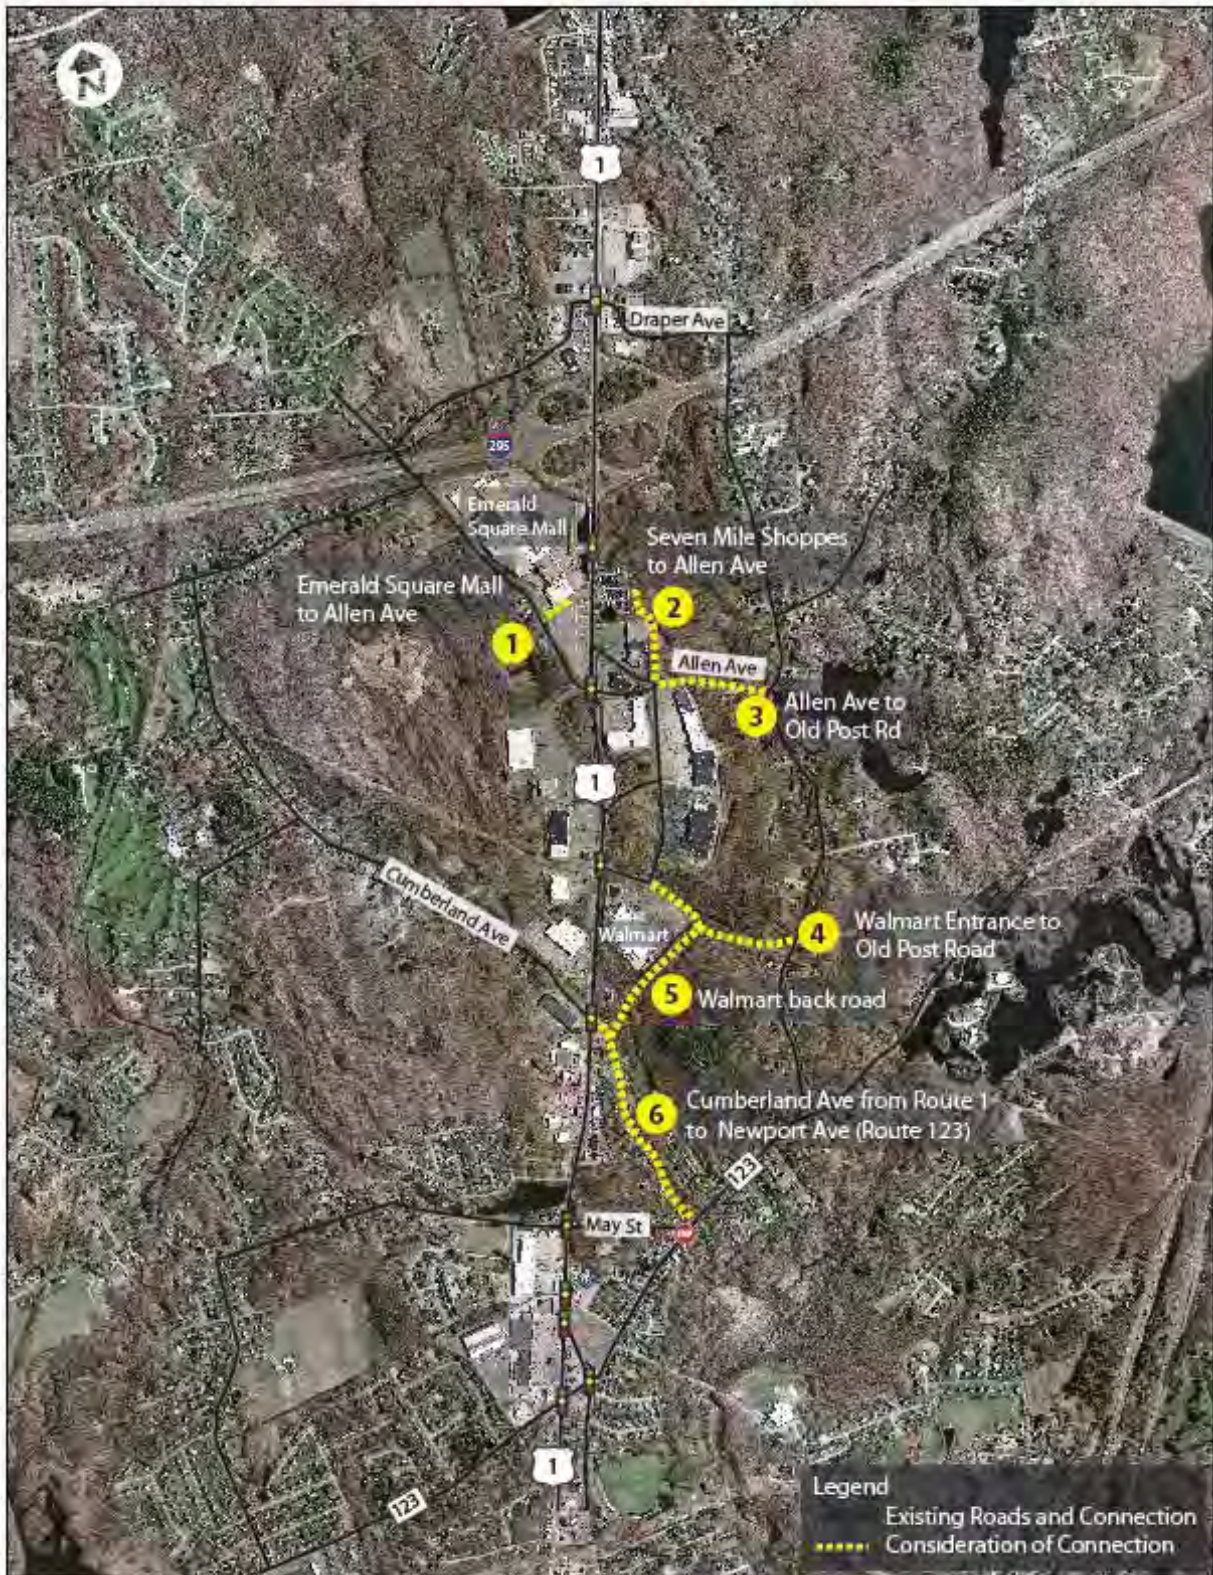
Figure 9- Possible Bypass Road Connections

Extension of the Route 1 Walmart Access Road to Old Post Road and the reconnection of Cumberland Avenue south of Route 1 combined with an internal connection between the Walmart Access Road extension and Cumberland Avenue would provide an alternate route for travelers from the east and possibly south (see areas labeled #5 and #6 on Figure 9.) The reconnection of Cumberland Avenue would require reconstruction to accommodate two travel lanes but may not be desirable and met with opposition by residents.

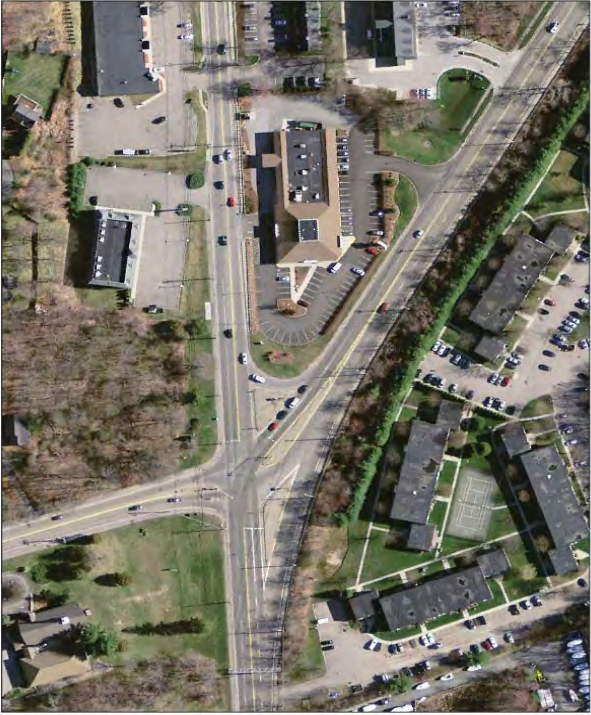
Figure 10

11 display the South Washington St/East Washington St at Hoppin Hill Road intersection prior to the recent improvements and the conceptual design for consideration.

An alternative that could be considered would include major modifications to the intersection and traffic flow. In order to better mitigate the heavy southbound movement along East Washington Street, the creation of two offset T-intersections could be considered. These intersections would be spaced approximately 650 feet apart and would require coordination. Motorists traveling south on South Washington Street would be required to travel onto a side street, where a roundabout could be considered, and through a traffic signal before completing their maneuver. Although more turning movements are introduced at the intersection, the frequency at which motorists are entering assists in improving traffic flow. These modifications would improve the failing LOS F to a LOS C or better during peak periods in 2040. Figures 10 and

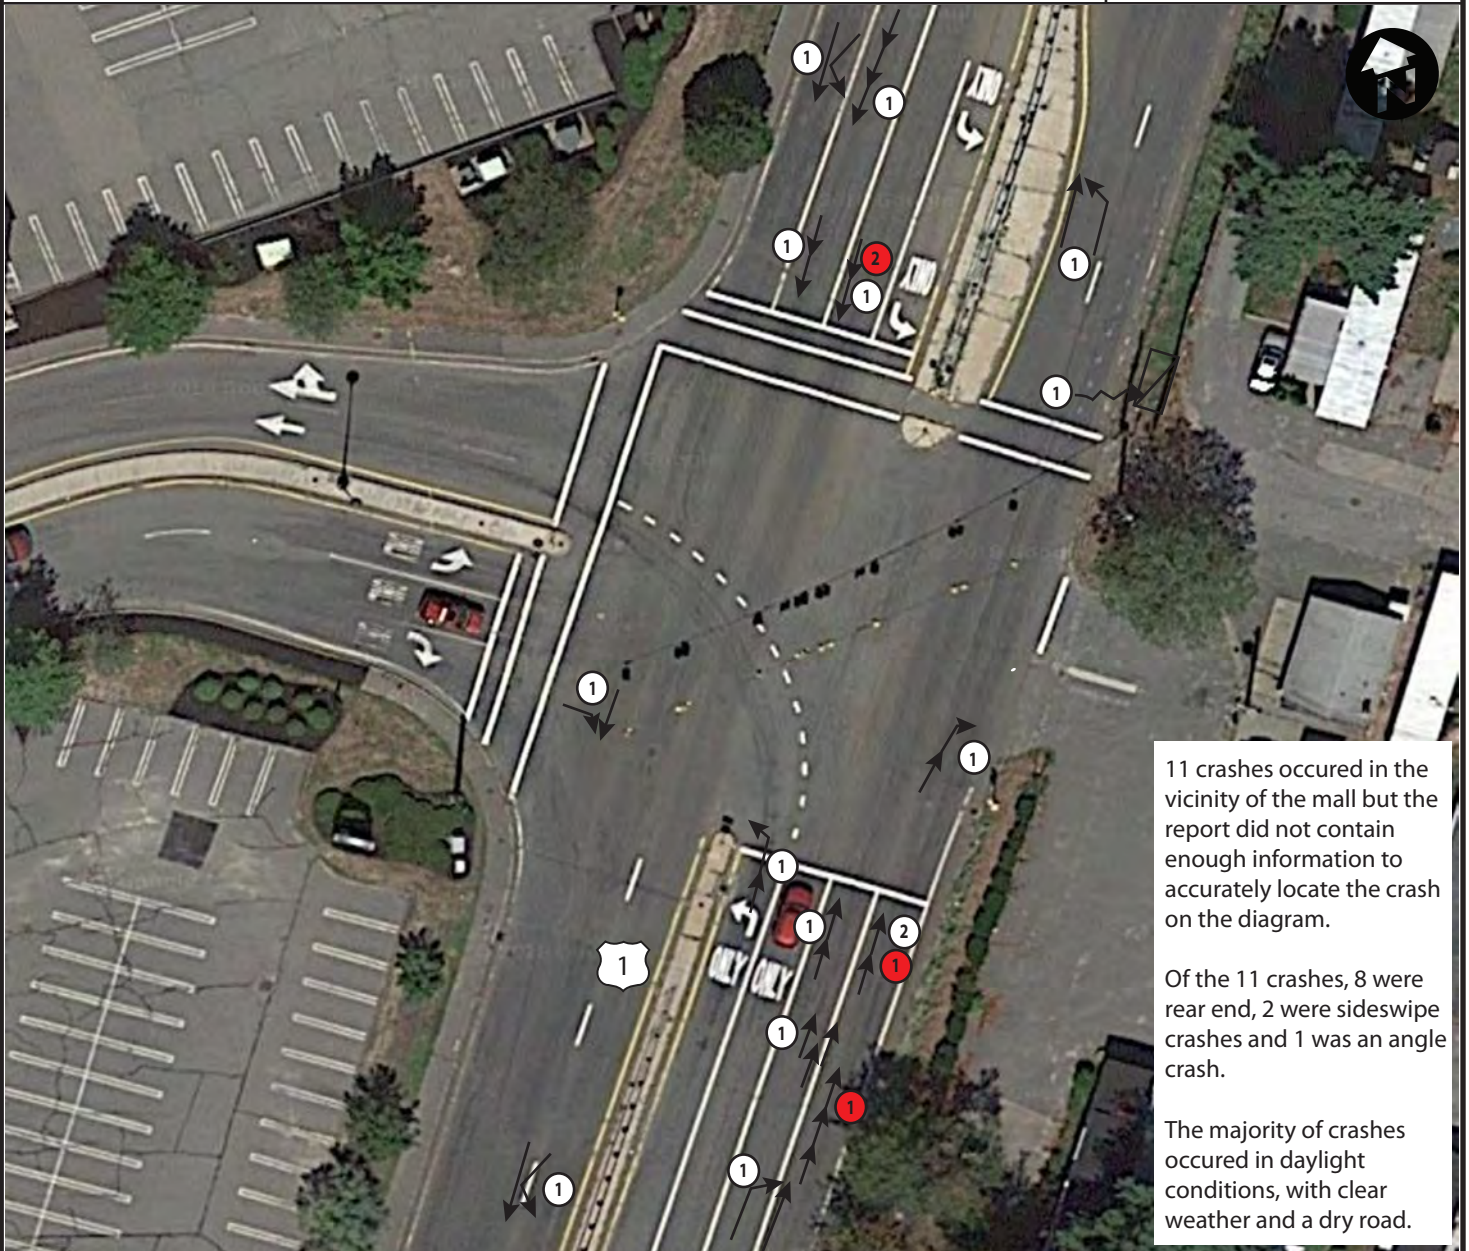
11 crashes occurred in the vicinity of the mall but the report did not contain enough information to accurately locate the crash on the diagram.

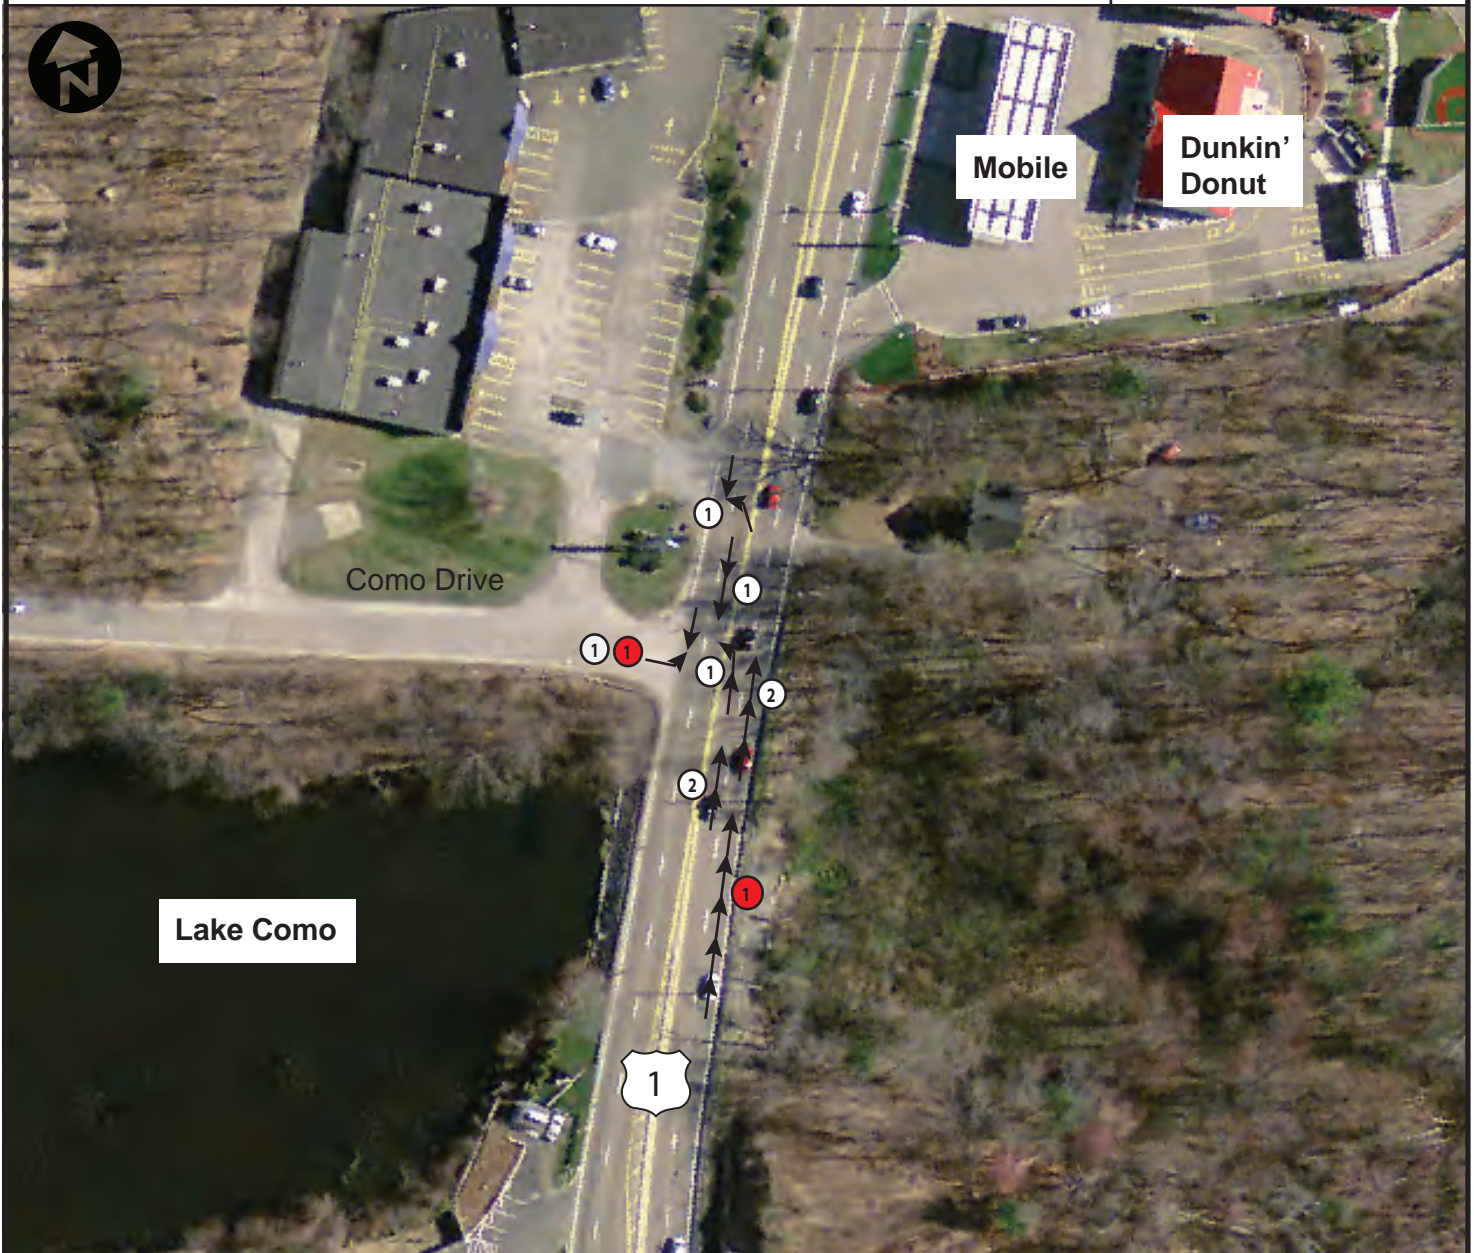
Municipality: City of Attleboro RPA: SRPEDD  
 Location: Route 1 @ Como Dr  
 Period: 3 Years 0 Months Period: From 2014 To 2016

Project: Route 1 Corridor  
 By: LE-P  
 Date: 08-14-2018

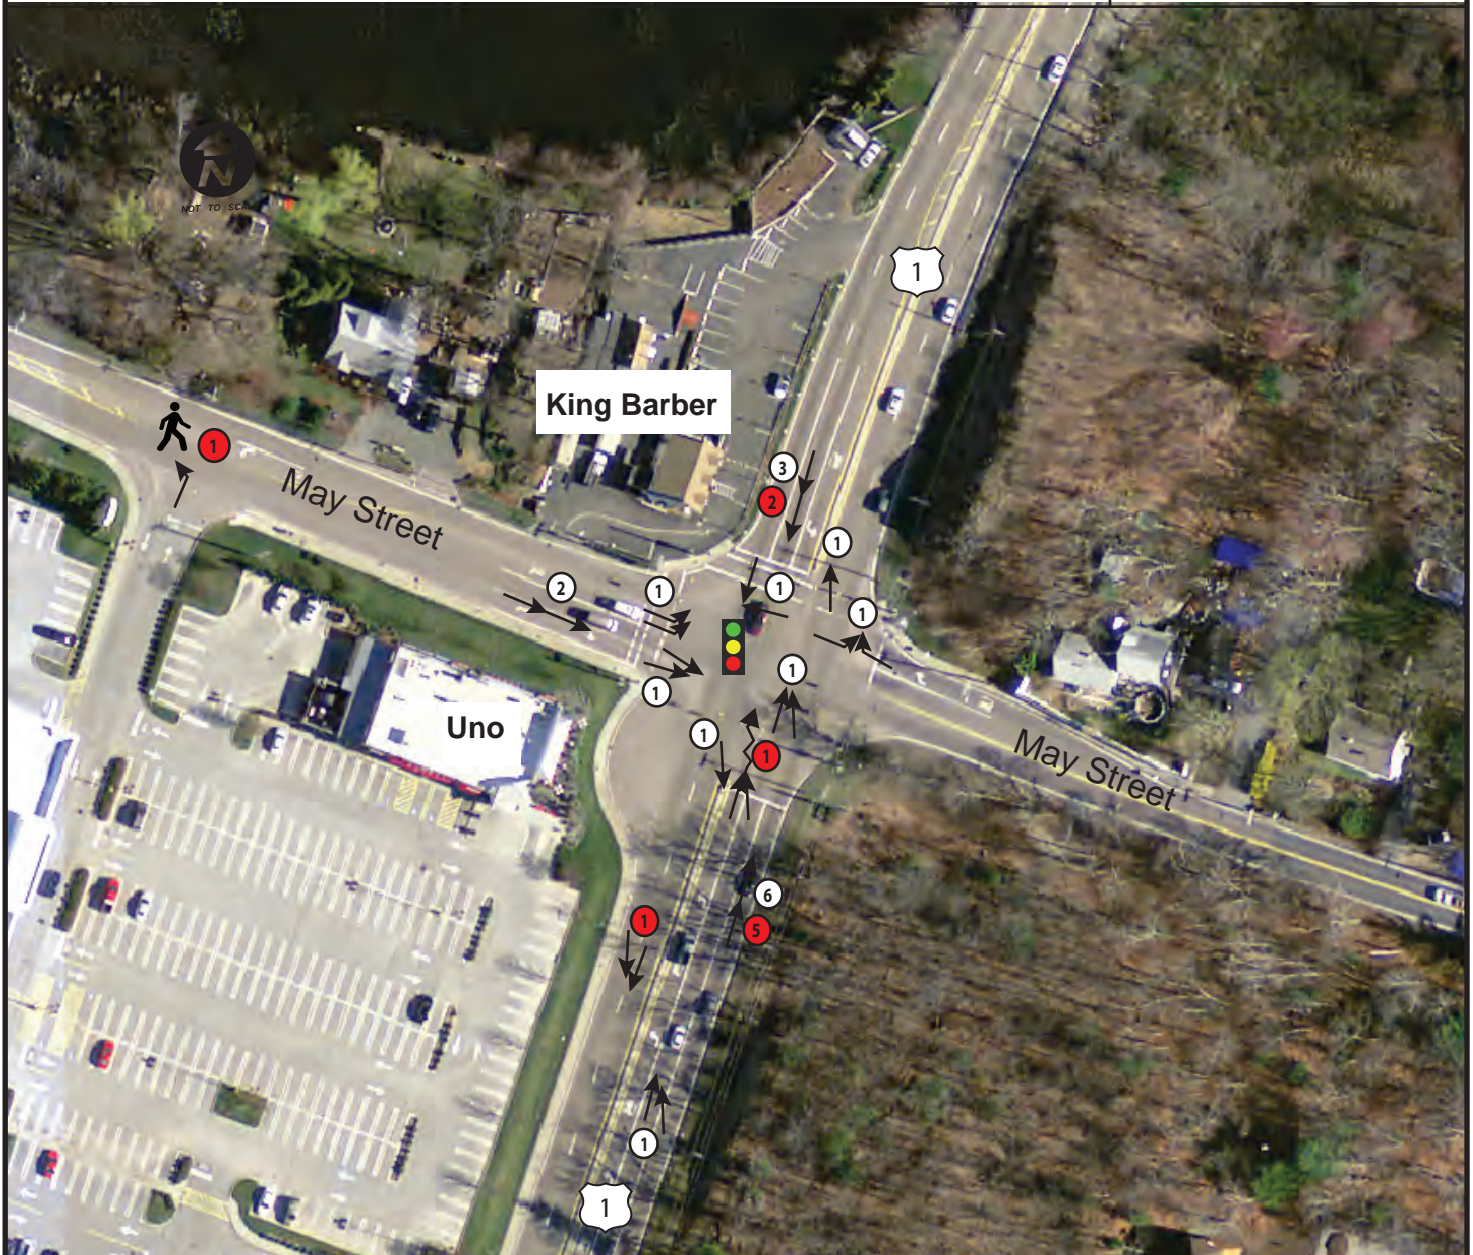
Municipality: City of Attleboro RPA: SRPEDD  
 Location: Washington Street (Route 1) at May Street  
 Period: 3 Years 0 Months Period: From 2014 To 2016

Project: Route 1 Corridor  
 By: LE-P  
 Date: 07-26-2018

Over the 3-year period of 2014-2016, there were 15 crashes that occurred at the intersection; 12 of which involved property damage only and 3 which involved injury. The ACC/MEV crash rate at this intersection is .46, while the regional average is 0.75. The EPDO is 9, well below the regional threshold of 15. The EPDO indicates that there are no safety issues at this intersection.

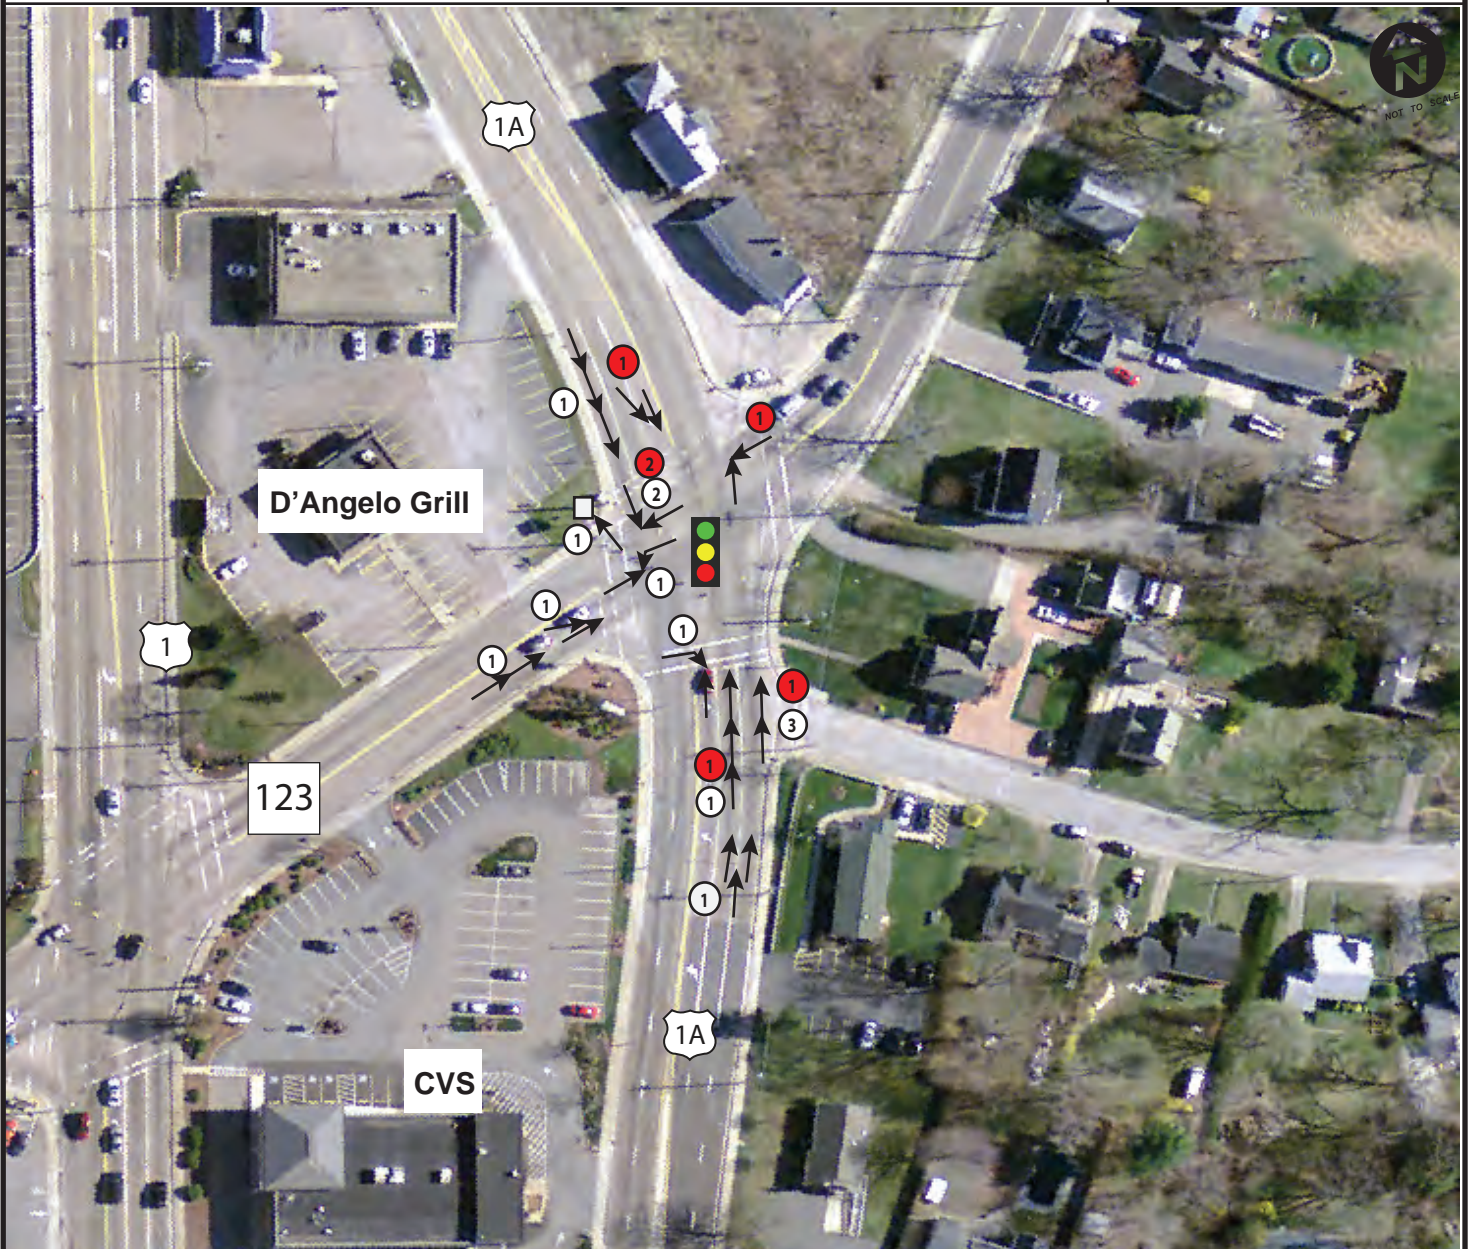
Municipality: City of Attleboro RPA: SRPEDD  
 Location: Route 1A (Newport Ave) @ Route 123 (Highland Ave/Newport Ave)  
 Period: 3 Years 0 Months Period: From 2014 To 2016

Project: Route 1 Corridor  
 By: LE-P  
 Date: 08-14-2018

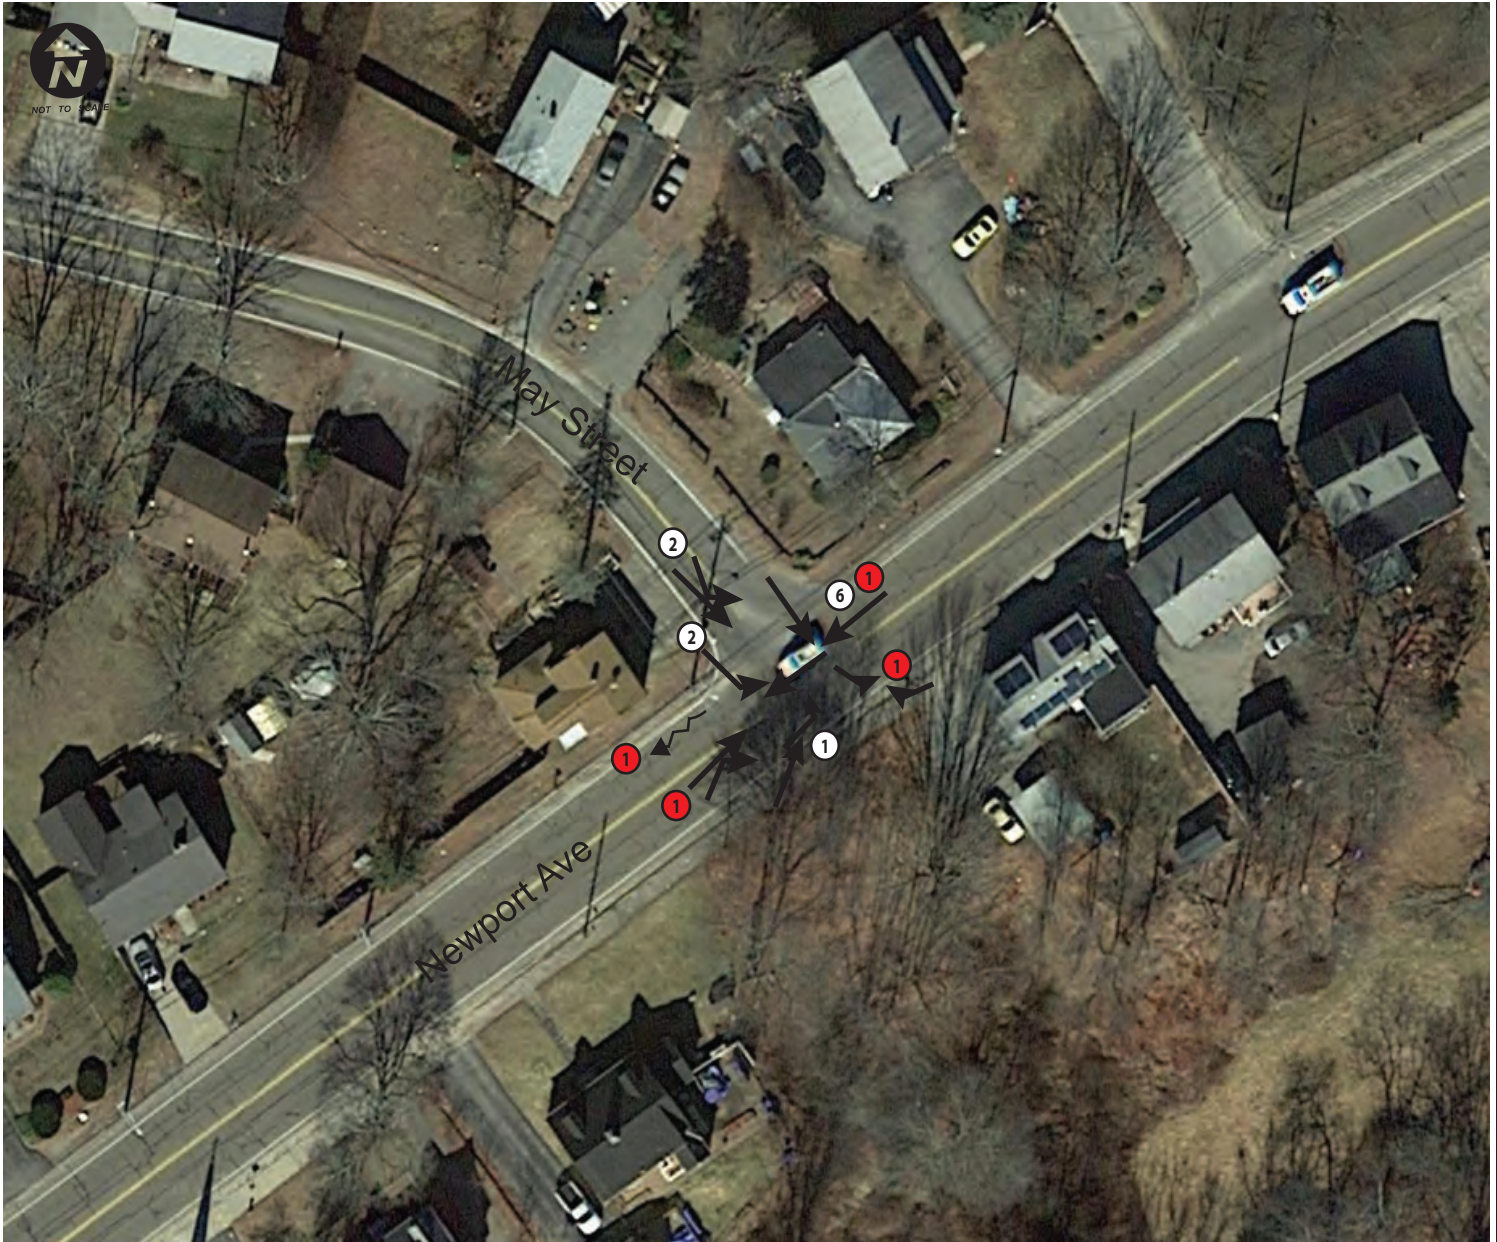
Municipality: City of Attleboro RPA: SRPEDD  
 Location: Newport Ave (Route 123) at May Street  
 Period: 3 Years 0 Months Period: From 2014 To 2016

Project: Route 1 Corridor  
 By: Charlie/Guoqiang  
 Date: 02-21-2019

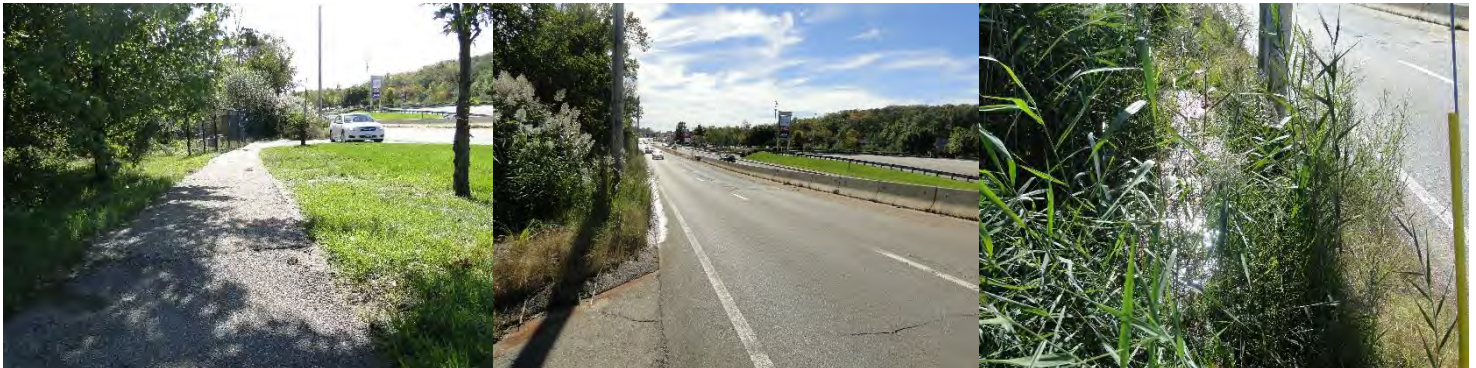
Figure 4: North Attleborough Marketplace Sidewalk End Conditions

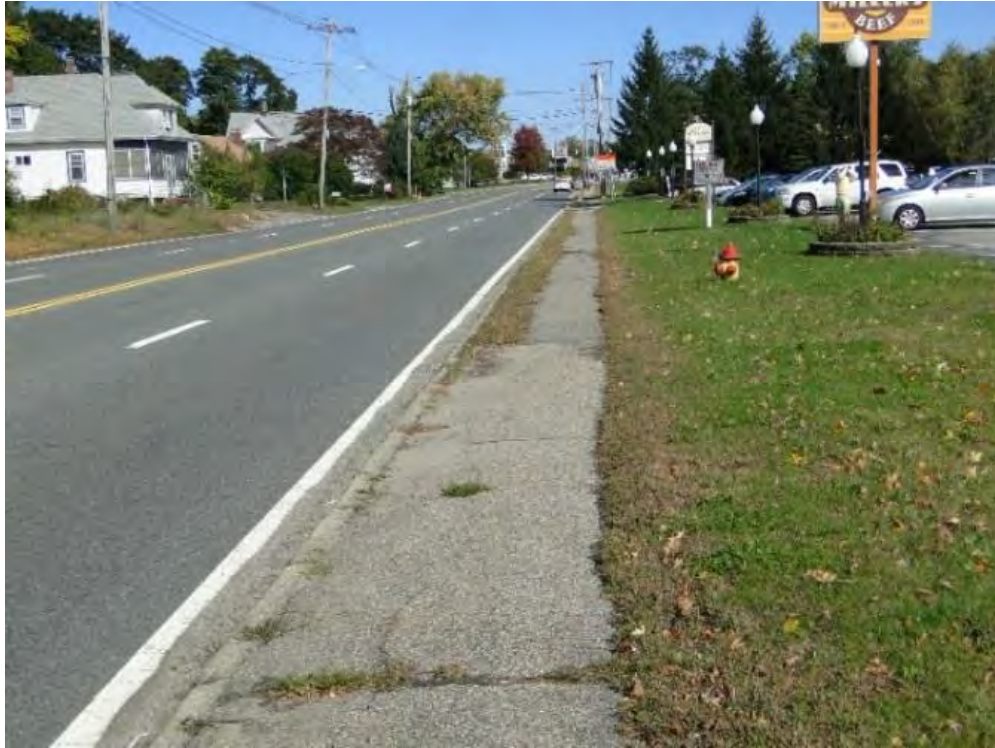
Figure 5: Poor sidewalk conditions on Route 1A south of Route 123

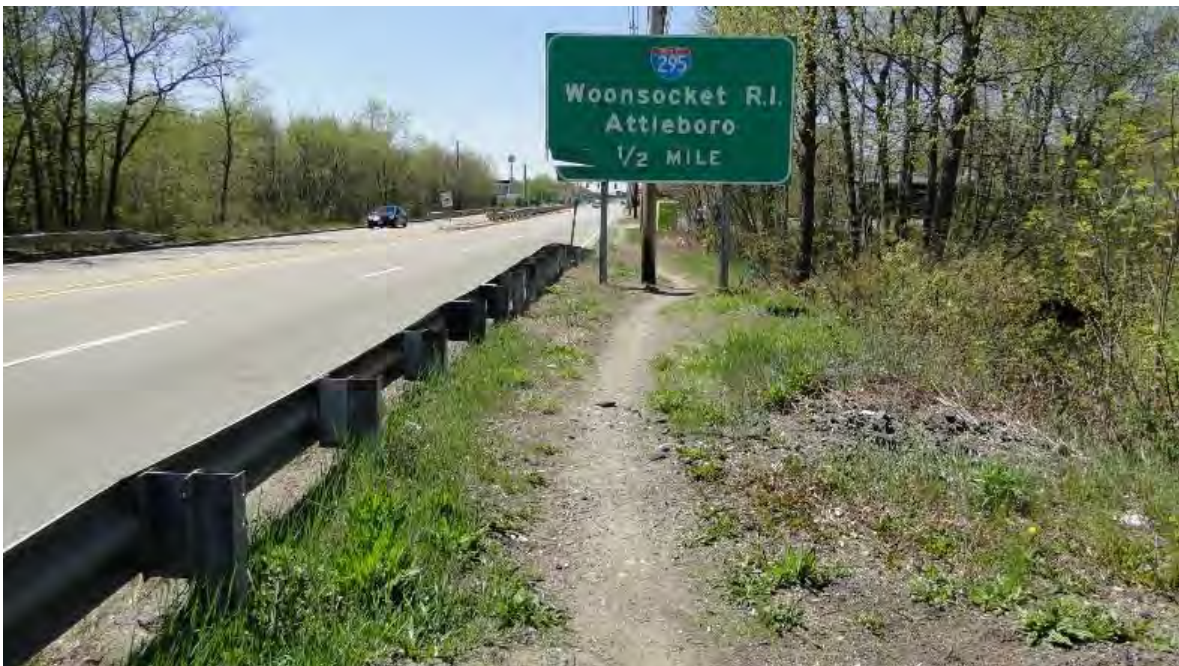
Figure 6: Pedestrian beaten path in North Attleborough near Quinn Street
