# Route 1 Corridor Study

North Attleborough and Attleboro

SRPEDD 88 Broadway, Taunton

September 2019

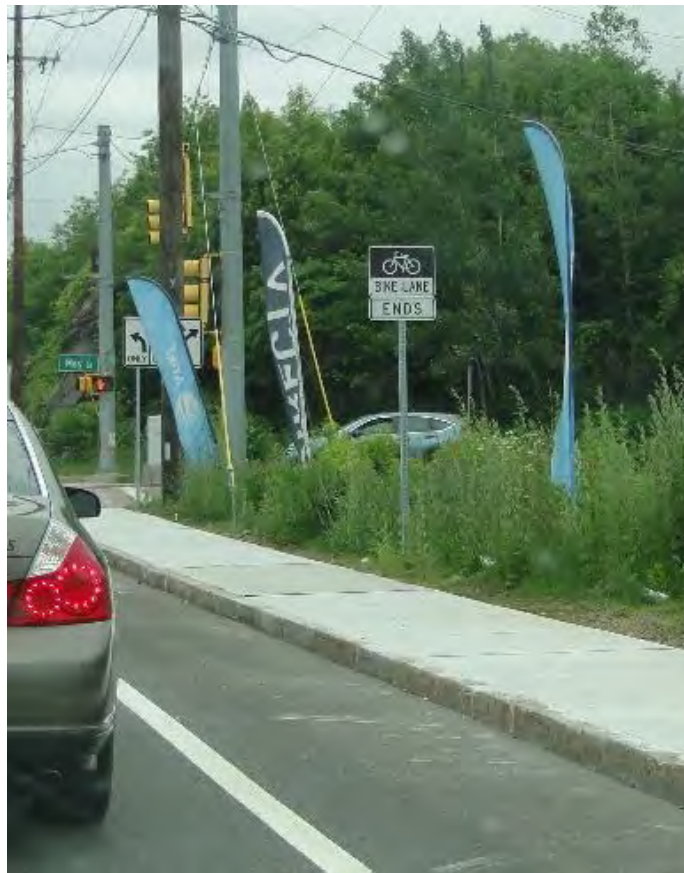
Figure 7: Bicycle Lane Markings and Signage near May Street

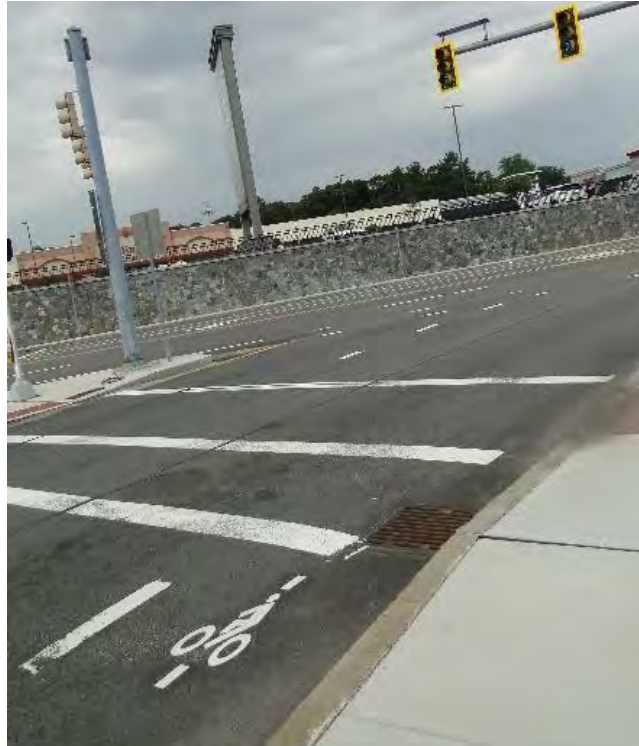
Figure 8: Bicycle Signal Actuation Lane Markings on Route 1A

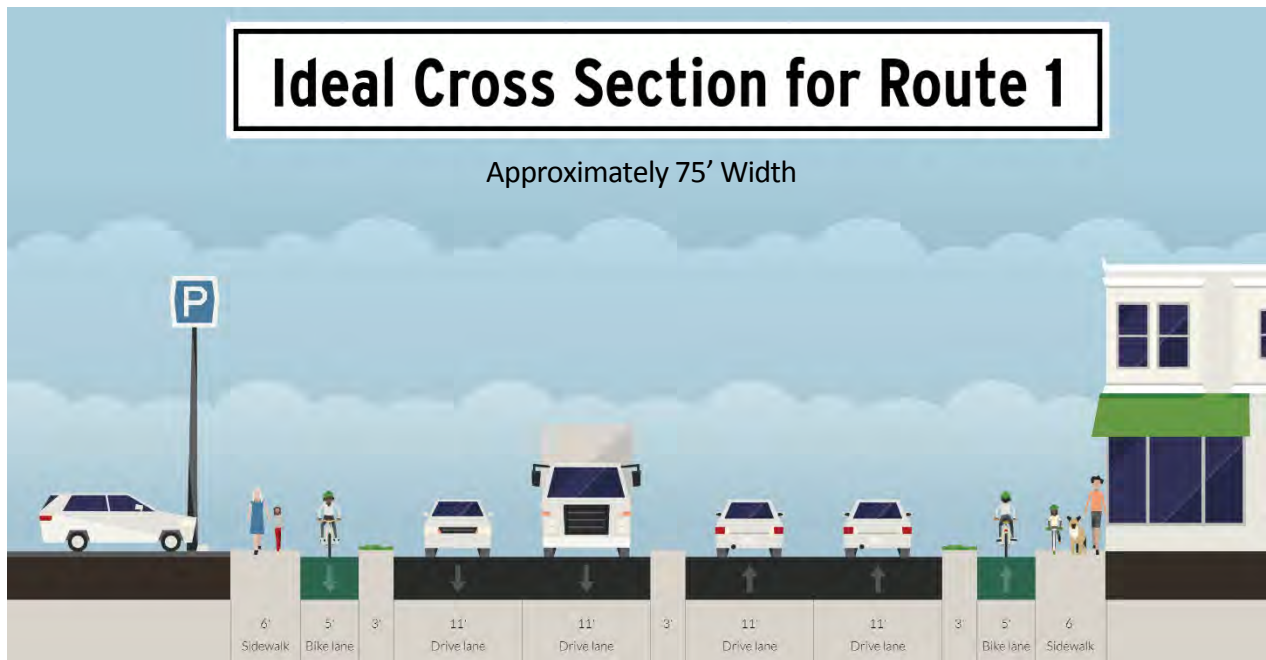
Figure 9: Ideal cross section for Route 1 (Source: Streetmix.net)

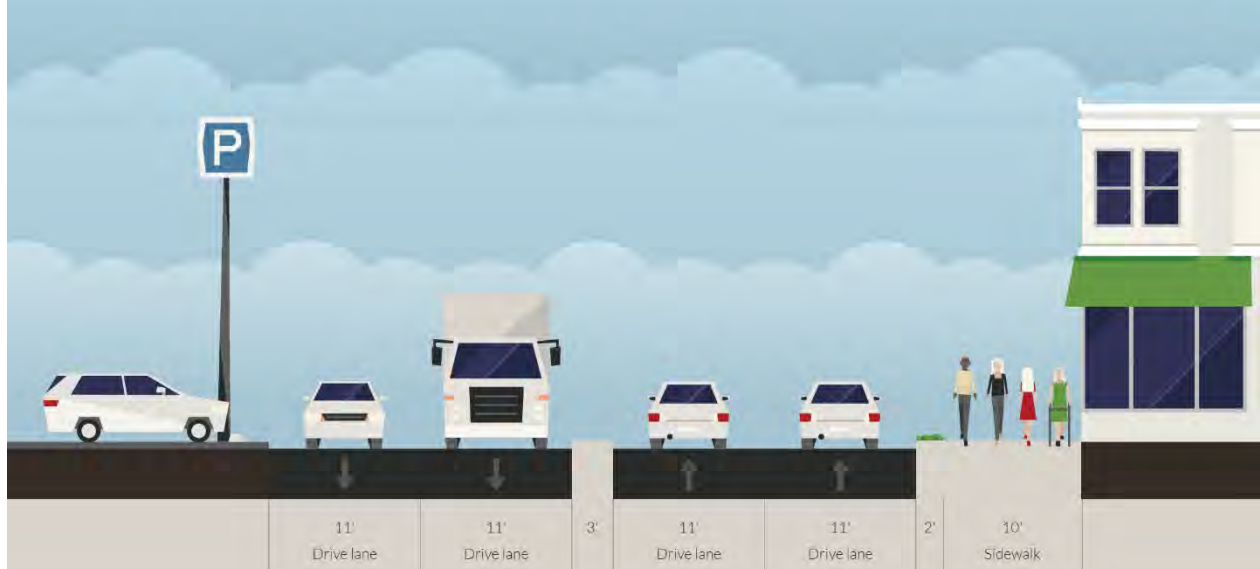
Figure 7: Potential Cross-section Options A and B for Route 1 showing separate use paths on both sides (A) and on one side (B) (Source: Streetmix.net)

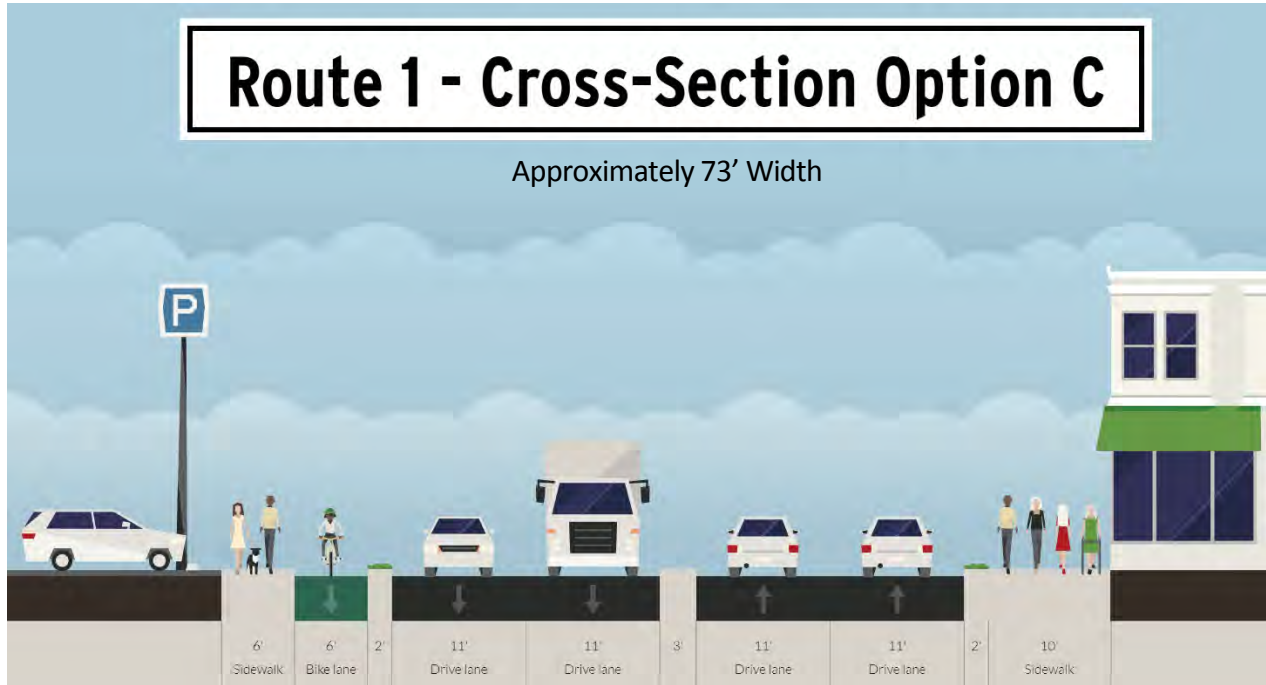
Figure 1: Potential Cross-section Option C for Route 1 showing a bicycle lane and sidewalk on one side and a separate use path on the other (Source: Streetmix.net)
