Appendix G: Intersection Crash Summaries

Route 6 Corridor Study - Crash Diagram

Municipality: Fairhaven RPA: SRPEDD

Project: Route 6

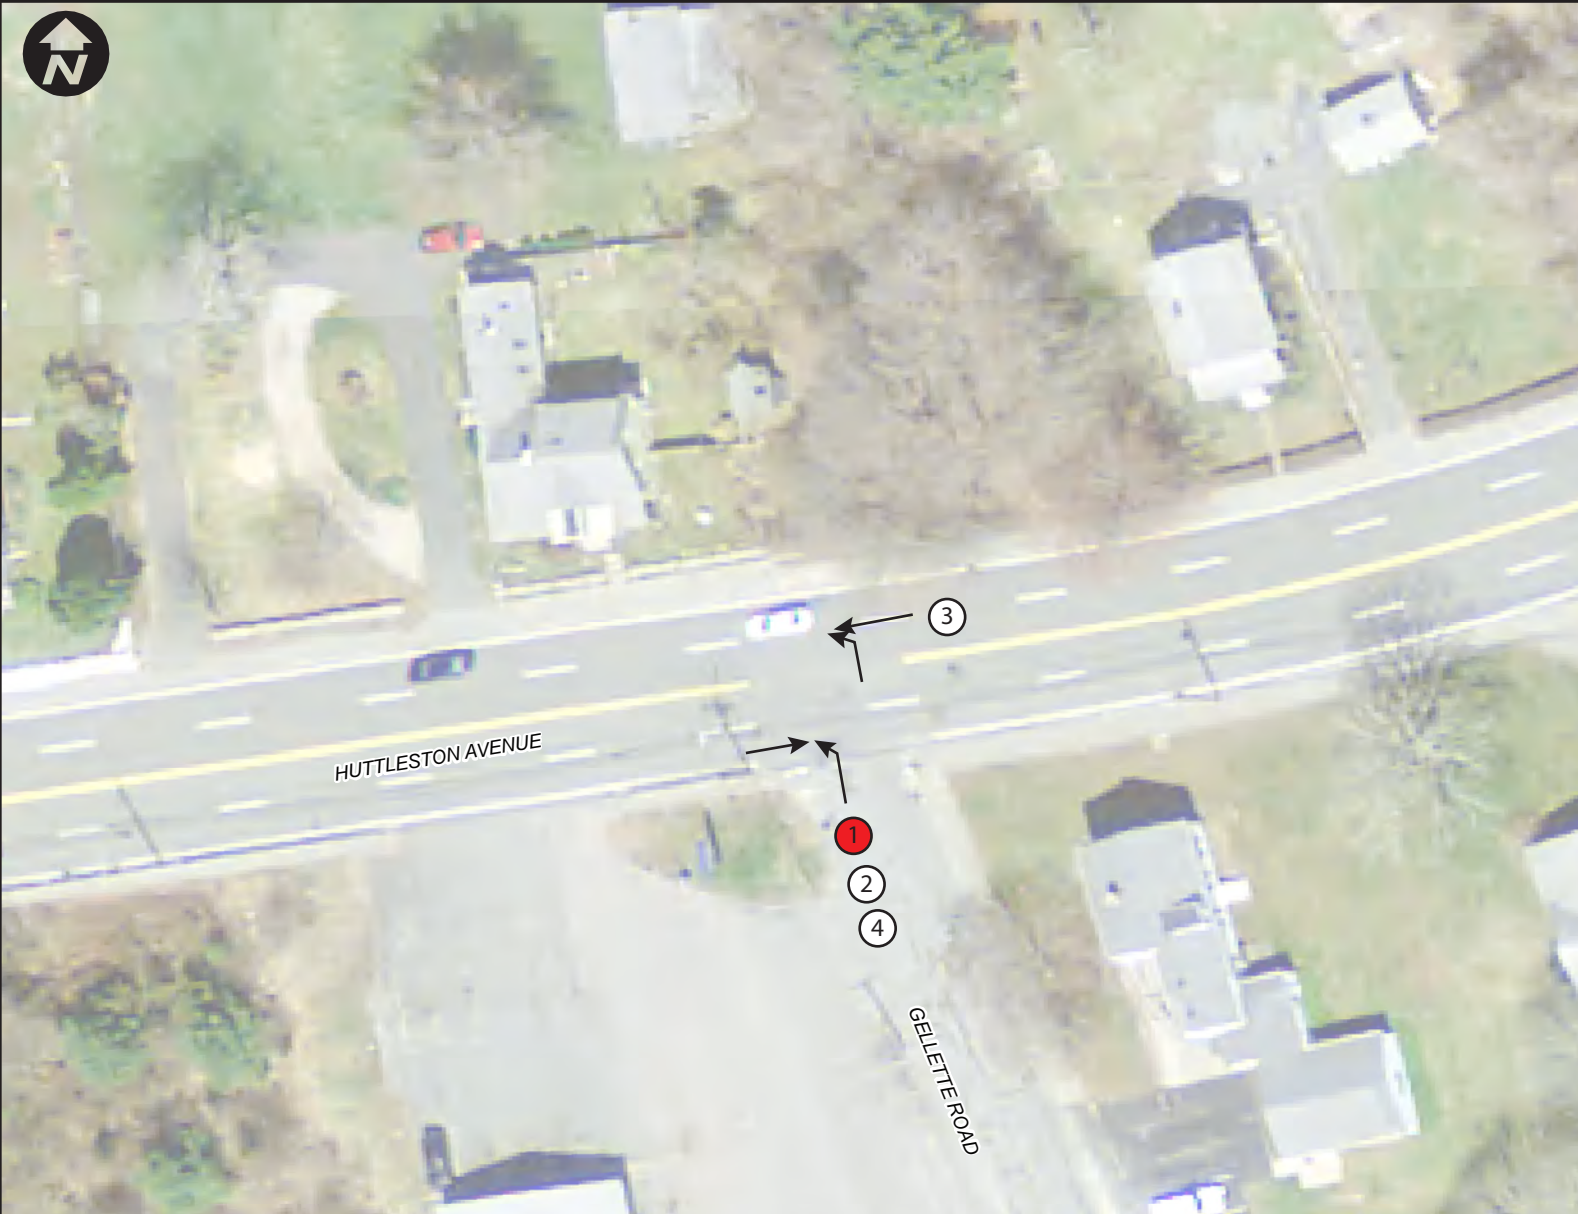
Location: Huttleston Avenue (Route 6) & Gellette Road

Route 6 Corridor Study - Crash Diagram

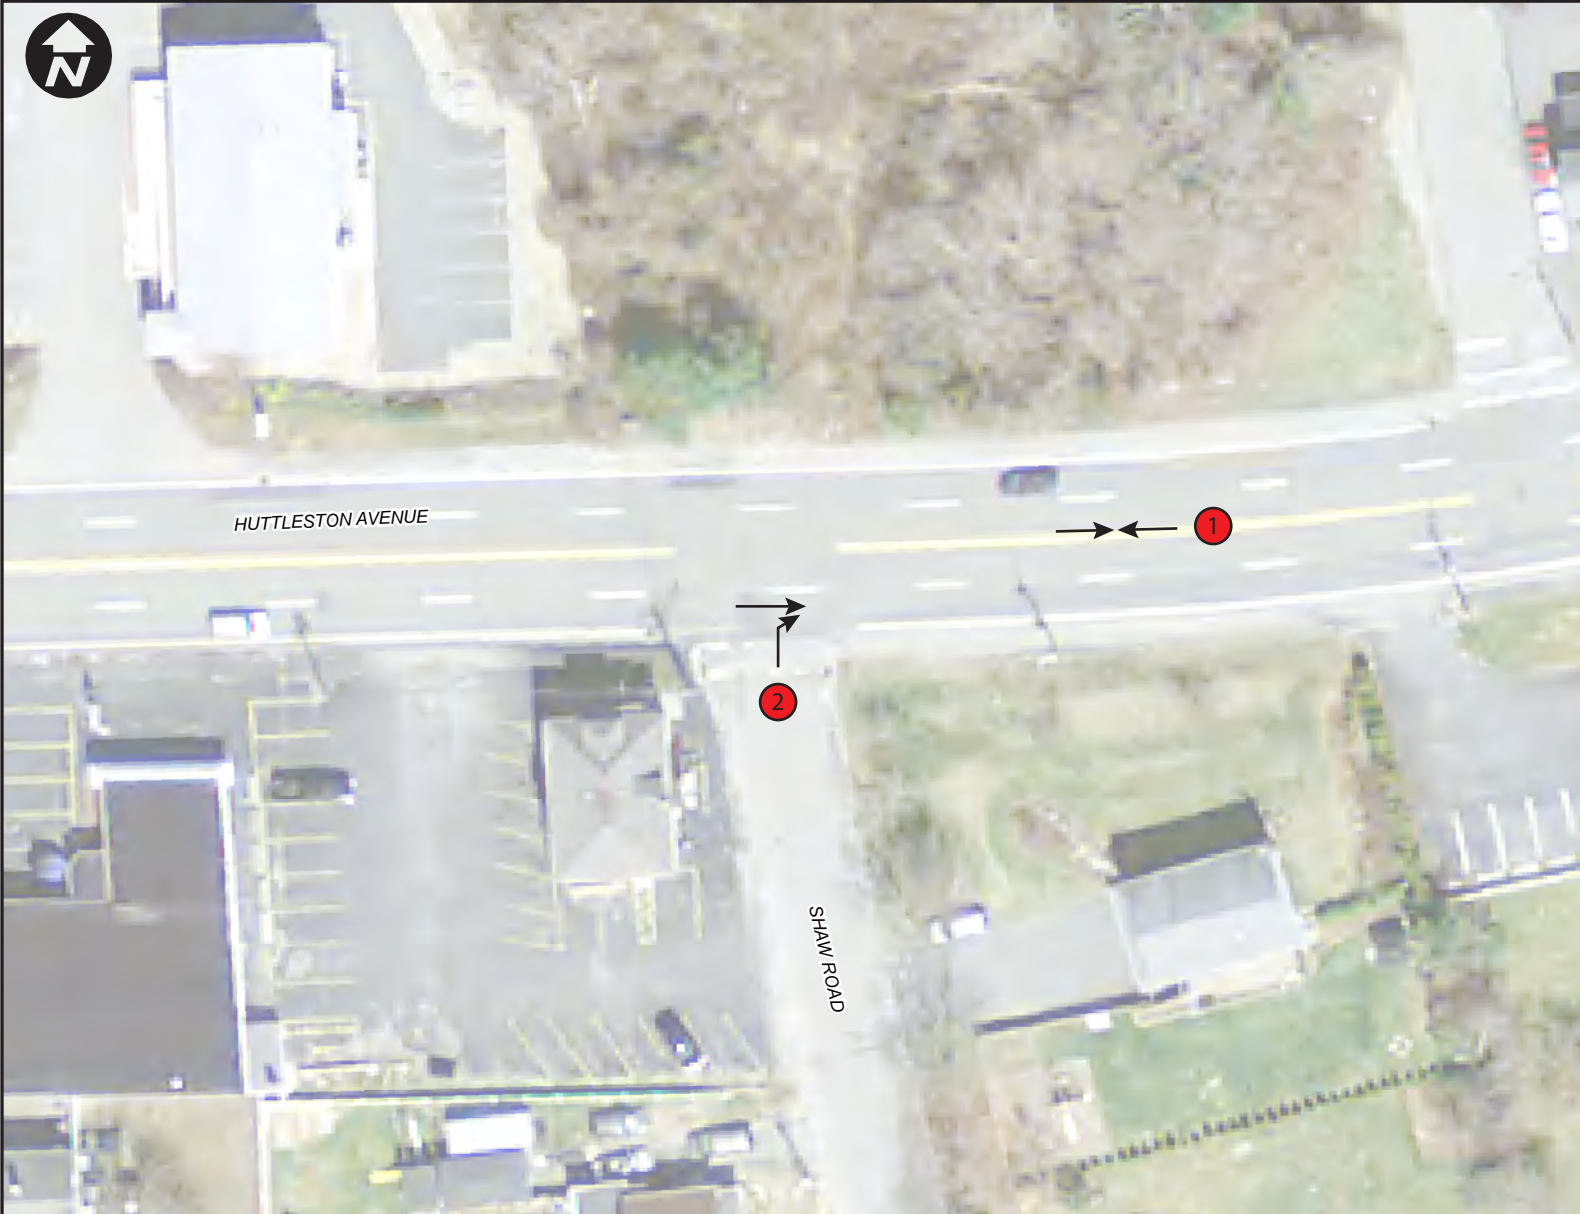
Municipality: Fairhaven RPA: SRPEDD
Location: Huttleston Avenue (Route 6) & Shaw Road
Period: 3 Years 0 Months Period: From 2015 To 2017

Route 6 Corridor Study - Crash Diagram
