Lane Departure Road Safety Audit for Main Street in Acushnet, Massachusetts

Prepared by
**Southeast Regional Planning & Economic Development District
and
University of Massachusetts Traffic Safety Research Program**

1.0 Introduction to Road Safety Audits & Lane Departure Crashes in Massachusetts

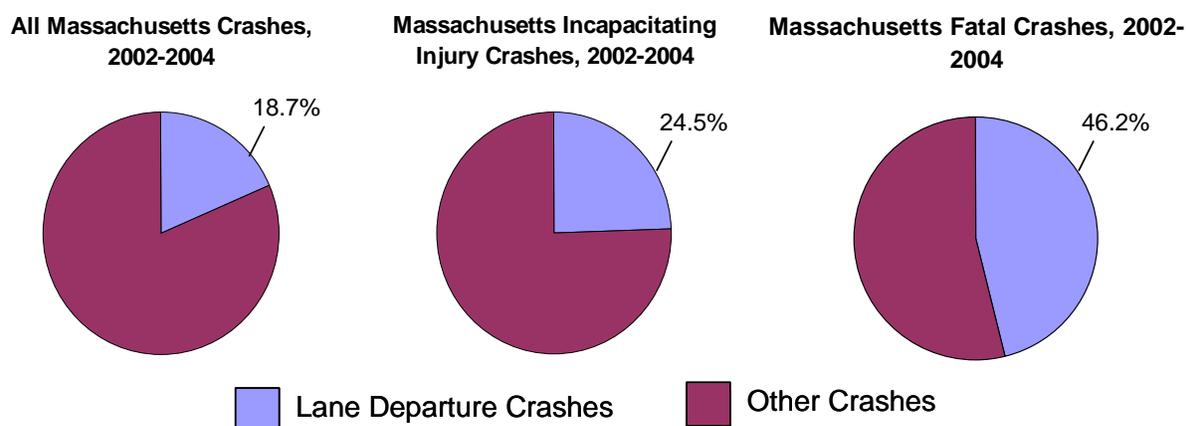
Figure 1. Relationship Between Lane Departure Crashes and Injury Severity

The RSA program in Massachusetts is being implemented in accordance with the Commonwealth's role as a lead state in preventing run-off the road (lane departure) crashes and in conjunction with the Strategic Highway Safety Plan (SHSP). Lane departure crashes are a notable problem area for Massachusetts, especially for crashes with high injury severities. Between 2002 and 2004, lane departure crashes accounted for nearly 20 percent of all crashes in Massachusetts and approximately one-quarter of crashes involving an incapacitating injury. Almost one-half of fatal crashes between 2002 and 2004 were lane departure crashes. As the crash severity increases, so too does the percent of crashes that are lane departures as shown in Figure 1.

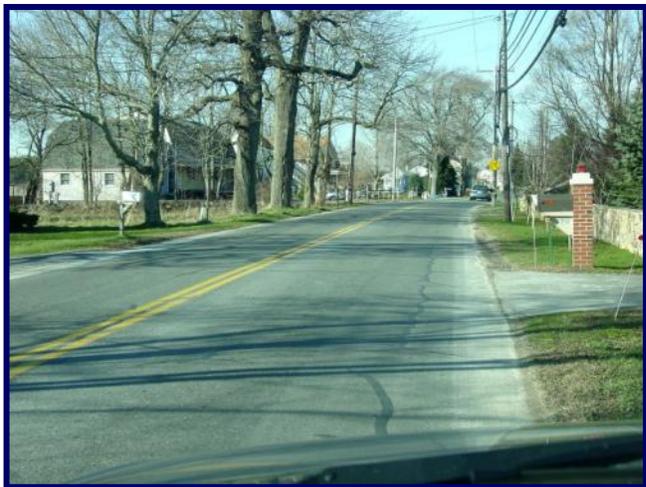
Figure 2. Sample Cross-Section for Main St

Acushnet is a Massachusetts municipality with approximately 10,000 residents located within Bristol County in the southeastern portion of the Commonwealth. Main Street is a major corridor in Acushnet, which connects New Bedford and Rochester, and totals 6.3 miles. Specifically, Main Street is a mixture of thickly settled residential units and commercially developed parcels with approximately 40 intersecting roadways. Main Street encompasses both a town-owned (4.8 miles) stretch to the south as well as a state-owned (1.5 miles section to the north where Main Street is also State Route 105). Throughout Acushnet, Main Street is a two-lane bidirectional roadway with varying lane and shoulder widths. Although there are only a few slight vertical changes throughout Main Street, there are several horizontal curves, including a high crash location known as “Diggle’s Curve”. A sample cross-section for Main Street is pictured in Figure 2, while some of the major characteristics, including crash clusters, for Main Street are summarized in Figure 3.

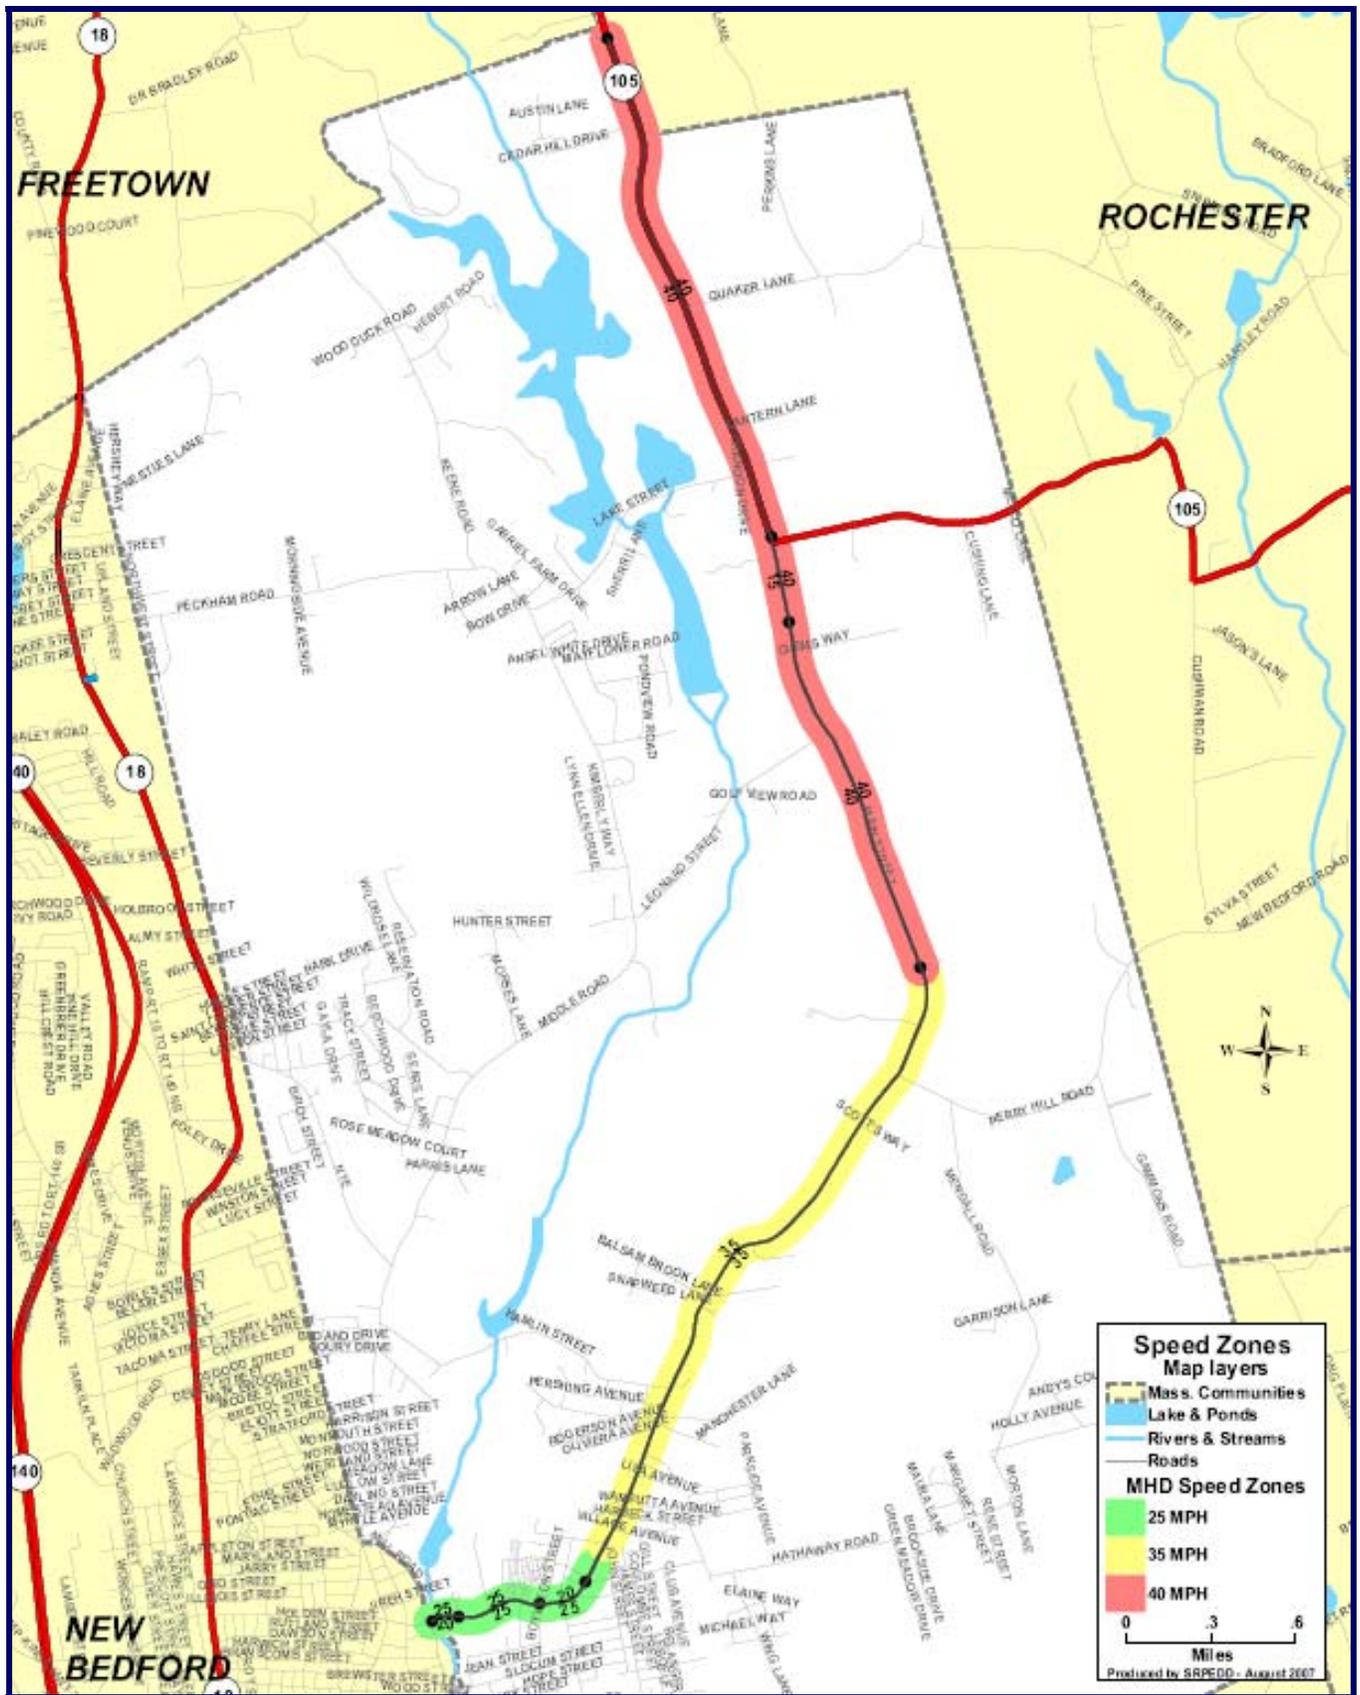
Figure 4. Main Street Posted Speed Limit Regulations

- Considering speed in greater detail, Main Street is similar in nature to many roadways, where the posted speeds vary with posted speed limits of 15, 20, 25, 35, and 40 mph. The official speed regulations for Main Street in Acushnet are summarized in Figure 4, which also shows the currently posted speed limits. As shown, these official speed limits do not appear to match the actual postings.

- Given the reported prevalence of speed among the lane departure crashes, it is recommended that Main Street continue to remain a high speed enforcement area. It is also recommended that speed data collection be completed by the Town of Acushnet, perhaps with the aid of SRPEDD and MassHighway to track current operating speeds throughout the year. This may also prove useful in targeting day of week and time of day enforcement as well as the establishment of enforcement thresholds. Along the same lines, it is recommended that the speed regulations described in Figure 4 are consistent with the current operating practice. For immediate consideration, the posted speed limit signs should be consistent with speed regulations.

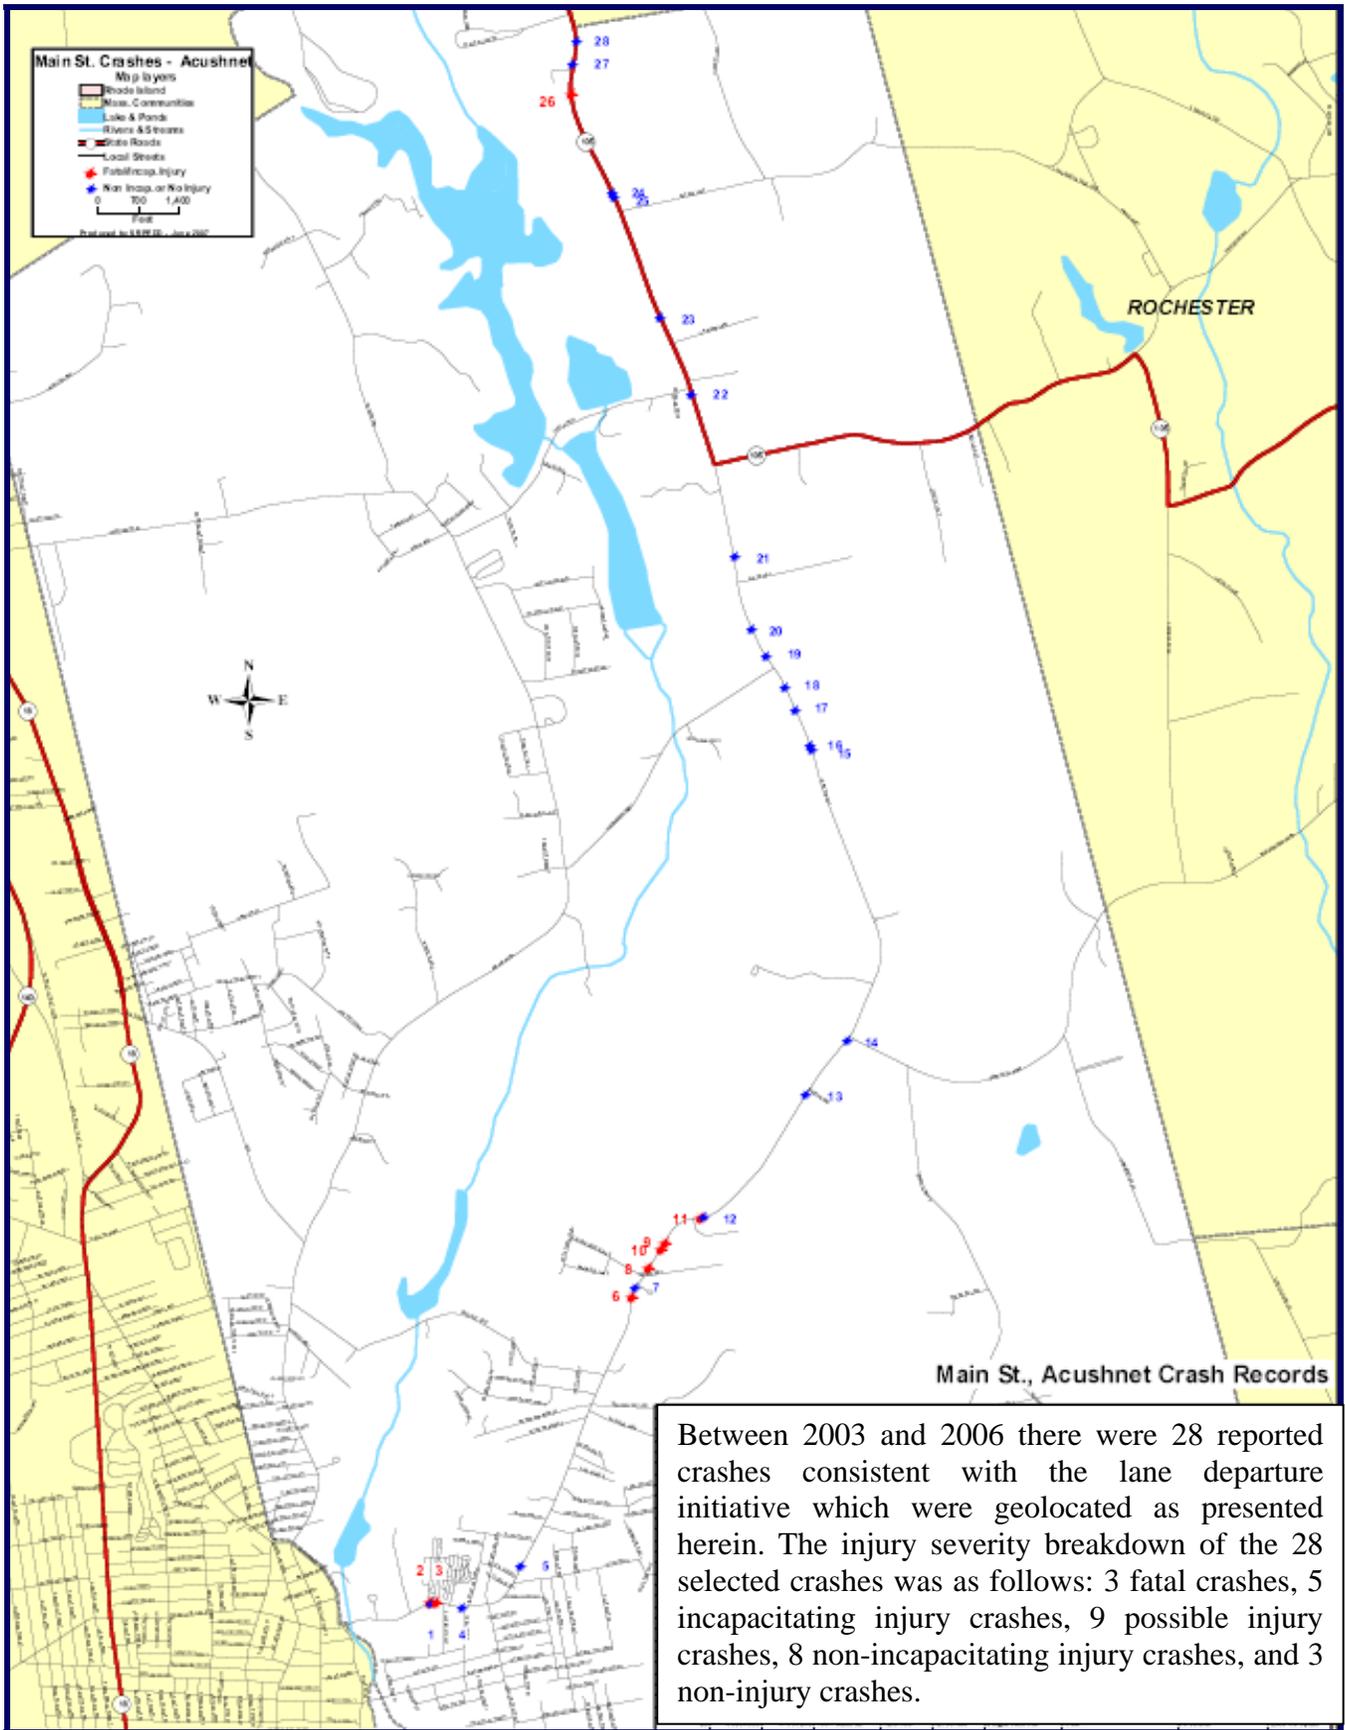
Figure 5. 2003 to 2006 Summary of Main Street Lane Departure-Related Crashes

- Between 2003 and 2006 there were 28 reported crashes consistent with the lane departure initiative which were geolocated and are presented in Figure 5. An initial safety summary by SRPEDD found that among the 28 crashes there were 3 fatal crashes, 5 incapacitating injury crashes, 9 possible injury crashes, 8 non-incapacitating injury crashes, and 3 non-injury crashes. Considering the primary factors 13 crashes were attributed to excessive speed, 2 to fatigue/inattention, 7 to failure to keep in proper lane, 3 to weather, and 2 to animals. Additionally, 25 of the crashes involved a single vehicle, and 20 crashes resulted in a vehicle striking a utility pole or tree. It is important to note that this does not reflect all crashes along Main Street, but those deemed relevant to this initiative.

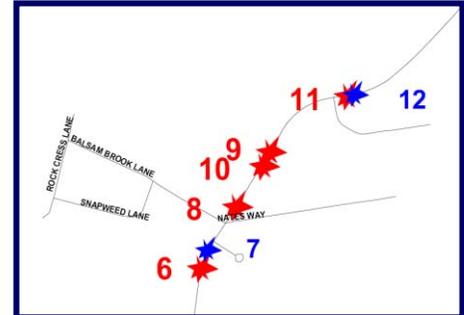
Figure 6. Crash Locations

- The identification of the problematic stretch of road and associated crashes known as Diggle’s curve (see Figure 6). Five of the 7 crashes at this curve involved an injury including 2 fatal crashes. Each of these crashes were single vehicle and four involved a utility pole.
- A second major factor discussed was the roadway speeds. As previously noted the posted speed limits vary greatly, including ranges from 15 to 45 mph. There was some discussion regarding the legitimacy of posting a 15 mph zone, which is not currently in the official speed regulations. This posting should be revised as soon as possible.

- The major crash problem (considering injury severity) at Diggle's curve warrants consideration of long term solutions. Ideally this curve should be redesigned to provide a straighter alignment with appropriate superelevation.

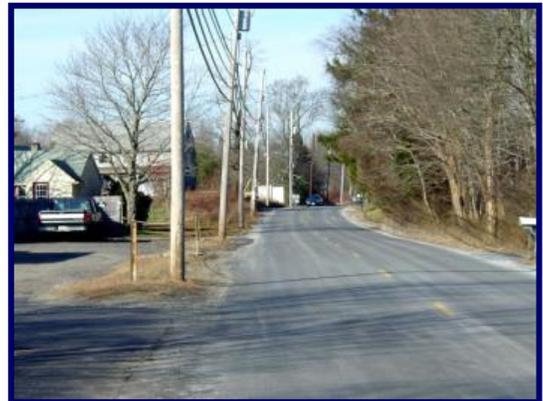
Figure 7. Sample Roadside Hazards

- A third major topic of discussion involved the proximity of the traveled way to a myriad of utility poles and trees. Contributing to this concern is the inconsistent use of reflectors on utility poles and trees. Drivers are unable to identify these hazards particularly in the vicinity of curves, during inclement weather or at night. As documented in the crash data these objects are routinely struck during crashes along this corridor.

- Utility poles and trees are in close proximity to the traveled way (see Figure 7). While longer term strategies are considered for possible relocation of the most hazardous poles, it is recommended that the poles and selected trees be reflectorized.

Presence of utility poles and trees within the roadway clear zone	Reflectorize utility poles and selected trees.	Short Term & Low Cost	Low

Add guard rails for particularly hazardous utility poles consistent with horizontal curves and previous crash locations.	Mid Term & Low/Mid Cost	Low	
	Work with utility company to remove utility poles from clear zone.	Long Term & Mid/High Cost	Mid

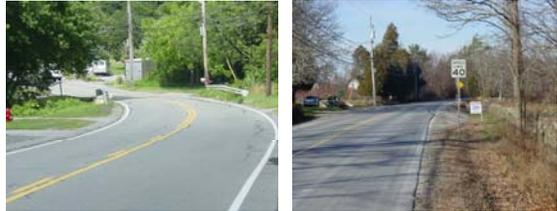
Continued maintenance	The pavement condition and coverage resulting from brush are in good condition; however there is some covering brush on the state section of the roadway. To assure safety this needs be maintained.	Short Term & Low Cost	Mid
