Accessible Plainville

ADA Self Evaluation & Transition Plan

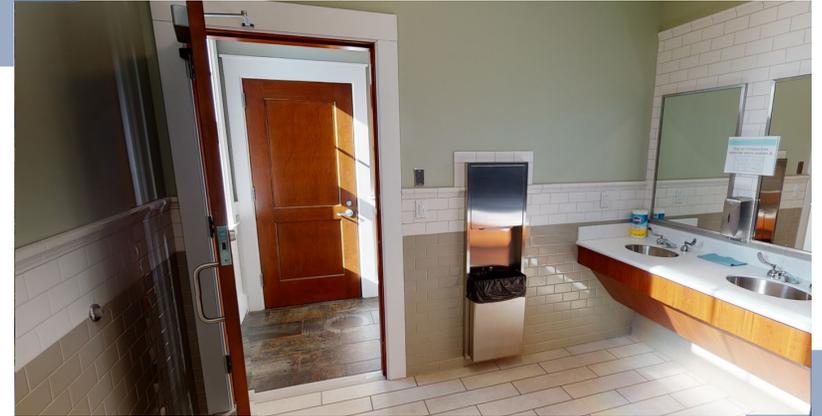
Ref #	Description	Recommendation	Cost	Priority
1.1	Mats and carpets throughout Town Hall are not secured to the floor	Secure carpets to prevent trip hazards	Maintenance	2
1.2	The accessible counter in lobby is 36" x 36", but obstructed by a white separator	Remove separator to ensure accessibility	Maintenance	2
1.3	Women's Restroom (102) a. Door requires more than 5 lbs. of force to open and closes too quickly b. Coat hook greater than 48" above the ground	a. Adjust door-closer b. Adjust height of coat hook	Maintenance	3
1.4	Men's Restroom (103) a. Door requires more than 5 lbs. of force to open and closes too quickly b. Coat hook greater than 48" above the ground	a. Adjust door-closer b. Adjust height of coat hook	Maintenance	3

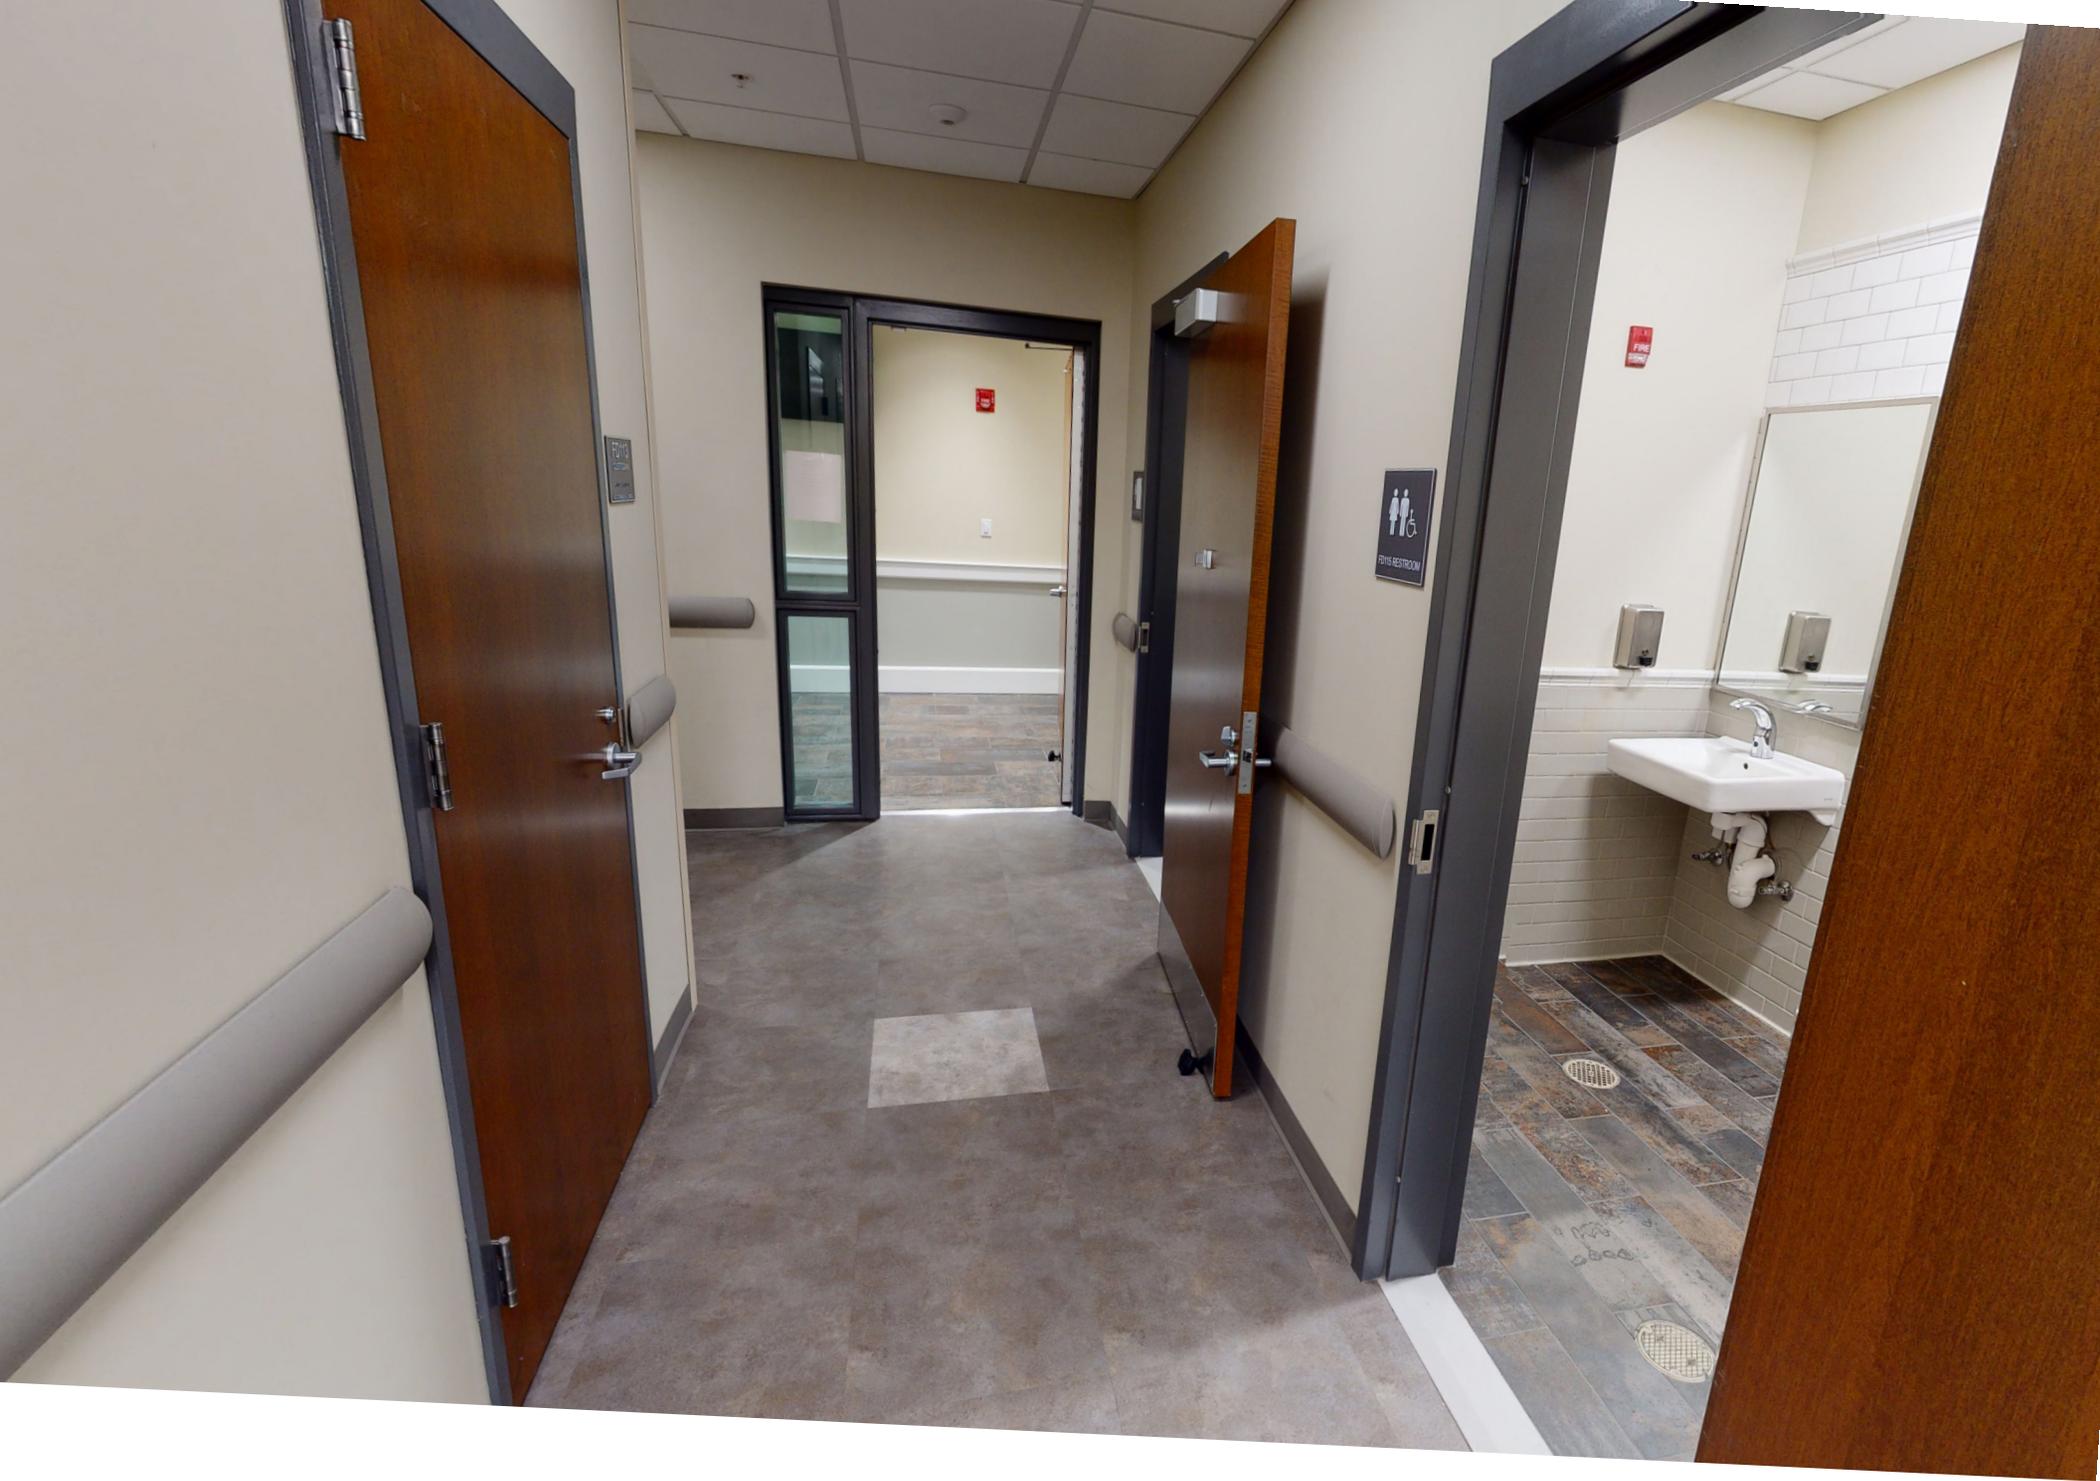
Public Library

Ref #	Description	Recommendation	Cost	Priority
3.1	The front approach to the pull side of the front entrance door (D3) provides less than 18 inches of maneuvering clearance	Designate alternative door (D4) as accessible entrance door with signage	Maintenance	2

3.2	Threshold of interior door (D5) requires maintenance of screws to create a flush threshold	Repair the screw in the threshold or replace it completely	Maintenance \$0-99	2

3.3	Doors in the staff area are equipped with round knobs which are inoperable with one hand and require twisting of the wrist	Replace inaccessible knobs with lever, loop, or push hardware	\$100-499	2

Ref #	Description	Recommendation	Cost	Priority
3.6	All mats and rugs in the library are unsecured and pose tripping hazards	Secure carpets to the floor to prevent hazards	Maintenance	2
3.7	Shelving designated for DVDs in the library are less than 36" wide	Widen shelving to allow for 36" of space	Maintenance	2
3.8	Restroom signs in the main room are greater than 60" from the floor	Lower signs to 60" from the center to the floor	Maintenance	2
3.9	Doors (D5,6 , 8, 9, 12) require greater than 5 lbs. of force to open	Adjust or replace closers to achieve maximum force of no more than 5 lbs.	Maintenance \$0-99	2
3.10	Tables in the Adult and Computer area provide less than 17" of knee clearance	Ensure that at least 5% of all seating in the library is accessible by providing 17" of knee clearance	\$500-999	2

Ref #	Description	Recommendation	Cost	Priority
3.11	The library counter is greater than 38" high	The sides of the checkout desk are 27" high and would comply with requirements to provide an accessible counter height. The library may assign these counters as accessible check-out areas with additional signage. There is no current clearance, for which the library should ensure that reconfigurations provide a minimum unobstructed 30" x 48" parallel approach	\$100-499	2

3.12	<p>Accessible Restroom (D11)</p> <ul style="list-style-type: none"> a. Sign placed on the door b. Mirror is placed too high c. Sink does not provide appropriate toe clearance d. Hand dryer greater than 48" high e. Grab bar is less than 54" from rear wall f. Lock to the bathroom requires twisting of the wrist to operate 	<ul style="list-style-type: none"> a. Relocate the sign to the latch side of the door b. Lower the mirrors so reflecting surface is no higher than 40" above the ground c. Replace the sink or alter piping to provide 6" or less of toe clearance below d. Lower hand dryer to 48" from the ground e. Relocate grab bar 54" from rear wall f. Replace lock 	<ul style="list-style-type: none"> a. Maintenance b. Maintenance c. \$500-999 d. \$500-999 e. Maintenance f. Maintenance 	3

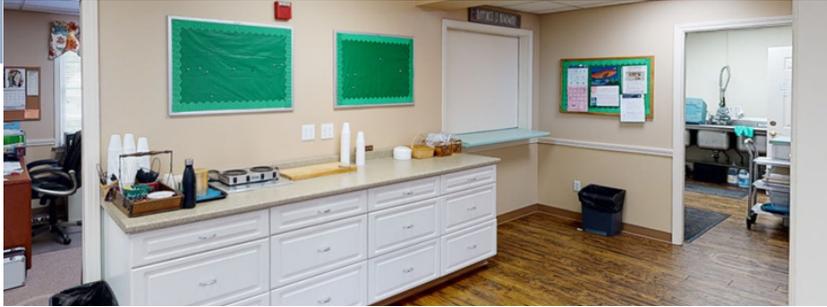
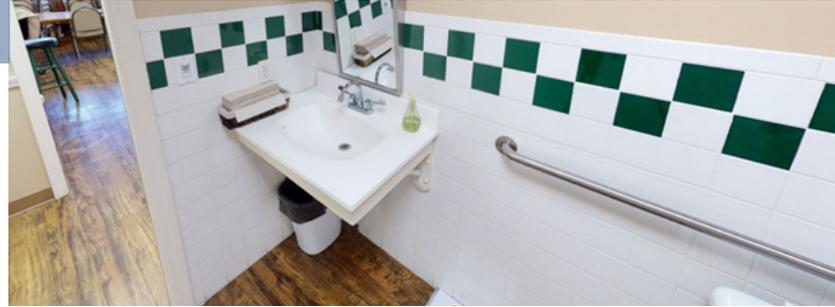
Ref #	Description	Recommendation	Cost	Priority
4.6	The edges of mats are not secured to minimize tripping hazards	Secure carpets to prevent hazards	Maintenance	2

4.7	Serving counter at the COA is greater than 38"	Lower counter or portion of the counter to 38"	\$100-499	2
4.8	All bathrooms on upper level lack directional signage	Install signs	\$0-99	3

4.9	Restroom Lower Level a. Signage, located on the door, doesn't indicate that it is accessible	a. Replace signage that provides high contrast writing and braille. Place on the latch side of door.	a. \$0-99	3

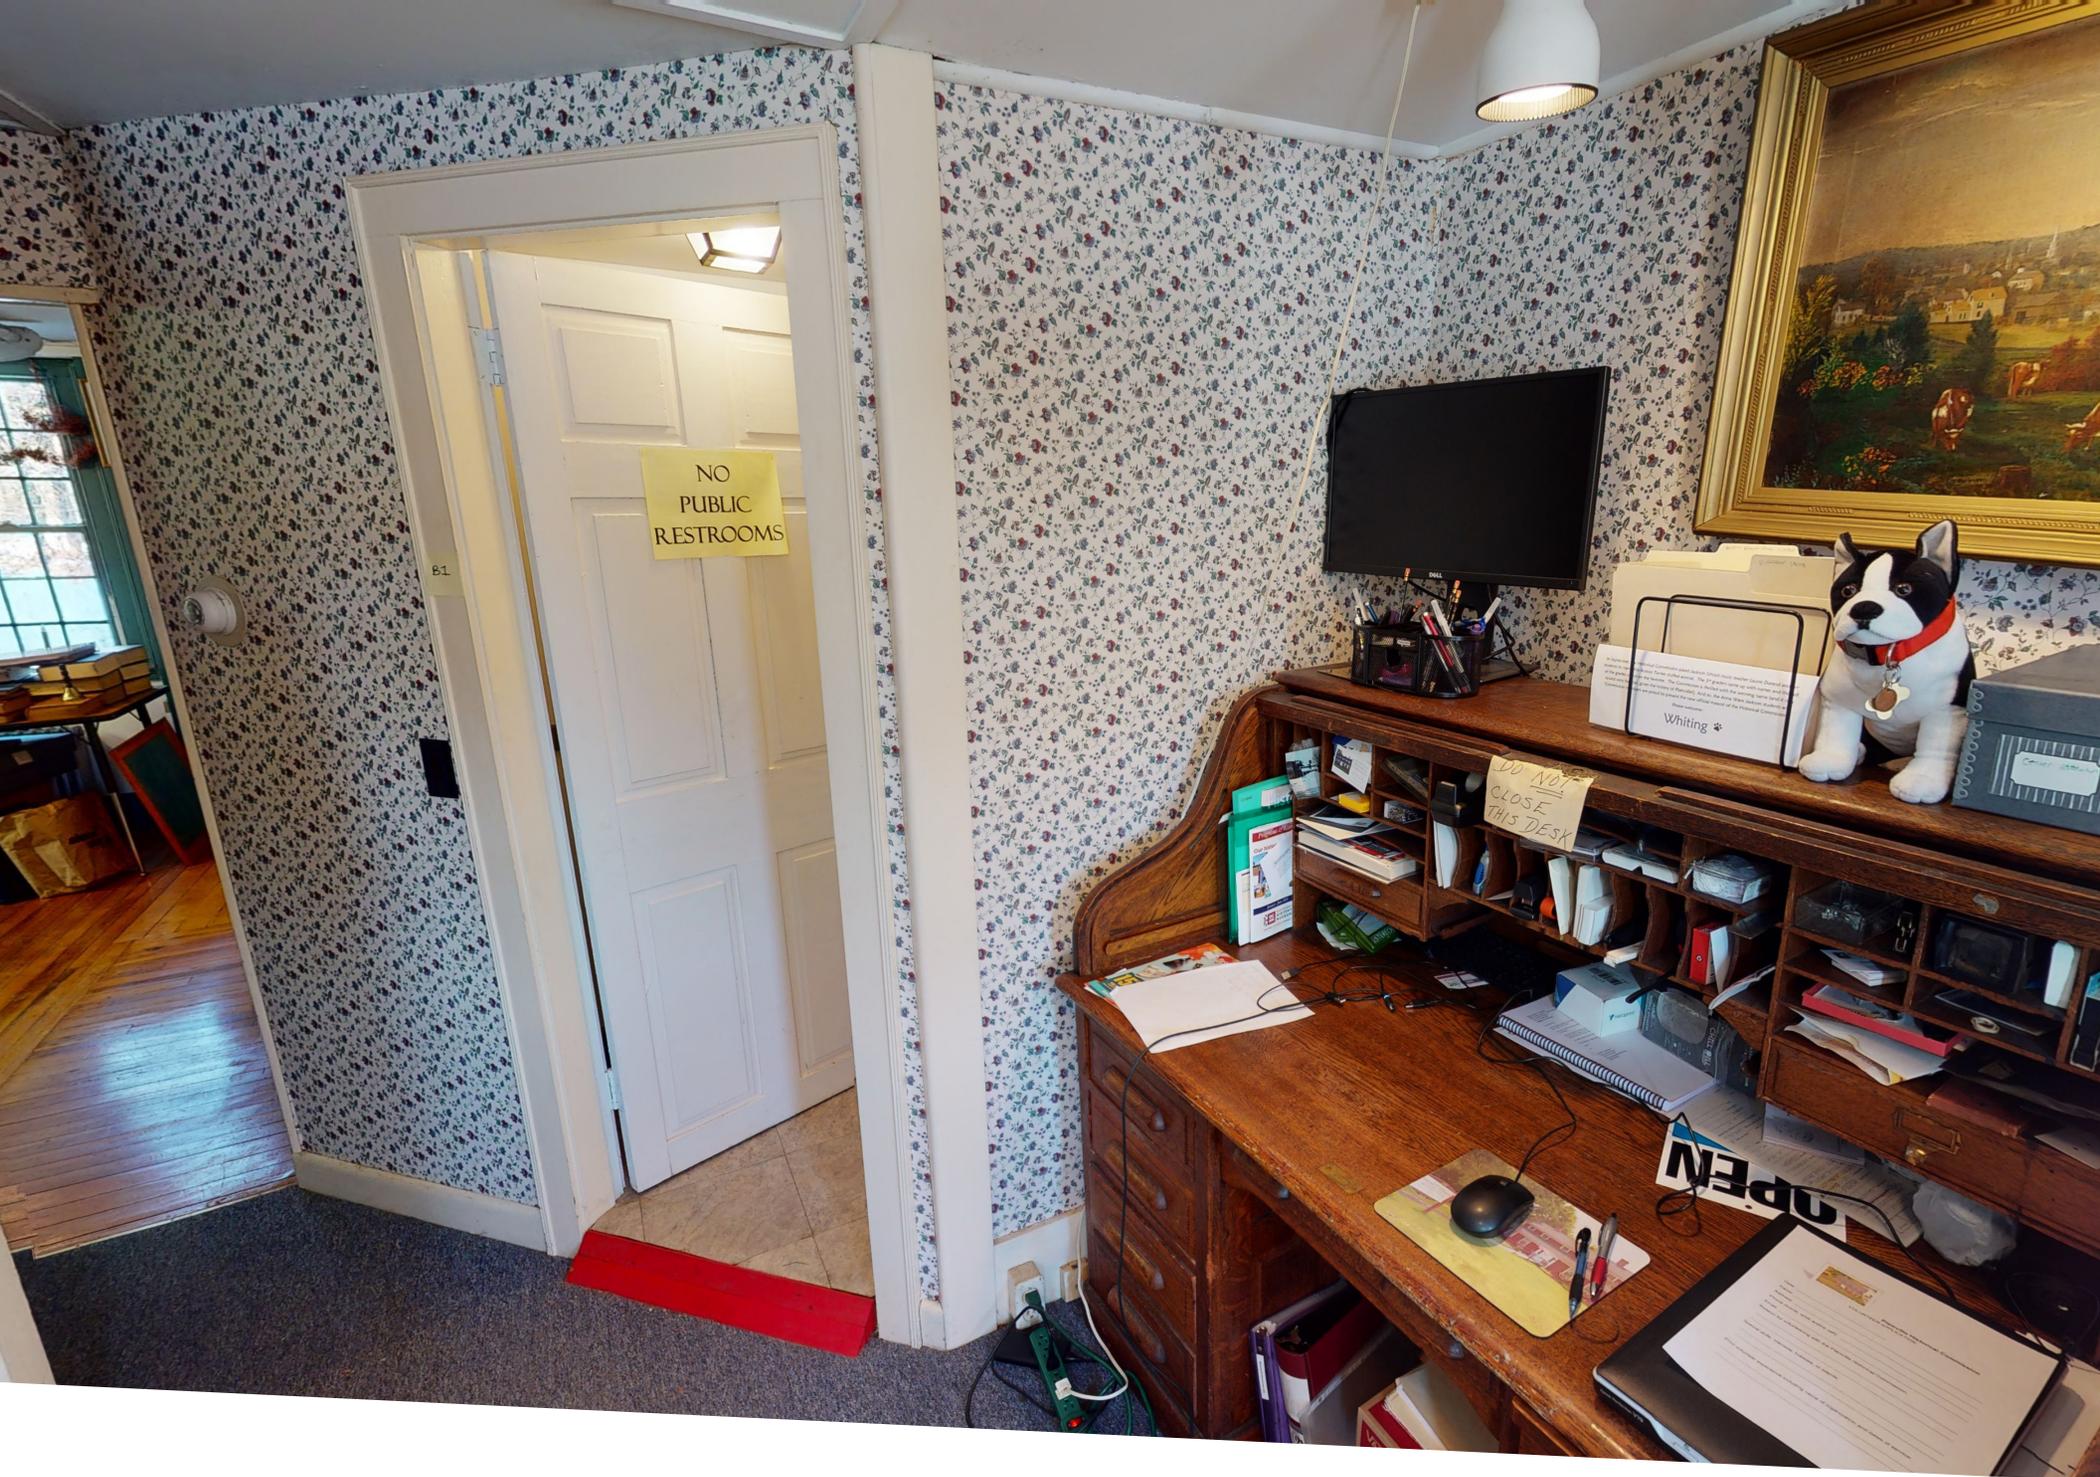
NO
PUBLIC
RESTROOMS

DO NOT
CLOSE
THIS DESK

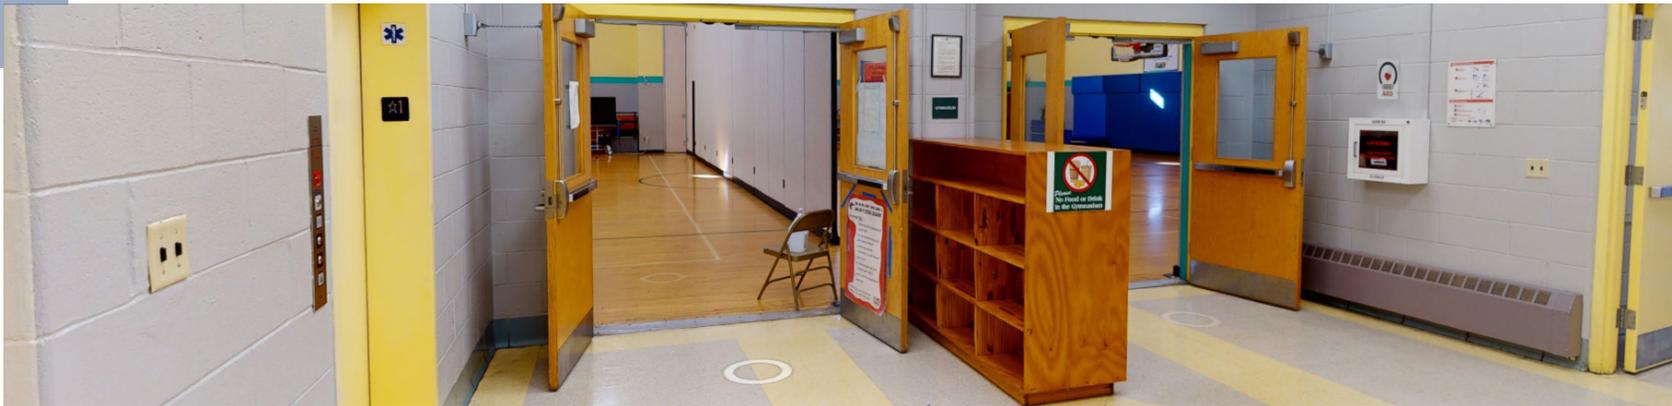
Ref #	Description	Recommendation	Cost	Priority
8.6	Gym Room directional sign obstructed by cubbies	Consider moving obstructions so there is a clear approach	Maintenance	2
8.7	Second floor men's restroom: a. Toilet height less than 17"	a. Replace toilet so it sits between 17"-19" from the top of the seat to the floor	a. \$100-499	3
8.8	Second Floor women's restroom (SW): a. Toilet height less than 17"	a. Replace toilet so it sits between 17"-19" from the top of the seat	a. Maintenance \$100-499	3
8.9	Second floor girl's Restroom: a. Does not provide appropriate toe clearance b. Door is not self-closing though enough clearance is provided to maneuver	a. Adjust or replace piping to allow 6" of toe clearance b. Adjust or install door-closer to automatically shut	a. \$100-4999 b. Maintenance	3

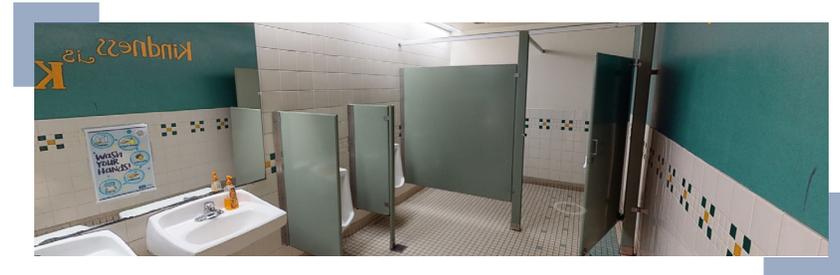
Ref #	Description	Recommendation	Cost	Priority
9.1	Boy's Restroom (A127) a. Side grab bar less than 54" from rear wall b. Door to stalls are not self-closing	a. Relocate grab bar to 54" from rear wall b. Install closer	a. Maintenance \$0-99 b. \$0-99	3

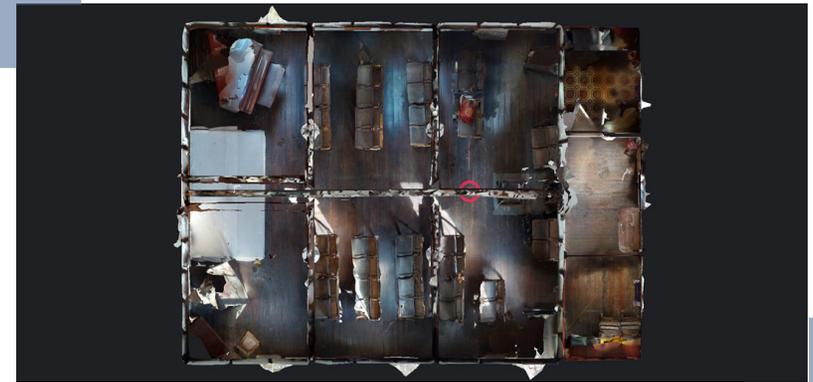
Ref #	Description	Recommendation	Cost	Priority
10.1	Lacks all parking amenities including accessible and van spaces	Limitations of the site and lack of existing pavement require extensive work. May not be feasible.	\$10,000+	1
10.2	Main entrance threshold greater than 1.5"	Should the town choose to convert this building into a public space they should consider installation of a ramp system for access	\$1,000-4,999	1
10.3	Lacks any public restroom facilities	Should the town choose to convert this building into a public space they should provide a public restroom as an addition to the building to maintain its historic character	\$1,000-4,999	3

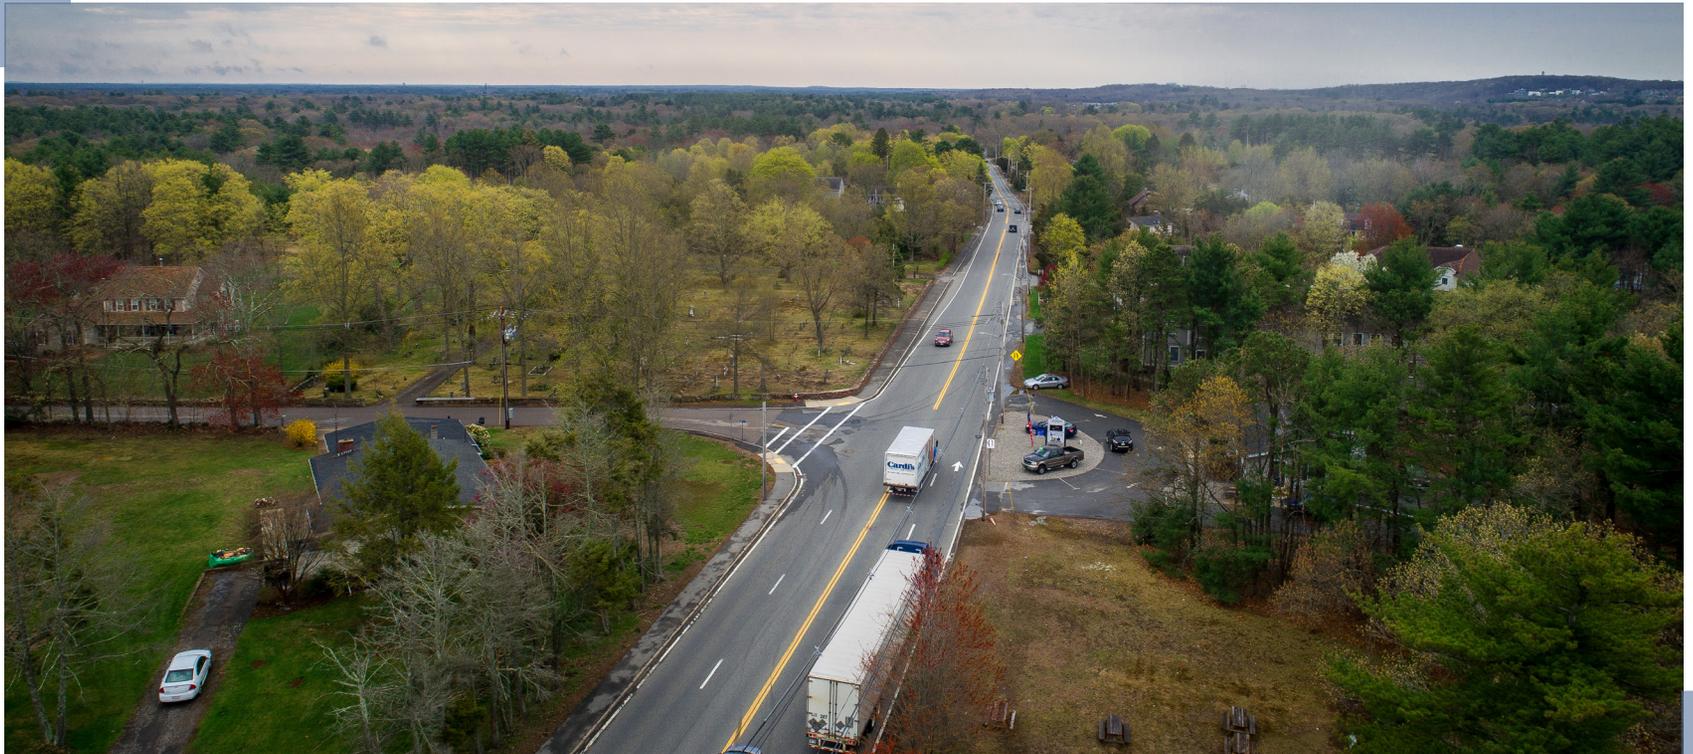
Quarter-Mile Facilities Walkshed

As part of the ADA Self-Evaluation and Transition Plan, the Town pursued an assessment of the 1/4-mile walkshed to and from public facilities along locally owned and maintained roadways. The assessment highlights inaccessible routes, pavement condition, as well as the need for sidewalks, and crosswalks at specific junctions. The findings from the survey show that Plainville requires modernization of their sidewalks including repaving, removal of barriers, as well as additional tactile warning signs.

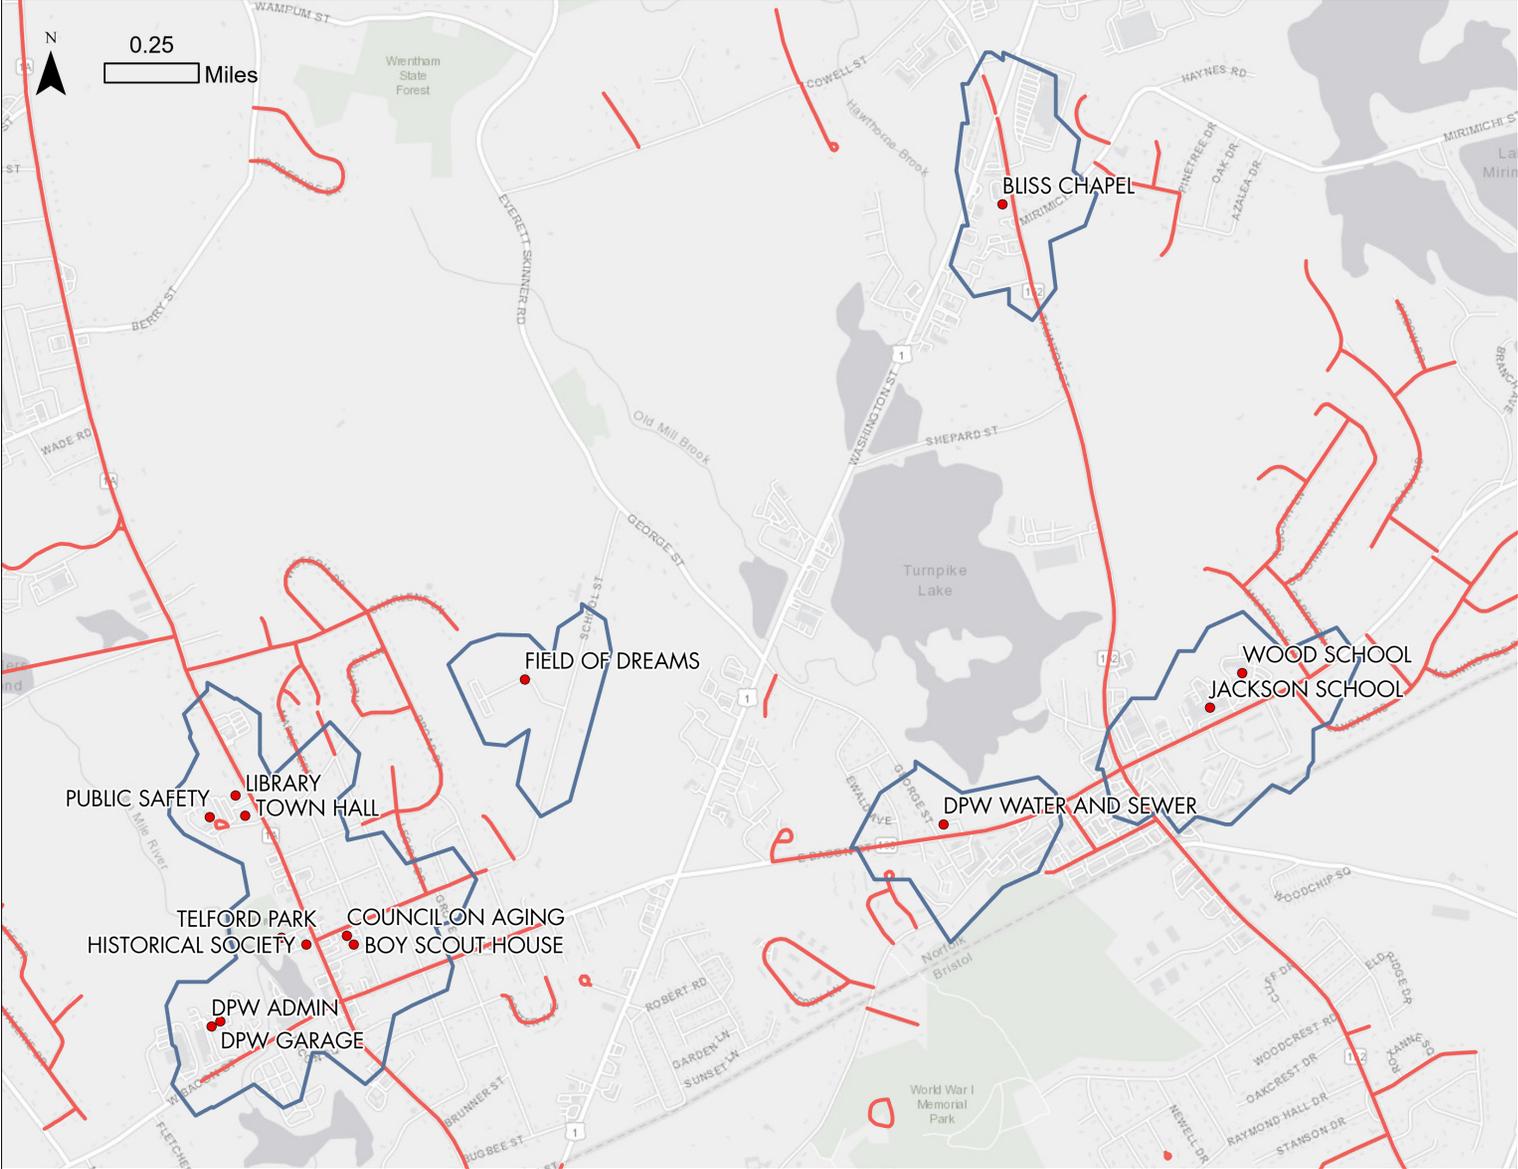
Existing Sidewalk Network

Street	Facility	Description	Recommendation	Estimate
South Street (From Hawthorne Drive to Bugbee Street)	Town Hall Police Fire Public Library Historic Commission Senior Center Boy Scout House	Sidewalks <ul style="list-style-type: none"> • Width less than 5ft • Poor condition • Uneven slope • Lack tactile warning panels 	<ul style="list-style-type: none"> • Replace the existing sidewalk surface with a new 5-foot-wide asphalt sidewalk with asphalt curbing on the left side of the road (Sharlene Lane to 439 South Street) • Install a new 5-foot-wide asphalt sidewalk with asphalt curbing on the left side of the road (439 South Street to the Wrentham Town Line) • Add ADA compliant curb ramps with tactile warning panels and high visibility crosswalks at all intersecting streets 	\$600,000
Taunton Street (From Washington Street to Shepardsville Drive)	Bliss Union Chapel	Sidewalks <ul style="list-style-type: none"> • Poor condition • Lack tactile warning panels • Lack crosswalk striping at appropriate locations • Shrubs and vegetation obstruct path 	<ul style="list-style-type: none"> • Replace the existing 5-foot-wide asphalt sidewalk with a 10-foot wide bidirectional sidepath on the right side of the road (Mirimichi Street to Washington Street) • Add ADA compliant curb ramps with tactile warning panels and high visibility crosswalks at all intersecting streets • Add striping to crosswalk at Mirimichi Street and Taunton Street • Maintain shrubs and vegetation to prevent obstructing sidewalk pathway 	\$200,000
