# **Route 6 Westport / Dartmouth Safety Study**

**November 2003**

**Southeastern Regional Planning and Economic Development District**

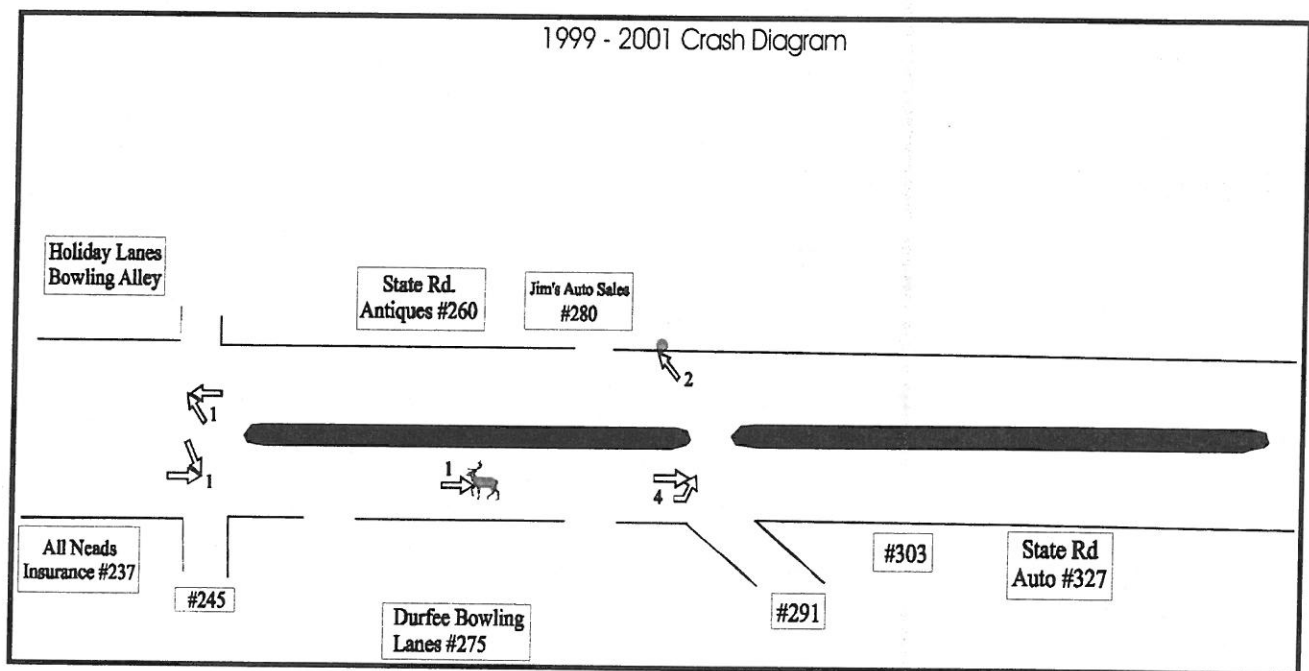
Figure 11  
Route 6 (Holiday Lanes Bowling Alley to State Road Auto) Crash Diagram

Noting the number and type of crashes, there does not seem to be any safety issues or design problems along this particular stretch of Route 6 at this time. (See Figure 11, below). There were, however, two crashes that either involved, or were caused by deer attempting to cross Route 6. In total, there were eight of these accidents during the study period. Since deer generally follow the same paths year after year, fencing along certain areas of Route 6 may help, but installation could be costly and could involve both public and private property. The Massachusetts Division of Fisheries and Wildlife can better advise the town on how to proceed. At the very least, deer crossing signs approaching locations where there have been deer mishaps, is recommended.

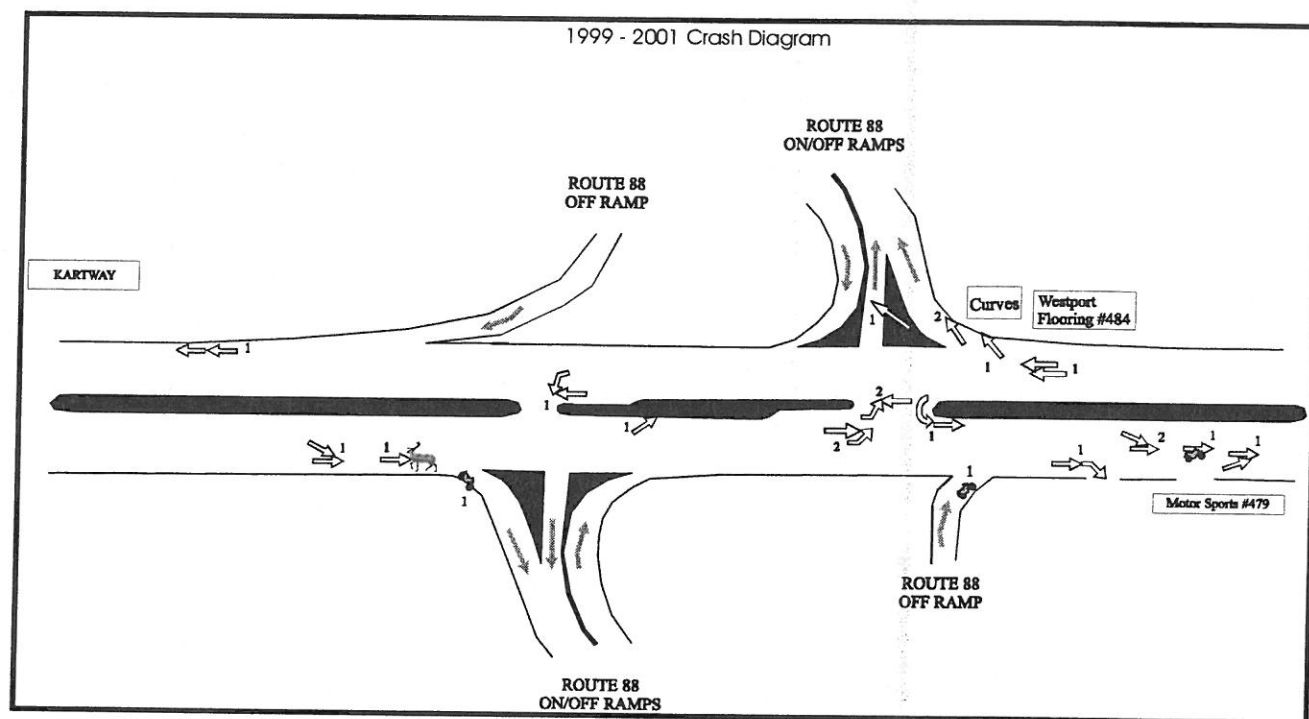
Figure 12  
Route 6 - (Kartway to Motor Sports) Crash Diagram

Once again, there do not seem to be any safety or design issues along this segment, but it should be noted that this is a stretch where two deer mishaps occurred and deer crossing signs should be considered here, as well. (See Figure 12, below).

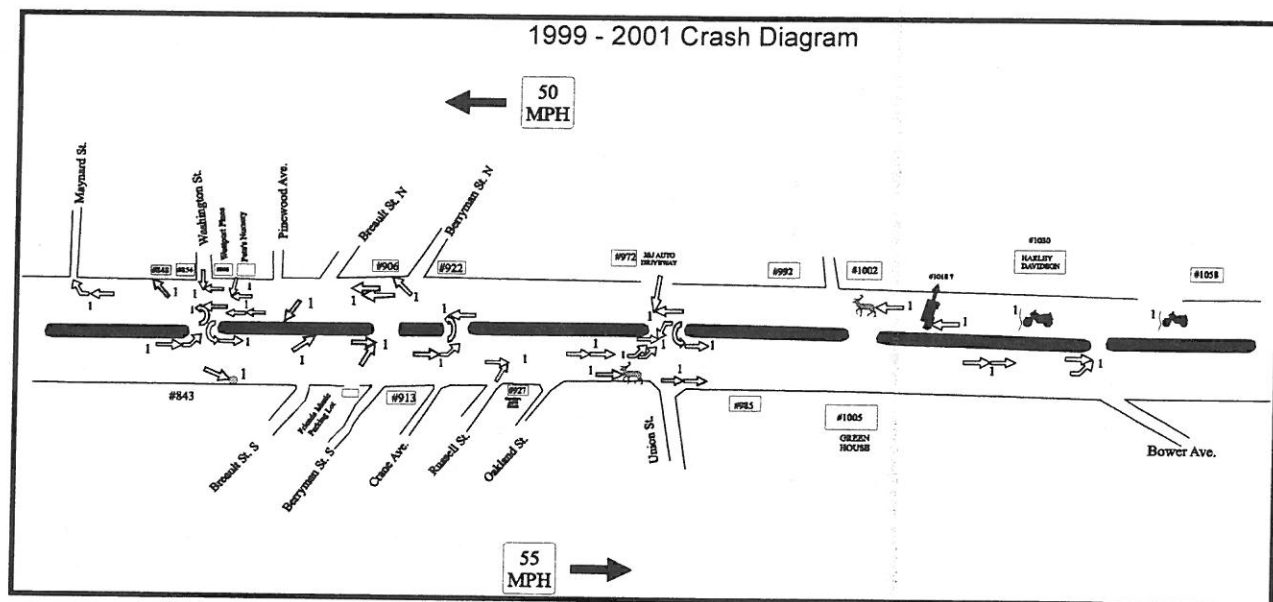
Figure 18  
Route 6 - (Maynard Street to Town Square Plaza) Crash Diagram

Although this is a section that does not experience a large number of crashes, a number of the crashes here were directly due to excessive speed. A greater police presence here may be advisable, if only to insure that this does not become a safety problem. This is also a section where two deer mishaps occurred, so deer crossing signs are also recommended. (See Figure 18, below.)

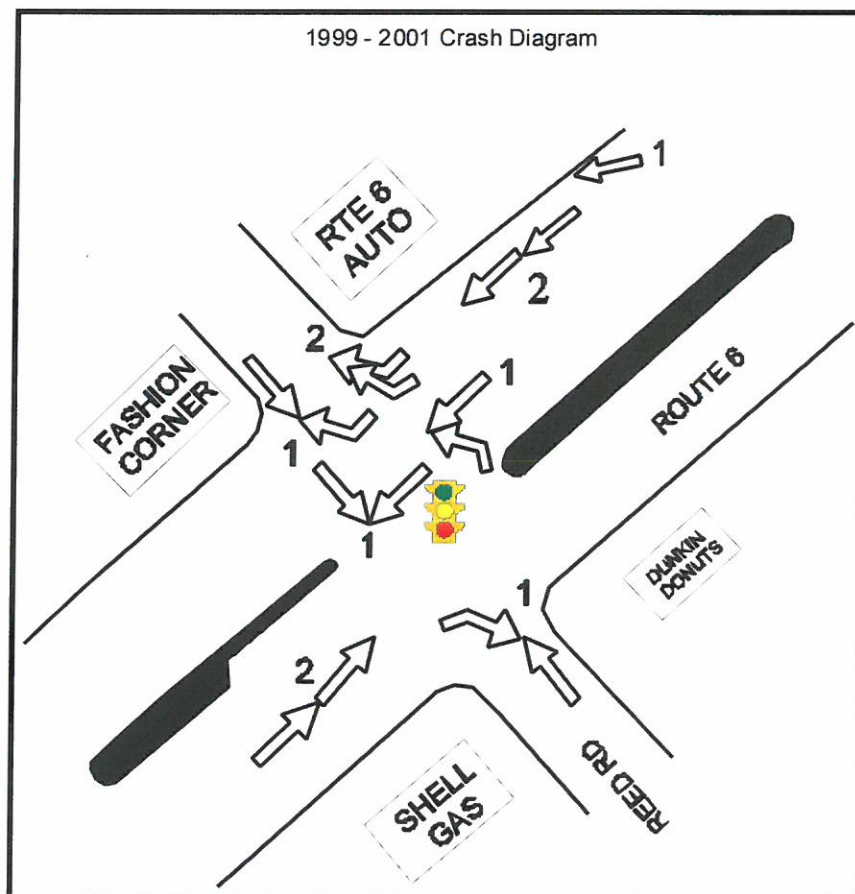
**Figure 24**  
**Route 6 - Barbero's to Reed Road Crash Diagram**

This section includes the intersection of Route 6 and Reed Road in Dartmouth, which saw only 11 total crashes during the study period. (See Figure 24, below.) There do not appear to be any safety or design issues at this intersection or in this segment of the corridor.
