GRRIP II Watershed Analysis for Rehoboth, MA

Estimates of Land Use, Impervious Surface and
Annual Nonpoint Source Pollution Loads

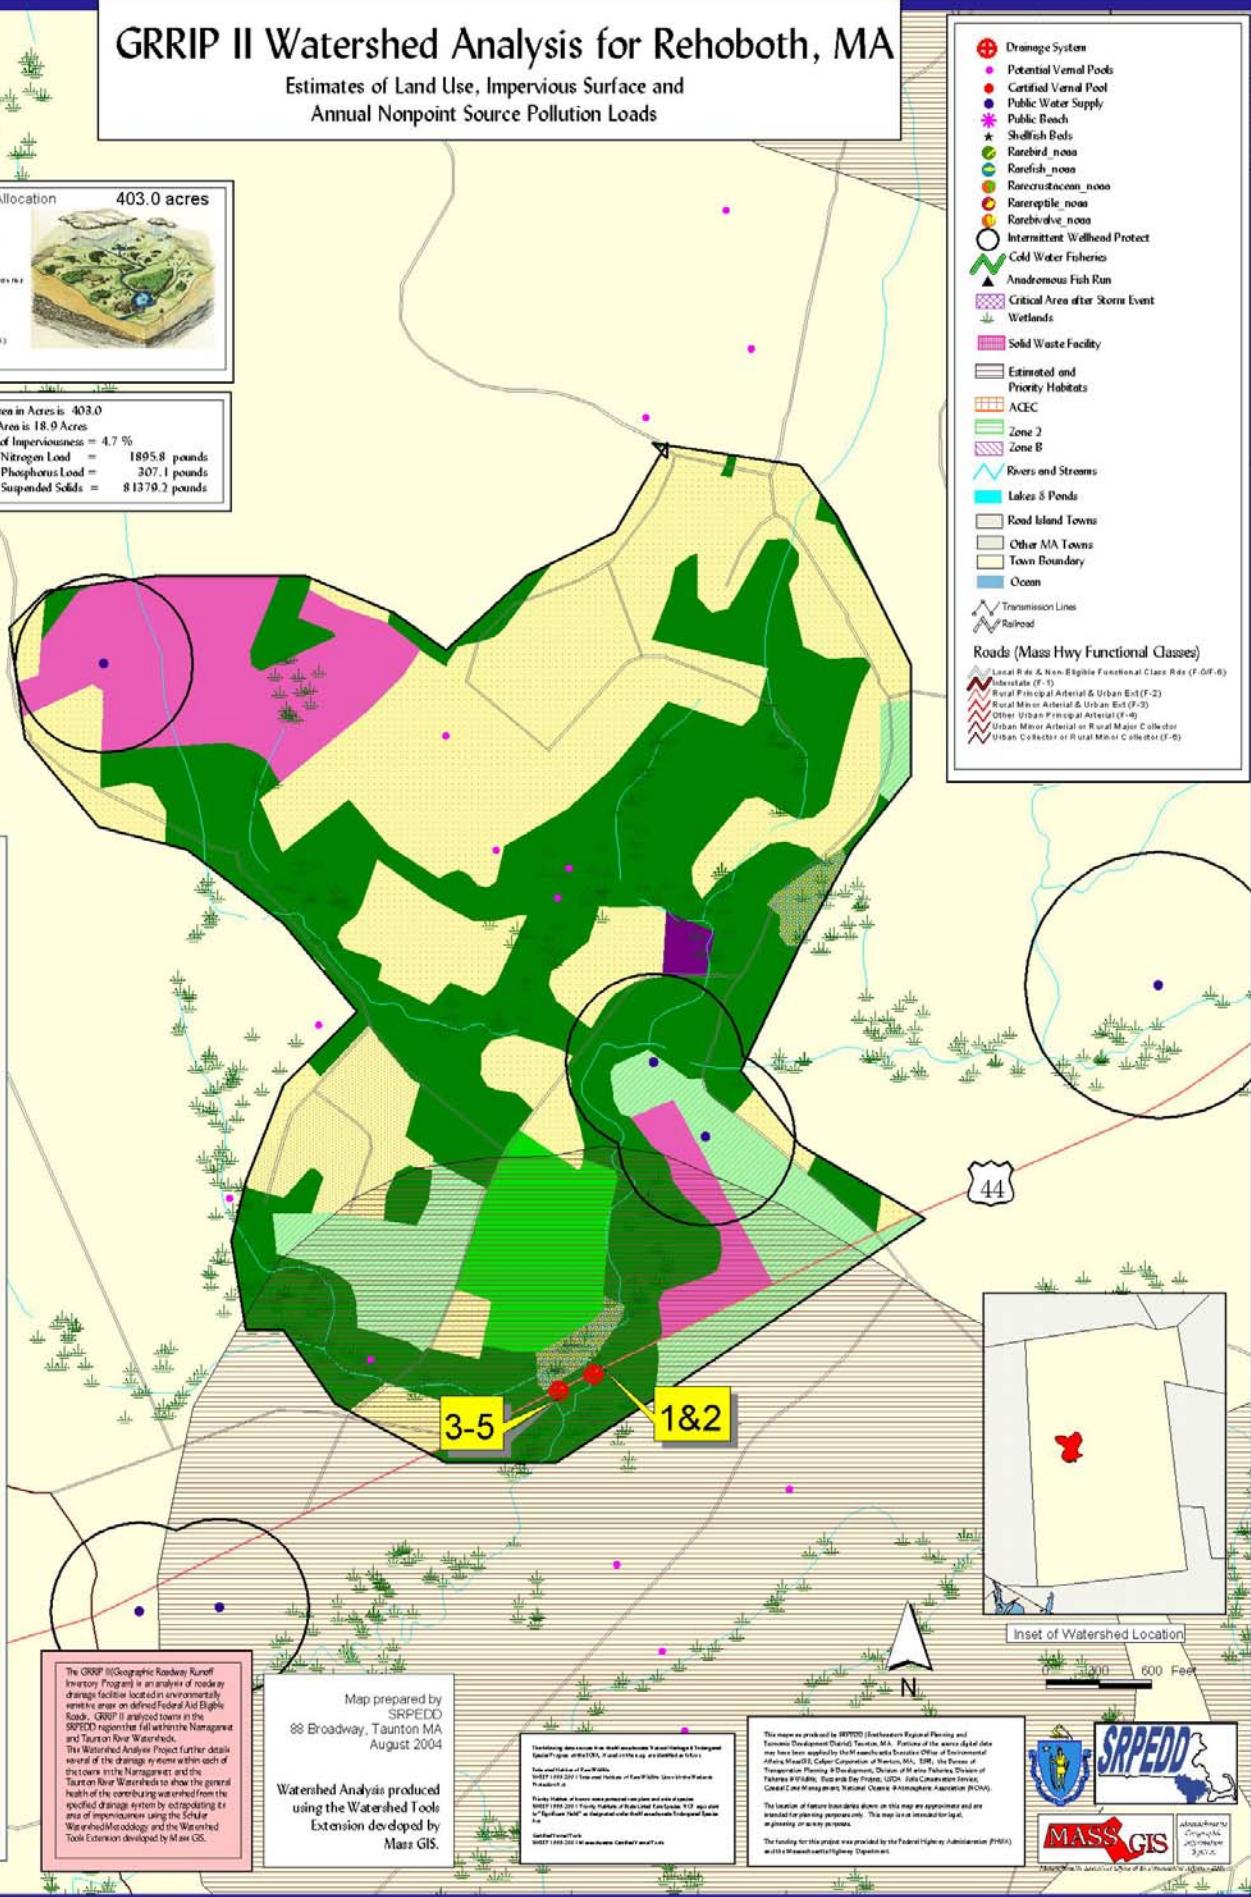
5

Route 44, bridge between Danforth and Broad Streets: east side of Route 44, there is a paved main near the bridge, a paved shoulder, and a paved shoulder through vegetated understory. The paving is in good condition. The headwall on the bridge has fading and cracking concrete. These structures are located adjacent to and over the Palmer River in a priority habitat and near a small community water supply/wellhead.
